**BRH ADMIN BUILDING EXTERIOR EVELOPE REHAB  
Contract No. BE23-199**

**ADDENDUM NO.: ONE**

# Siding & Window Investigation

8/30/2022  
Jensen Yorba Wall, Inc.  
Dan Fabrello

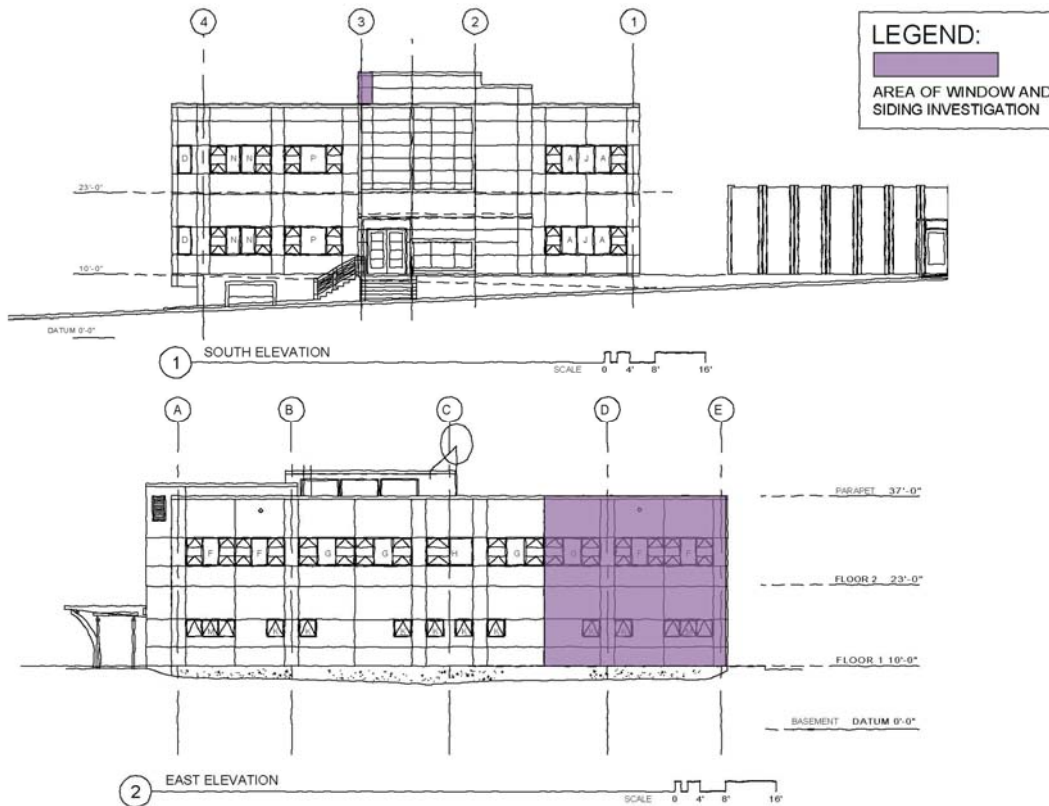
It appears that there are a few paths for water intrusion into the building envelope. The primary cause appears to be the exposed fasteners and the caulked joints in the siding panel joints. These penetrations and joints could allow water to deposit behind the metal wall panels and travel horizontally into fenestrations along the face of the weather barrier. Another is the water that has deposited at the base of the wall panels and wicked up into the plywood substrate. Water intrusion through the weather barrier into the plywood substrate through siding fastener perforations, deteriorated staples perforations, and the manufactured micro perforations in the weather barrier. The welded aluminum window trim and exposed fasteners at the trim could be a possible path for water intrusion. The window trim design should be part of a comprehensive window and siding project.
