Gastineau Elementary

Douglas, Alaska

Facility Condition Survey Report Prepared June 2005

By NorthWind Architects, LLC, PN&D Inc., Haight & Associates,
Murray & Associates, and City & Borough of Juneau Engineering
Department

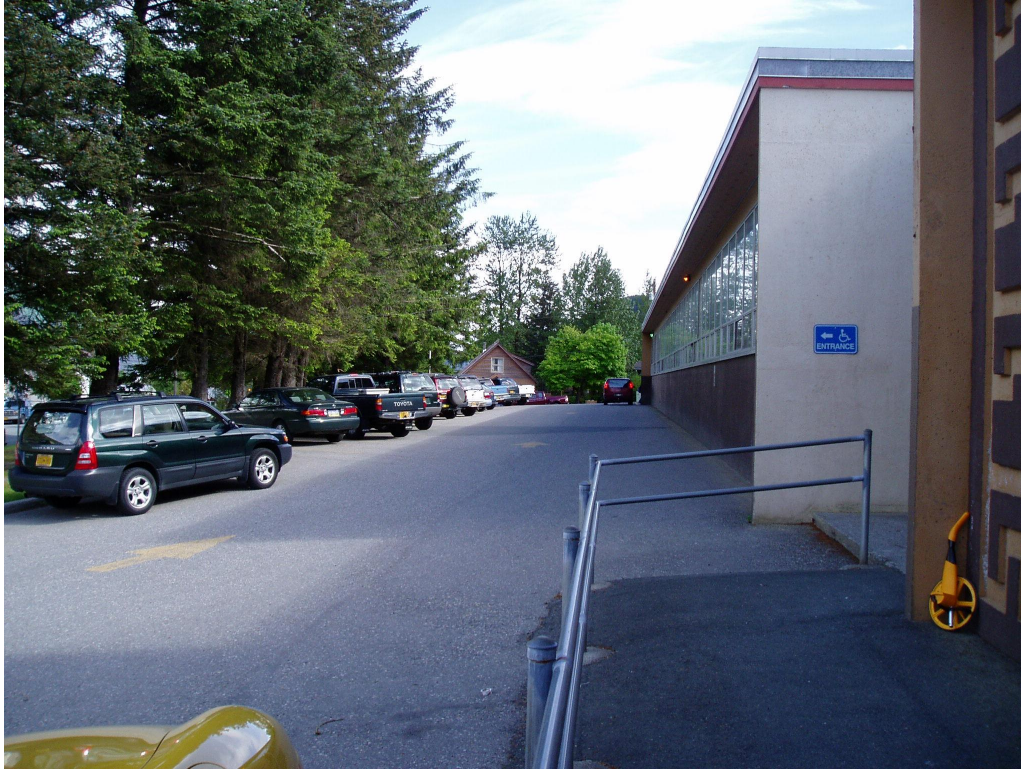
0131-1 Inadequate Parking: Existing parking spaces, not counting the spaces in the snow storage area, number 38 and CBJ Land Use Code requires 48 spaces (based upon 2 per classroom). The spaces south of the library may not be useable in winter as that is a designated snow disposal area. Additional spaces may be needed if one considers that there are seven offices and the library, which add additional parking demands. Community events at the gymnasium or open-house activities are likely to require more parking. During the different days of inspecting the school building, there was rarely a free parking spot to be found.

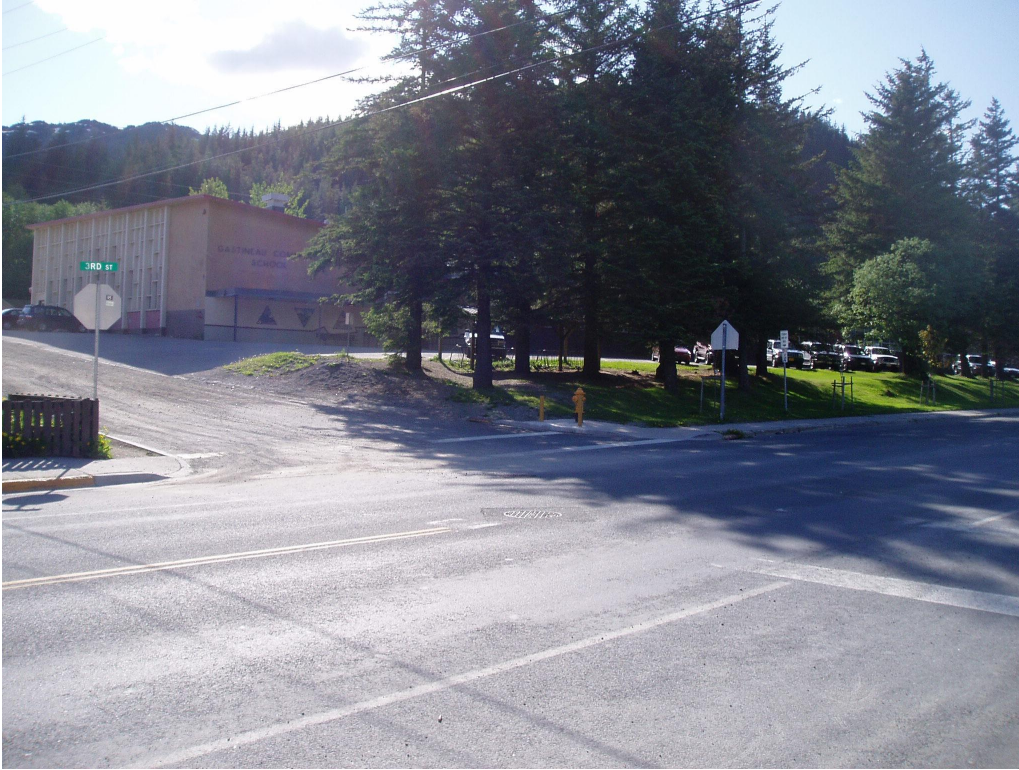
0132-1 Inadequate Drop Off Zone:

The designated drop off zone is along 3rd Street. This is often not used as there is no designated path between the street sidewalk and the paving at the main entry. As a result parents drop children off at the main entry. This causes students arriving on foot to cross the traffic lane. As there is no defined crosswalk or path the situation is likely very confusing and has a high potential for an accident.

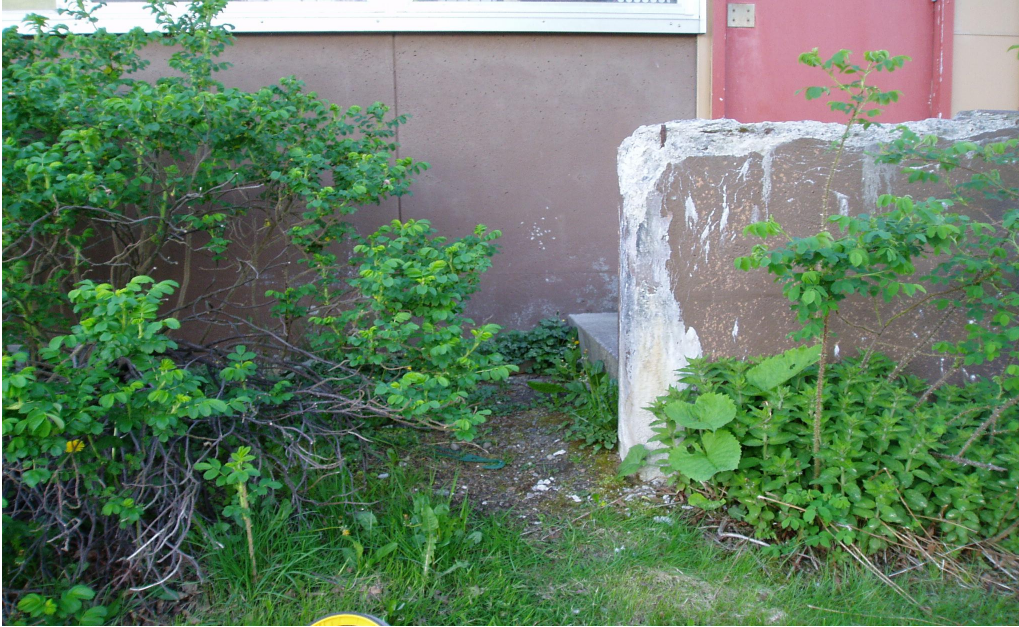
0132-2 No Landings at Classroom Exits

At the east side of the building exits from classrooms have stairs but no landings at the base of the stairs. Areas where there should be a landing are overgrown. In an emergency egress of students is likely to be confusing without a clearly designated path. There are 5 locations where this deficiency exists.

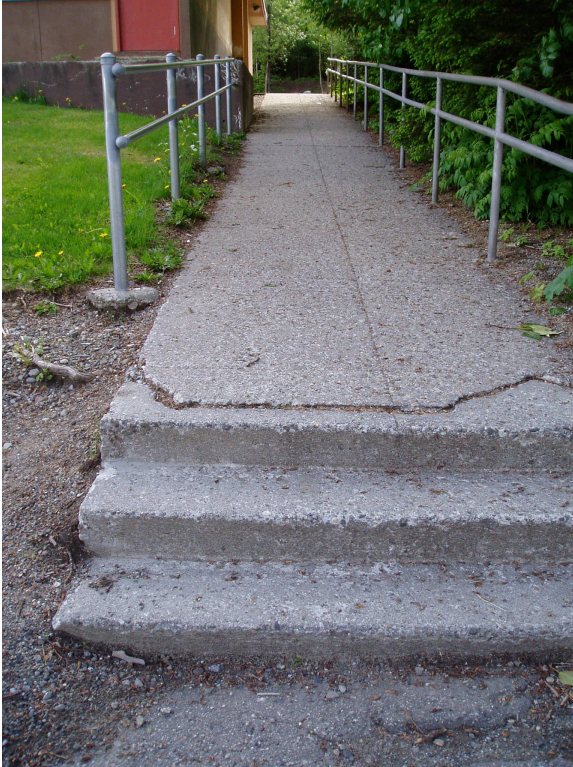
0132-3 Poor Condition Concrete:

The walk leading to the north building entrance should be replaced as the concrete is poor. The spall/poor patch at the main entry should be repaired. The surface of the concrete slab at the east entry at center of building should be repaired or replaced.

Replace 750SF of concrete walk. Repair spall and repair entryway concrete

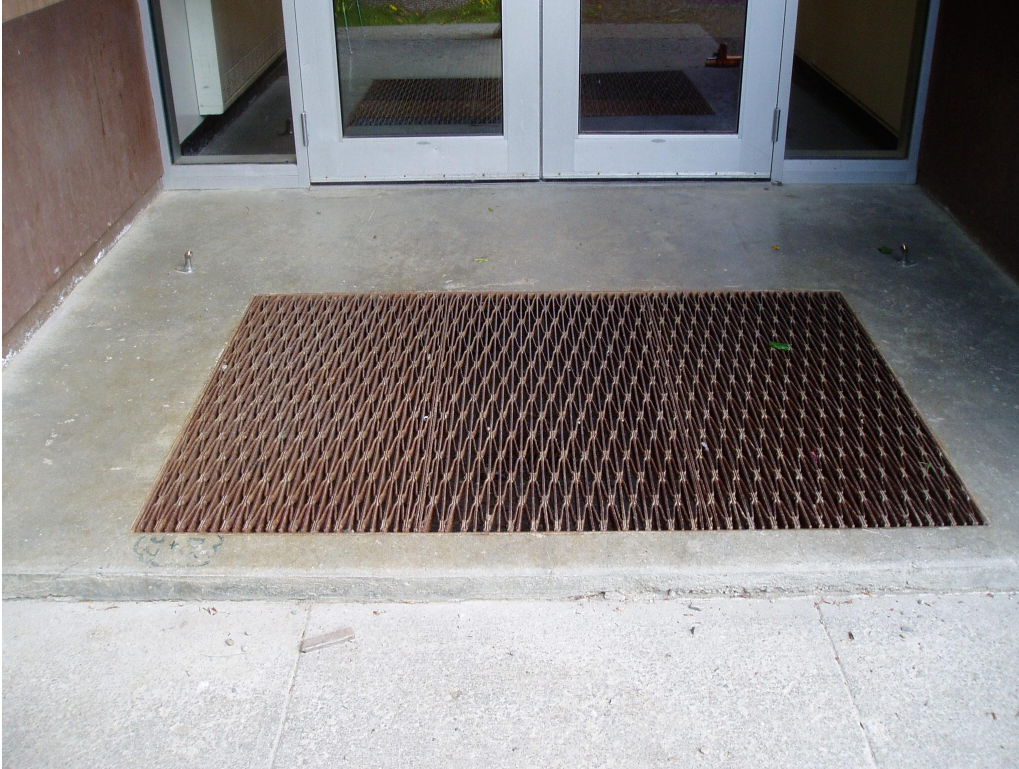
0132-4 Inset Grating not ADA Compliant:

Inset grating at the north and west central entries has openings greater than ADA allows.

Replace grating with ADA compliant grating (approximately 72 square feet)

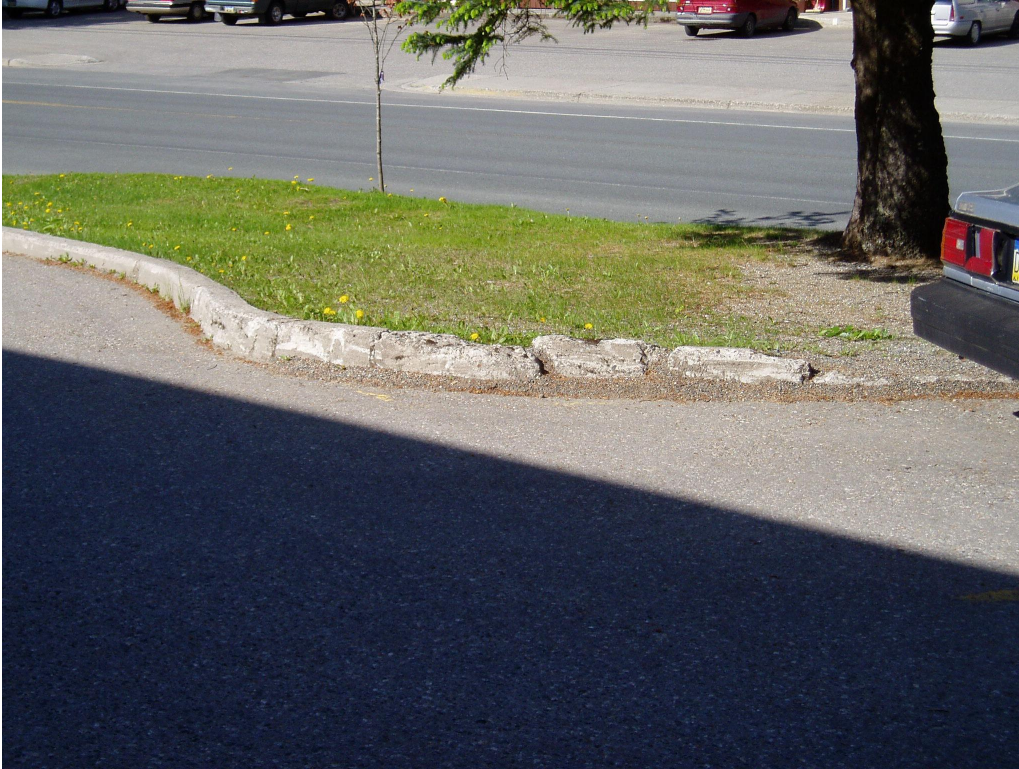
0132-5 Curb East of Building:

Curbs at edge of access drive are in poor condition. (approximately 76 lf)

Remove and replace 76 LF of concrete curbs.

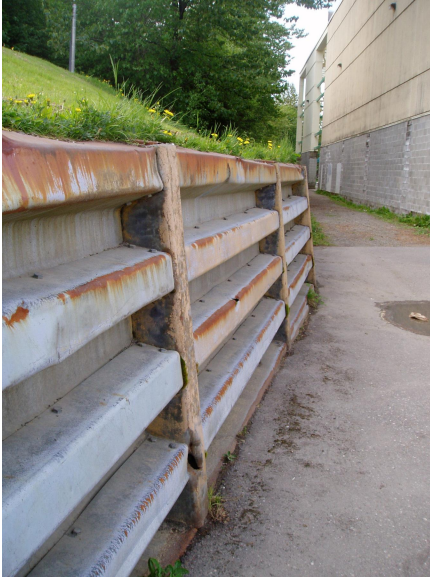
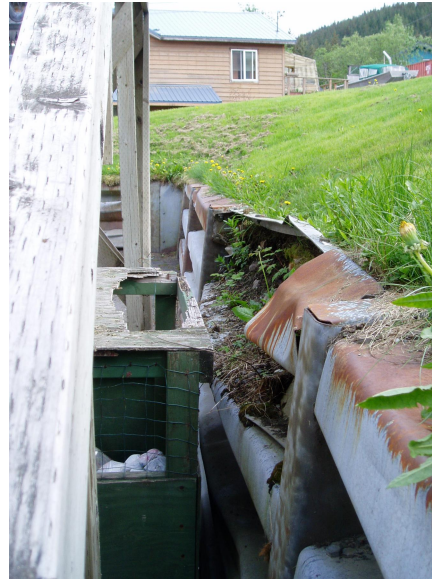
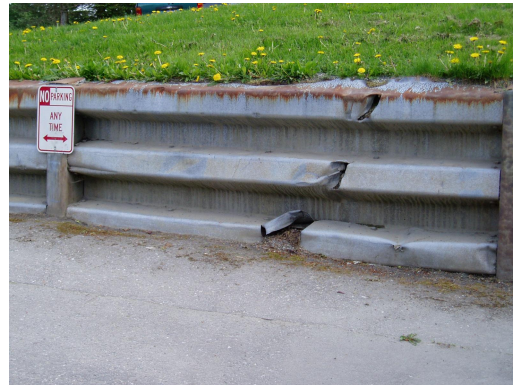
The bin wall is in poor to fair condition. At the paved area southwest of the building the bin wall has punctures and has one section missing. Galvanizing is depleted at the top of the wall and at exposed faces of horizontal members. There is rust evident where galvanizing has been depleted.

0135-1 Bin Wall Coating:

The bin wall will continue to corrode if existing coatings are not improved. The bin wall should be able to last for decades if it is painted.

Clean and paint 2,800 SF of bin wall with a moisture cured urethane paint system. This system can be applied during low temperatures and high humidity conditions.

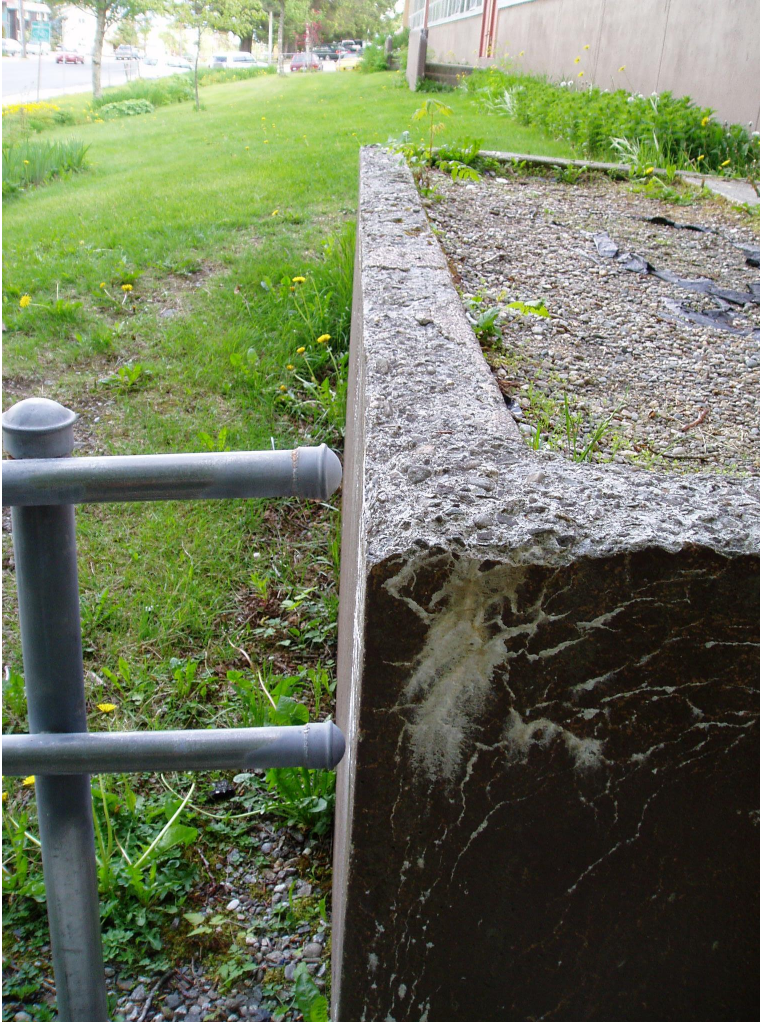
The concrete retaining walls are in poor to fair condition. There is efflorescence, cracking and spalling. Estimated life of these walls is 5 years.

0135-2 Concrete Wall Poor Condition:

Deteriorating concrete will continue to deteriorate if not repaired. The top of all retaining walls at east side of building classroom exits are in poor condition.

Remove and replace deteriorated concrete

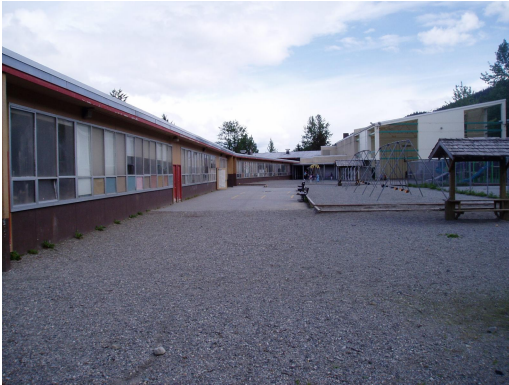
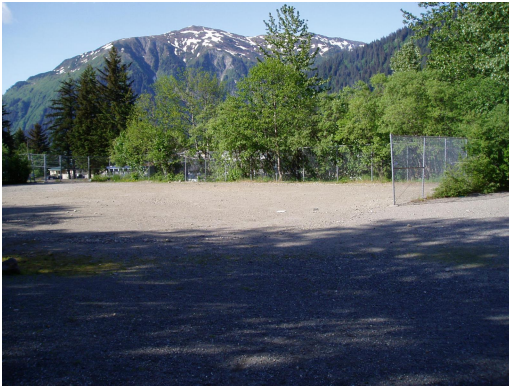
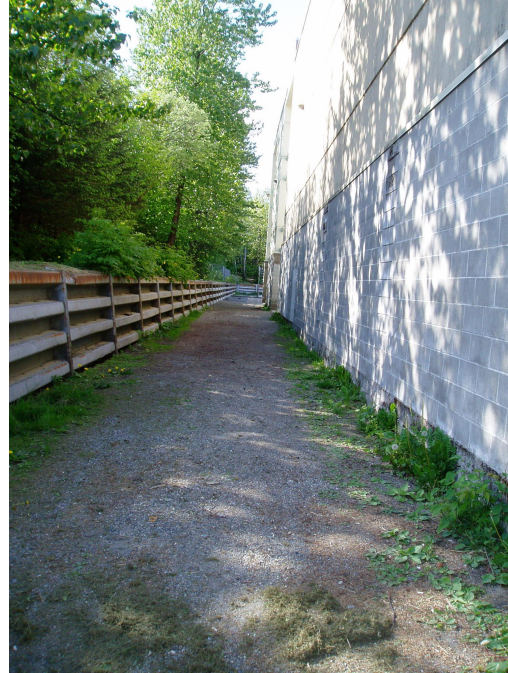
0153-2 Improve Playground Drainage.

School personnel report that there is ponding in winter during heavy rains. In near freezing weather rainwater freezes on the frozen ground creating ice hazards.

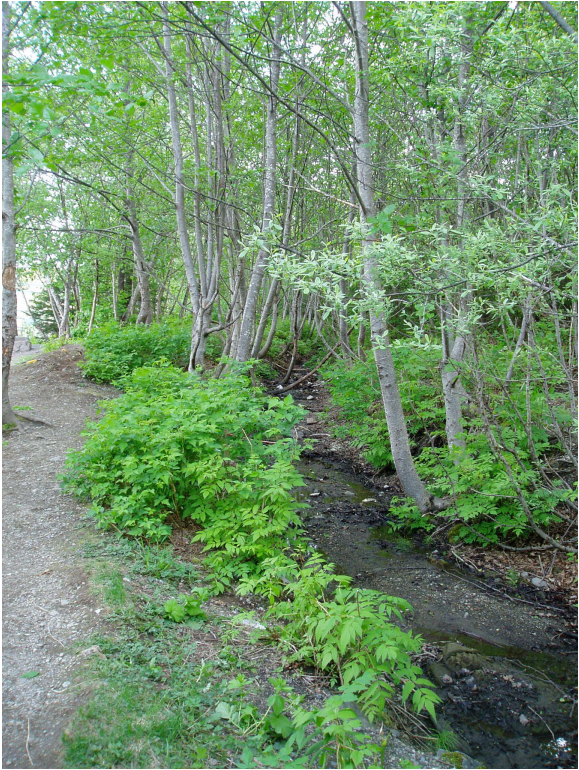
0153-3 Clean Drainage Swales/Ditches

Drainage swales and ditches uphill from playground are overgrown, thus reducing the ability of the ditches and swales to drain.

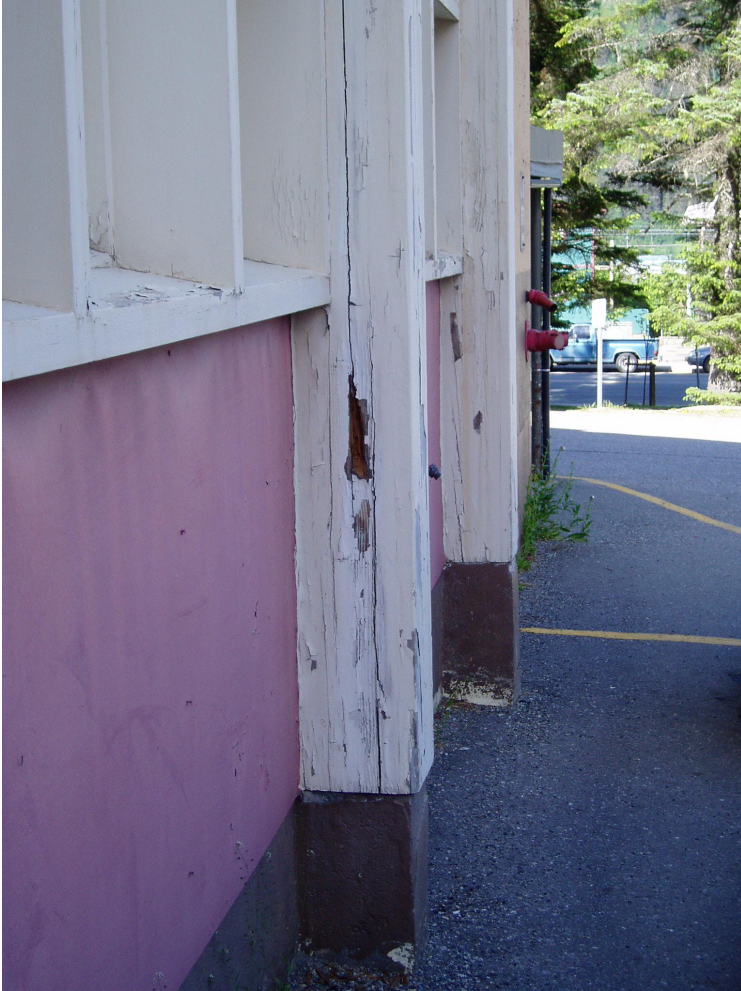
0321-1 Library Wall Columns

The exterior portions of most of the library exterior wall columns exhibit rot. These glulam timber columns extend from the interior to the exterior of the building and have little or no separation at their bases from water accumulating at grade.

Rehabilitate or replace columns. Rehabilitation will require removal of rotten laminations from the base to an elevation where the laminations are not rotten. New laminations will need to be installed using glue and screws to secure them to the solid material to remain.

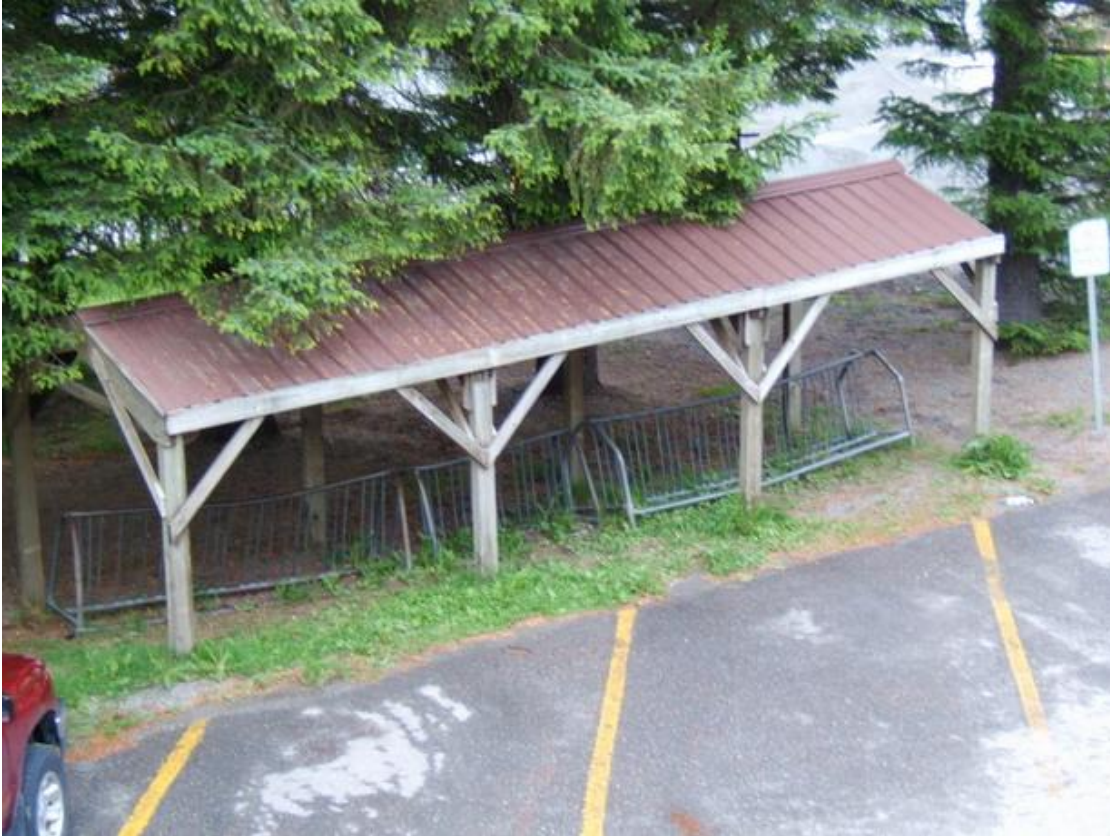
0141-1 Bike rack shelter location and grading

The bike rack shelter grade is below that of the adjacent parking area and is subject to drainage off the asphalt. Due to proximity of parking area, snow plowed off parking is piled under the shelter roof. This snow berm takes a long time to melt in the spring, hampering early season use of the bike rack shelter.

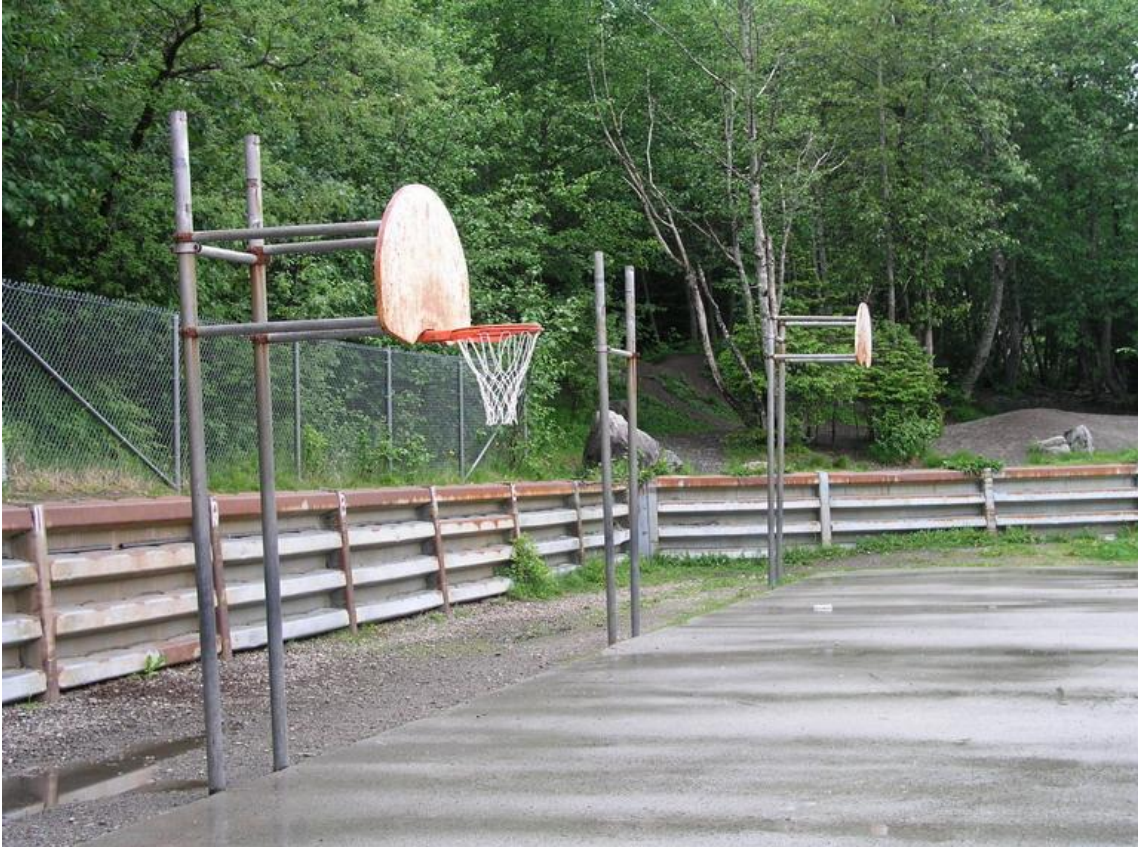
0141-4 Outdoor basketball backstops

Existing equipment is missing pieces and is in generally poor condition.

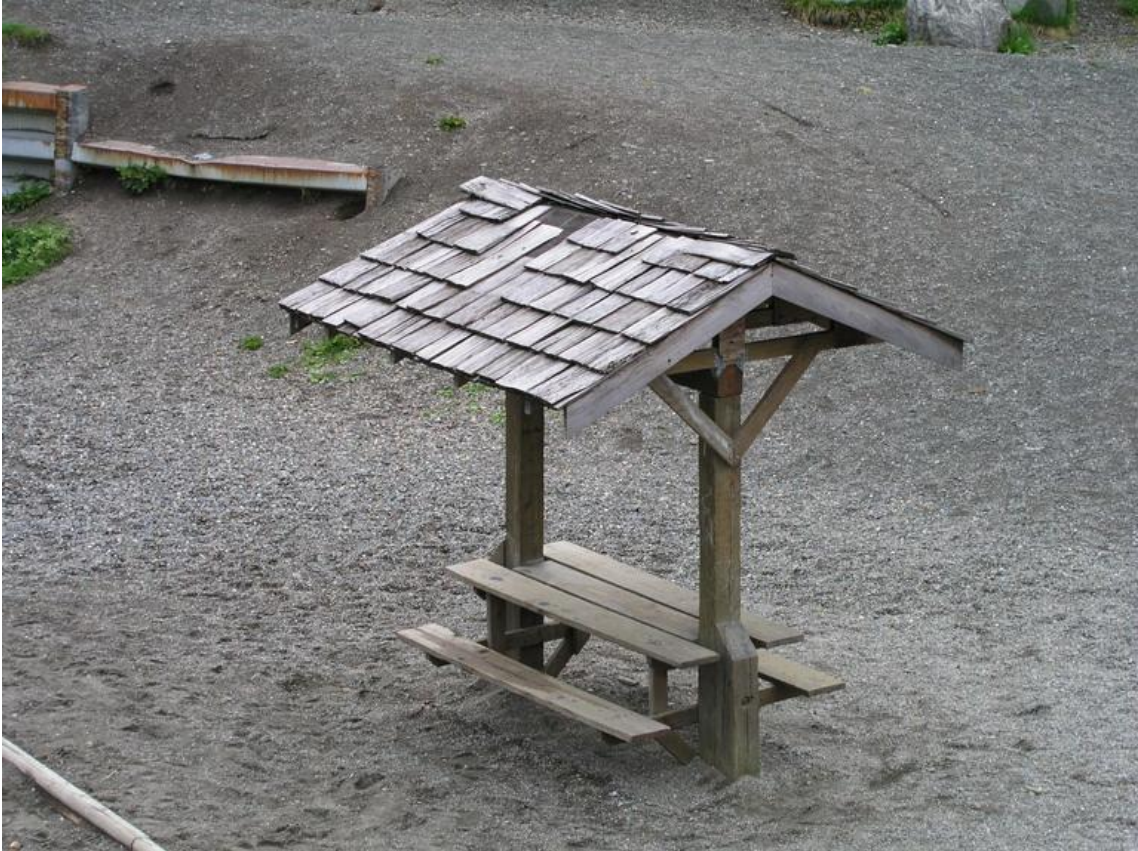
0141-5 Covered outdoor picnic tables

Cedar shake roofing in disrepair at three site structures

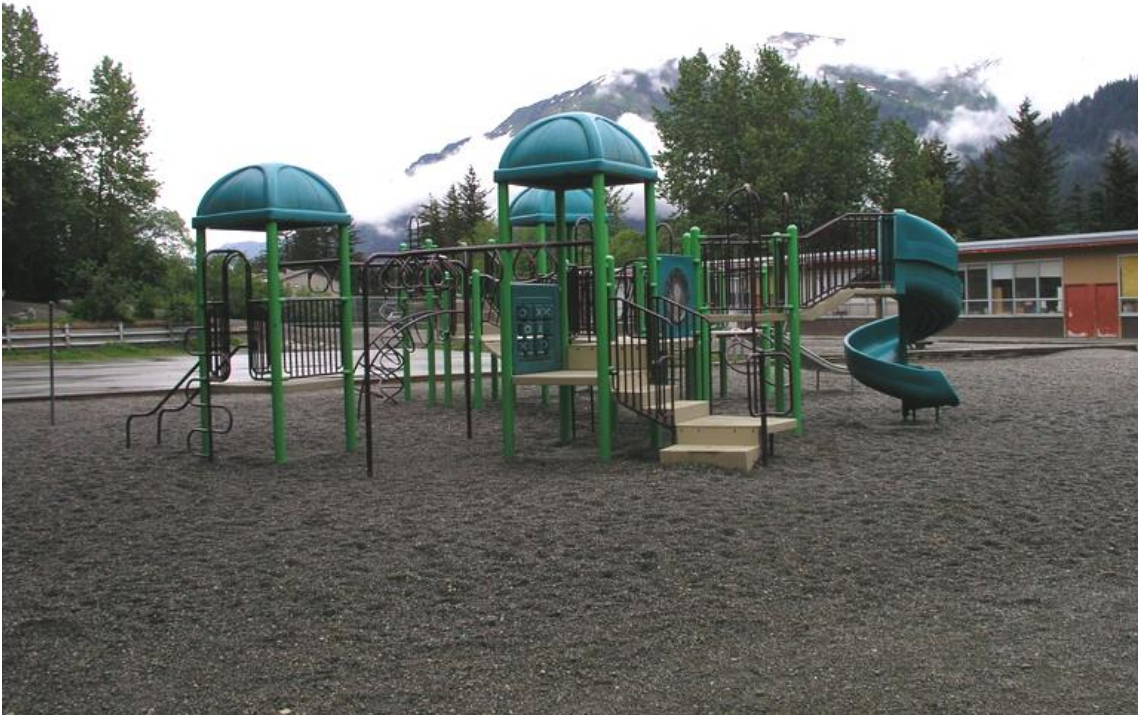
0141-6 Fall Protection

Pea gravel is utilized as fall protection surface at Primary climbing equipment. Pea gravel doesn't provide sufficient fall protection during below freezing weather and does not provide ADA access to play equipment.

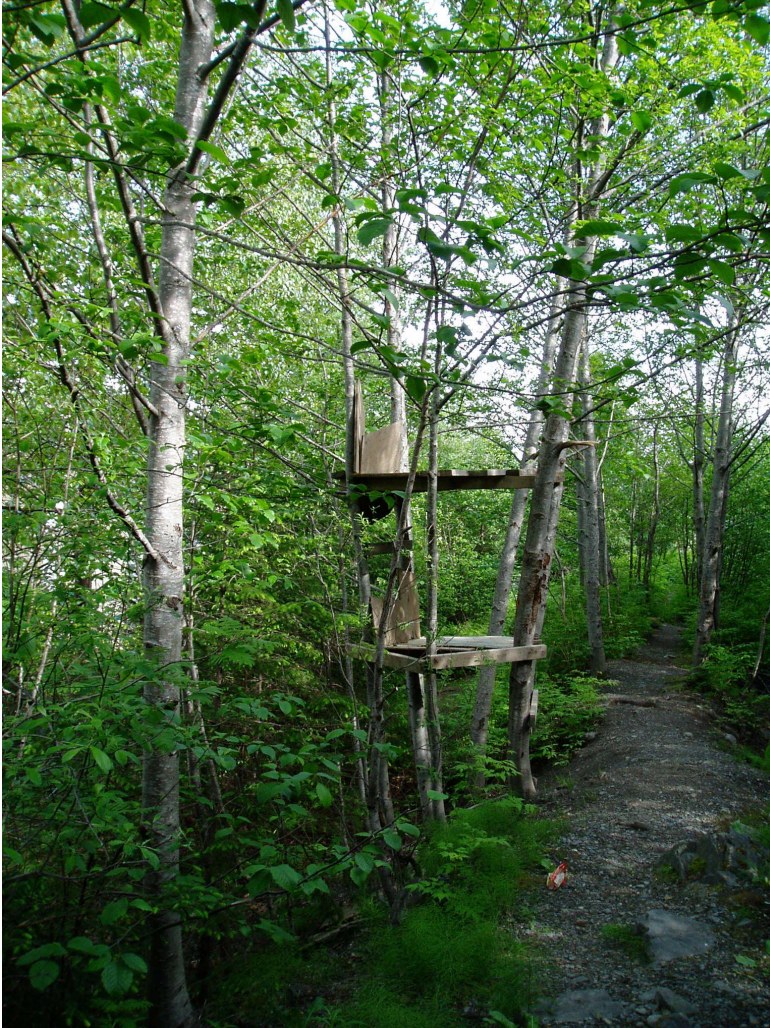
0143-2 Tree fort is Attractive Nuisance

The tree-fort is an un-authorized structure that will likely be a hazard.

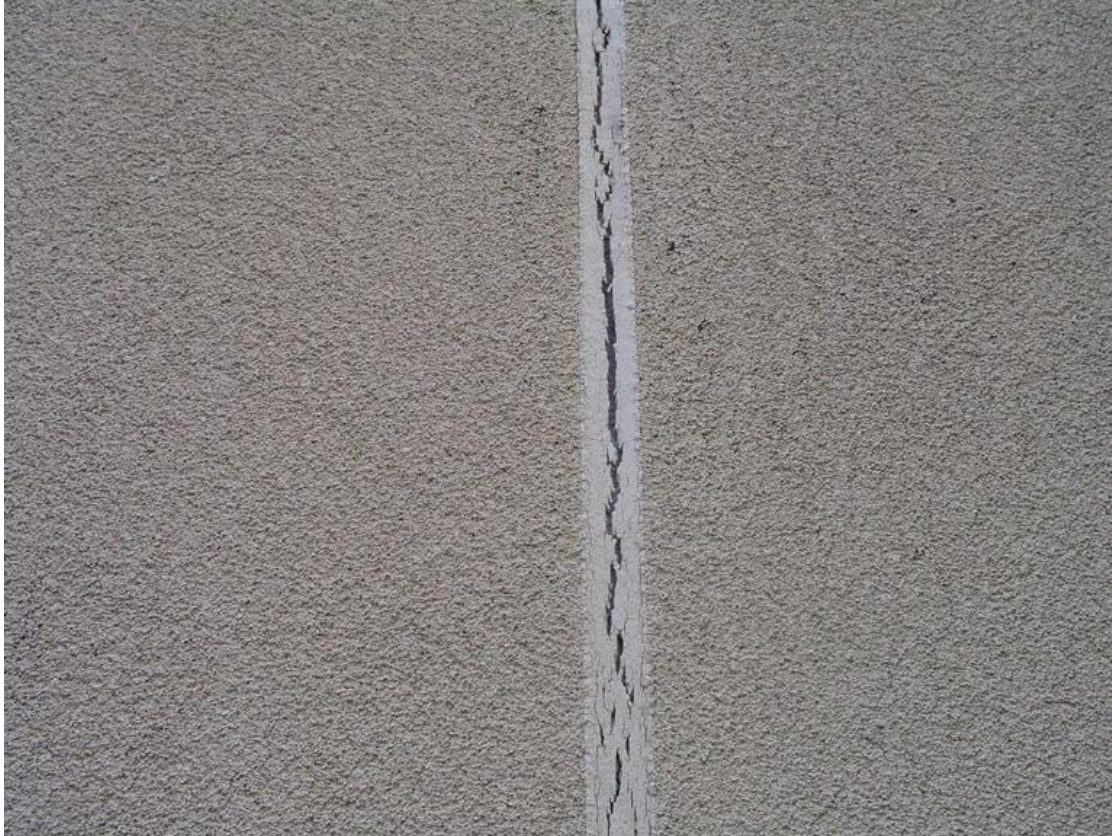
0411-1 Replace sealant joints at EIFS

All vertical and horizontal sealant joints at EIFS wall system exhibit signs of weathering and failure of elastic properties. Cracking as show in this photo is typical throughout assembly type.

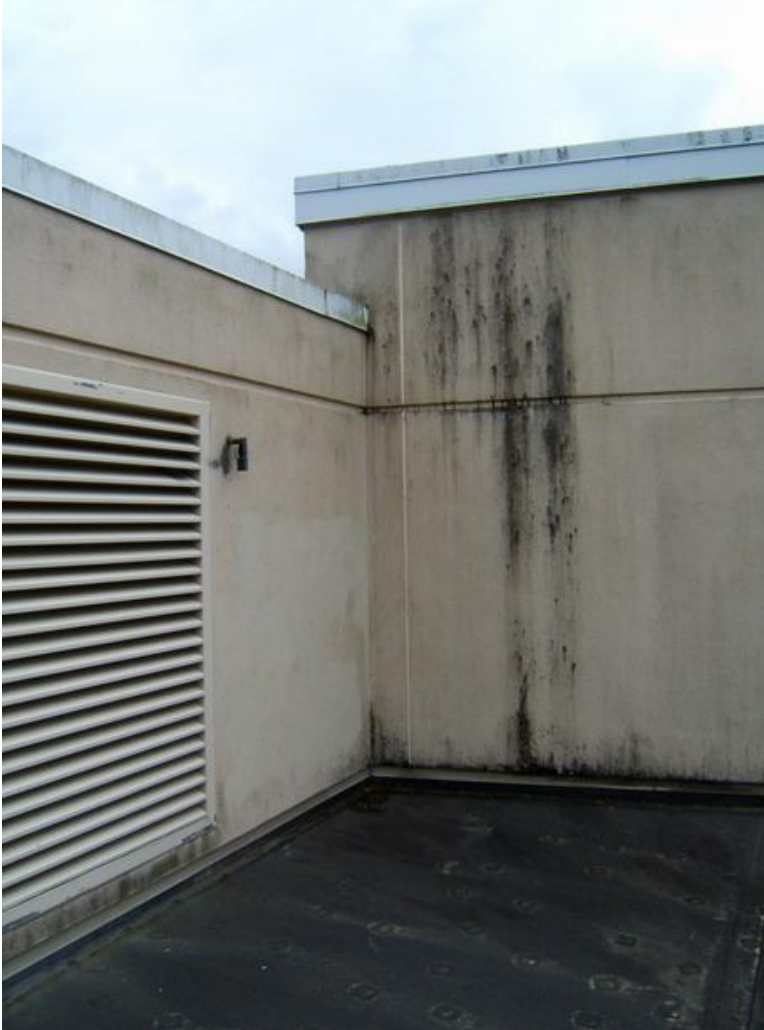
0411-2 Cleaning, repair, and resurfacing of EIFS

Granular EIFS surface collects dirt and harbors mold and mildew growth, most prominently at wall surfaces below eaves where missing or plugged gutters overflow down wall face. All vertical EIFS faces exhibit signs of organic growth and weathering, and are clearly near the end of their useful life in this climate. Minor damage has occurred where water has gotten behind system (typically at head and sidewall flashing conditions). Mold growth conditions as shown in photo are typical.

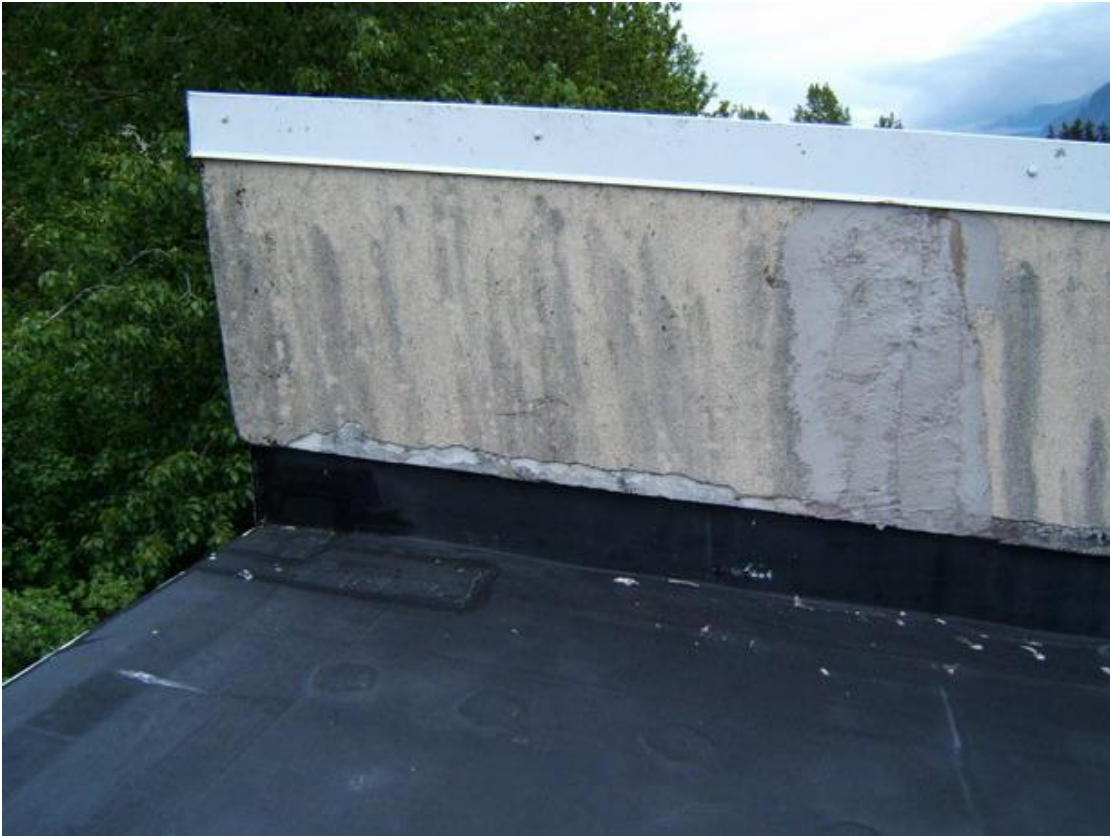
Minor damage has occurred where system has been subject to impact. More substantial damage has occurred where the 2-hour rated parapet wall extends up above the roofline, between the gymnasium roof and the outdoor covered play area.

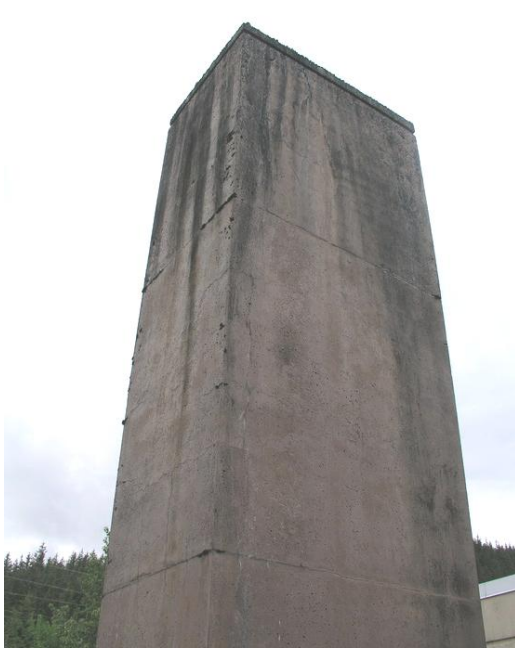
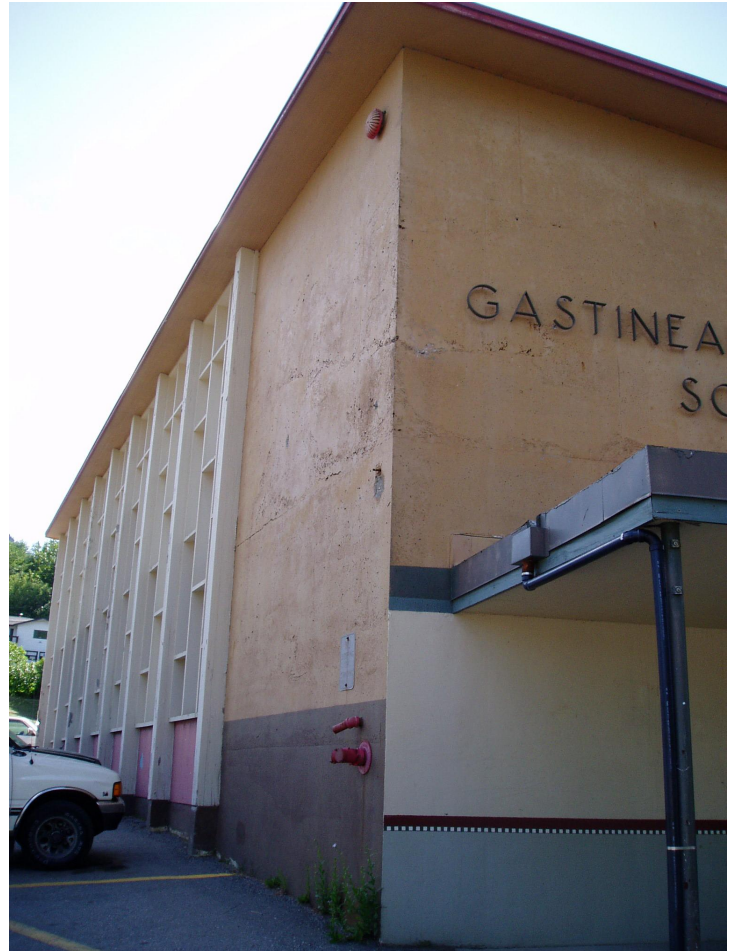
0411-4 Cracked surfacing and organic growth at site cast concrete

Existing site cast concrete wall surfaces are highly textured, and frequently cracked, offering good purchase for moss and mold growth. Paint system on concrete is deteriorating.

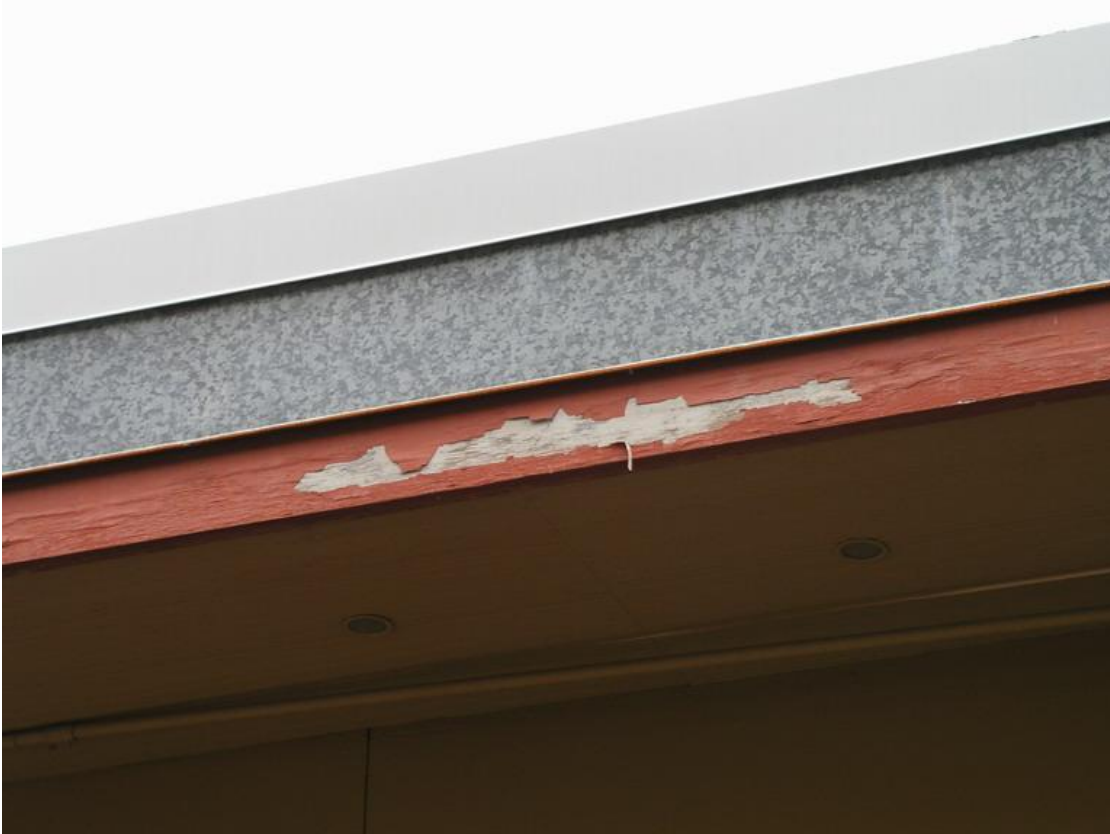
0412-1 Wood and galvanized fascias

Wood surfaces are peeling. Galvanized steel surfaces are starting to rust at edges. This condition is typical at 80% of the roof perimeter of the 1958 and 1965 buildings.

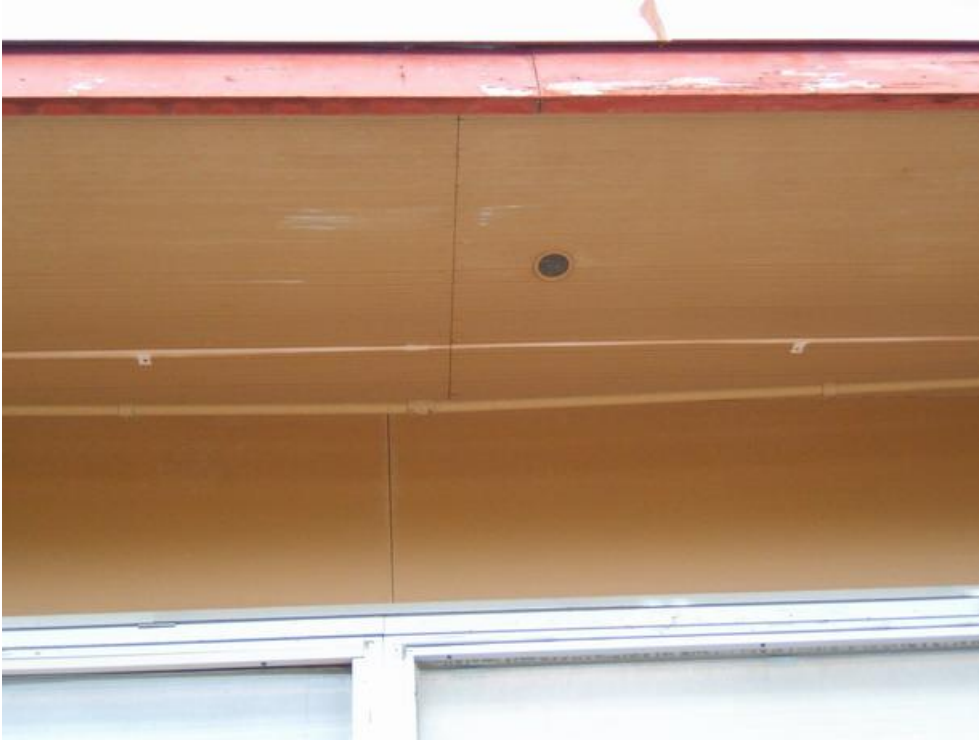
0412-3 Cement Asbestos Board Soffits

Paint finish on cement asbestos board soffits is wearing thin and peeling in some places creating the potential for weathering of the soffits. Since the soffits are a known ACM, care should be taken to ensure that the material is protected from degradation.

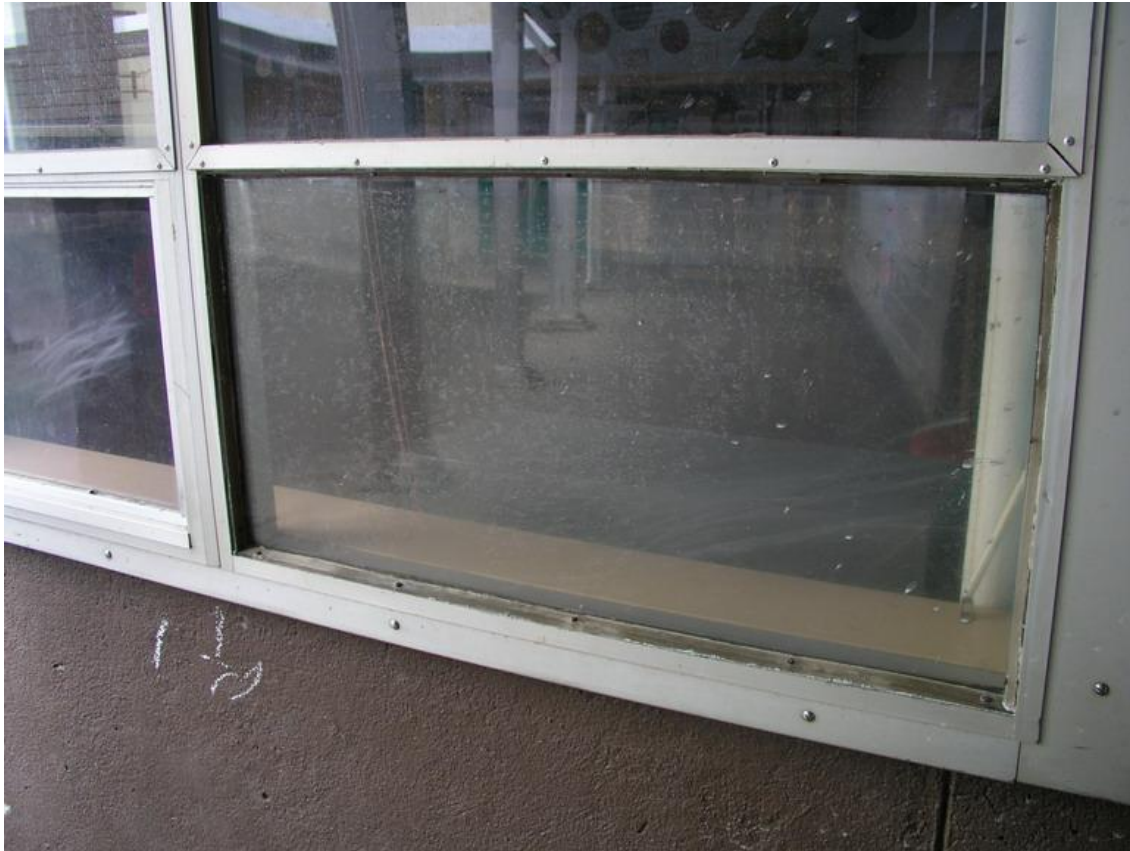
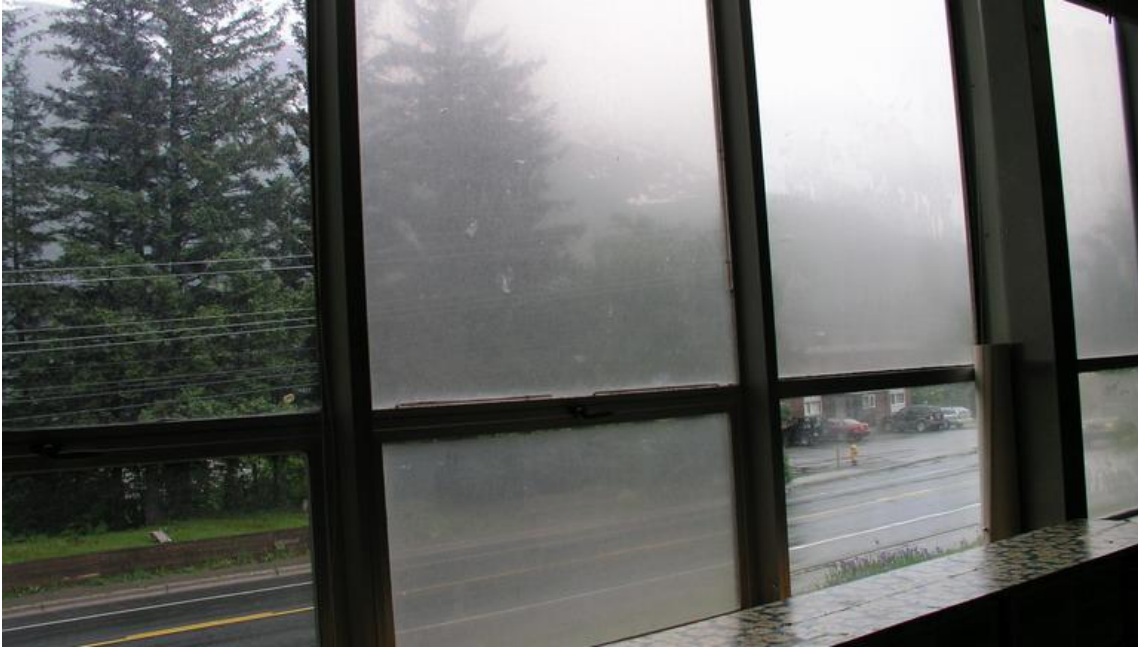
0421-1 Substandard window system and glazing at classrooms

Non-thermally broken aluminum window frames with single pane glass (or Plexiglas) contribute to substantial heat loss through the building weather envelope. Uncoated glass does not reflect solar gain in the spring, summer and fall months, causing classrooms with southern exposure to become overheated during hours of operation. Window system has no screens, allowing insects to get in when open during the day to vent heat. Window system does not seal when closed. Many glazing panels have been replaced with plastic Plexiglas panels, which in many instances have started to discolor from UV exposure and loose their clarity. Older glass panels have been "sandblasted" by wind driven dust, and are losing their clarity. This condition affects all windows in all classrooms, the windows at the library work area, the windows at the boiler room, and the windows at the administration area.

The proposed remedy is to replace the substandard windows with a new high quality commercial thermally broken aluminum window system with high performance thermal glass units. Insulated glazing units will also improve acoustic separation between the classroom and the street.

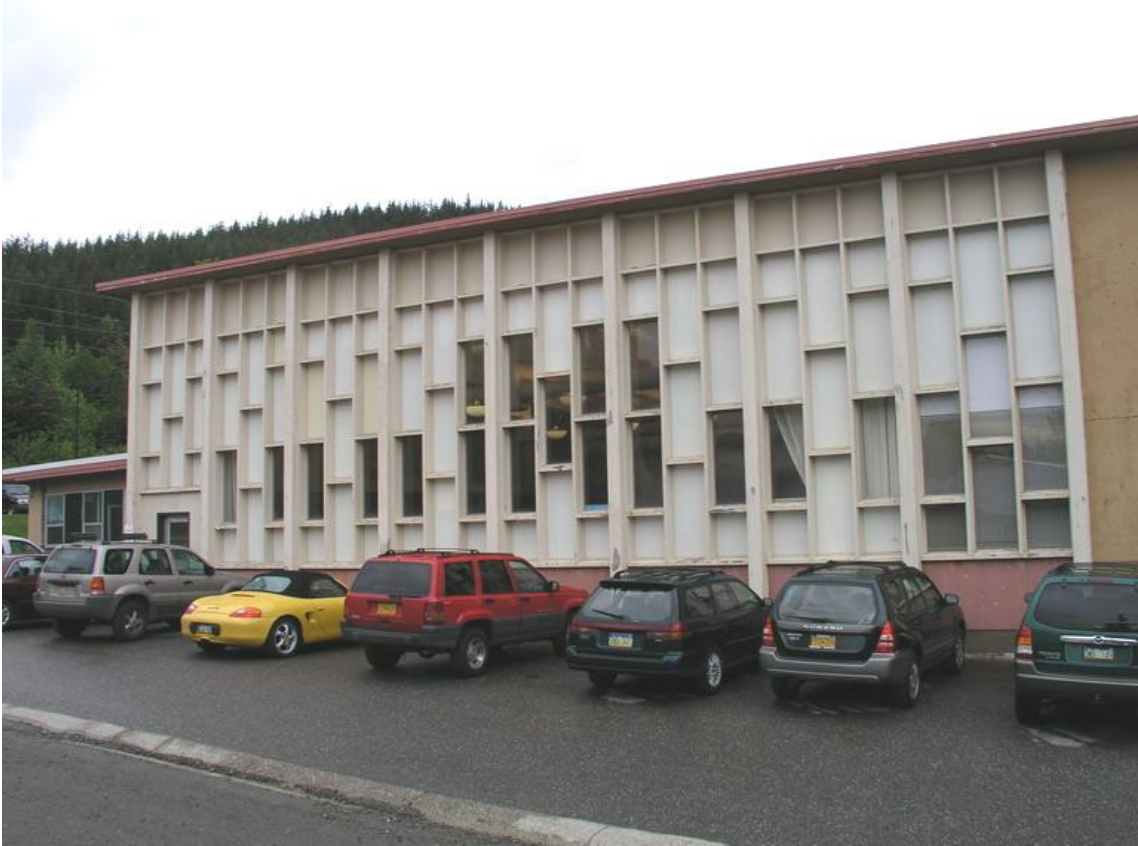
In general the system is in fair condition and appears to be intact. Paint on the wood window frames are peeling severely. In some areas the wood appears to be saturated with water, and some leakage into the building is occurring. This is affecting the interior painted finish on the window frames. Glazing is comprised of translucent and transparent Plexiglas panels. None are thermal assemblies. Section *Structural Inspection - Exterior Wall* addresses a structural issue associated with this window wall that must be remedied as a part of any work on the window system.
