Gastineau Elementary

Douglas, Alaska

Facility Condition Survey Report Prepared June 2005

By NorthWind Architects, LLC, PN&D Inc., Haight & Associates,
Murray & Associates, and City & Borough of Juneau Engineering
Department

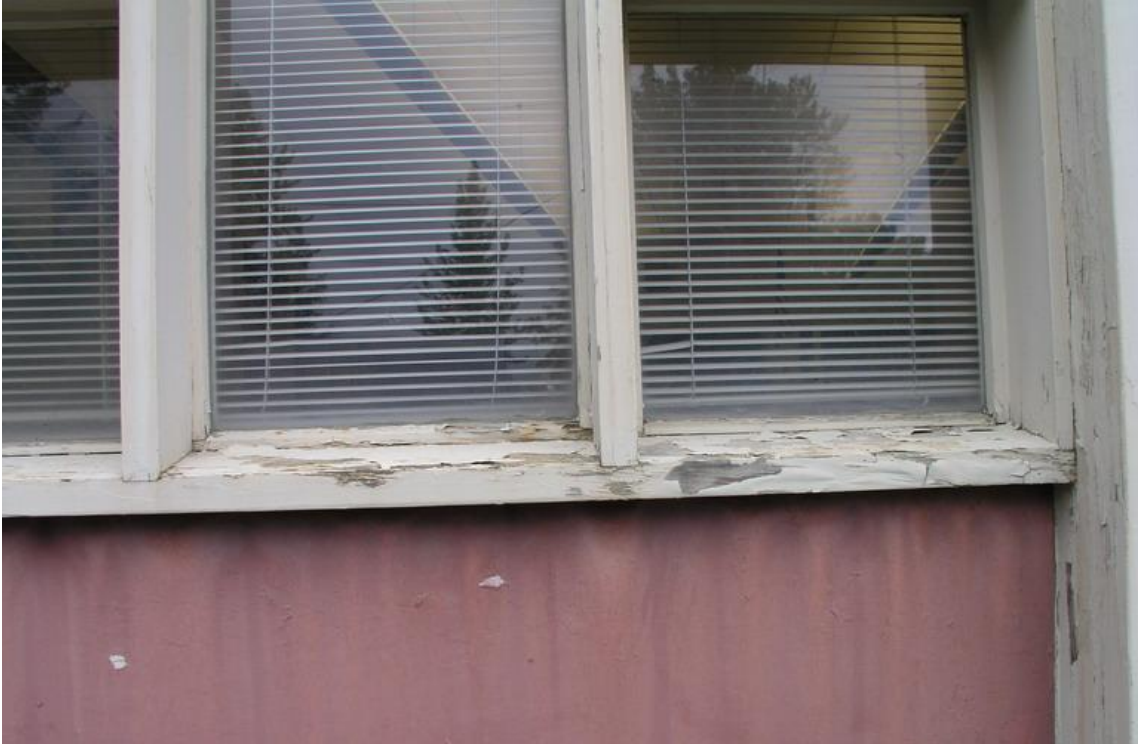
0423-1 Deteriorating paint system at wood window system

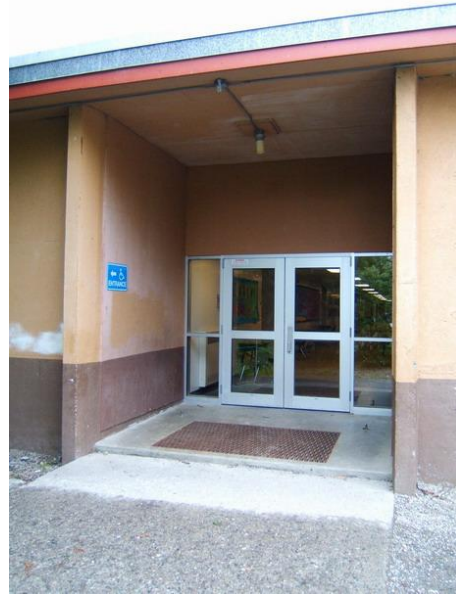
0431-3 Repairs at North hallway door assembly

1965 Building, door at north end of hall: The aluminum door and storefront assembly at the north end of the hall is in good condition. Door glazing has been replaced with plastic glazing panels, and the outer panel of the thermal glazing assembly of one of the side-lights has been broken out. These glazing panels should be replaced.

One insulated glazing sidelight in the storefront assembly is broken. All four insulated glazing panels in the pair of doors have been broken and replaced with plastic glazing, which is getting scratched.

Deficiency category: RR

Replace broken insulated glass sidelight with new insulated glass panel constructed of 3/16" tempered glass. Remove plastic glazing panels at doors and replace with new insulated glass panels constructed of 3/16" tempered glass.

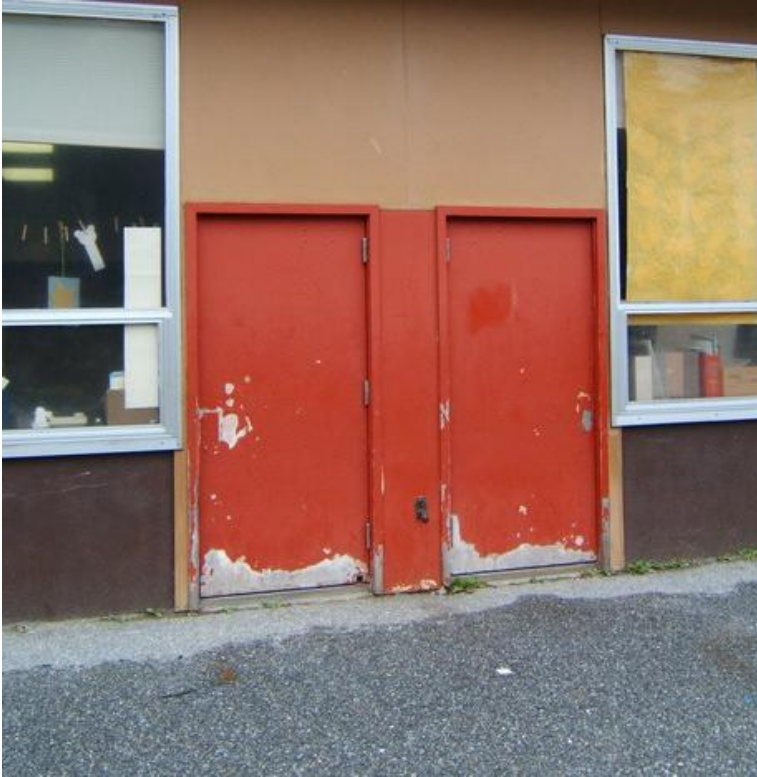
0431-1 Southwest facing exterior classroom doors

Solid-core wood doors in the southwest facing classrooms are deteriorating, thresholds represent a tripping hazard, weather stripping is inadequate, hardware is antiquated.

Deficiency category: RR, C (threshold projection > 1/2"), E

Remove existing doors and replace them with new galvanized and painted thermally broken hollow metal doors and frames, and new hardware. Repair drainage at adjacent outdoor play area (see Civil Inspection).

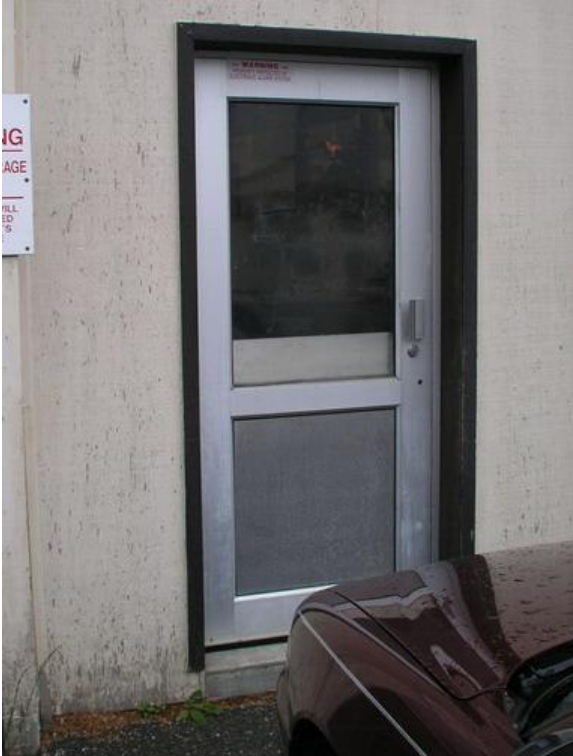
0431-2 Exterior Library Door

Full light aluminum door is not thermally broken and is equipped with single pane plastic glazing. There is a 6"+ step down at the door threshold which represents a code violation and a hazard to the safe egress of the space served. The door hardware is antiquated.

Deficiency category: RR, C (IBC 2003, 1008.1.5), E

Remove existing aluminum door and frame and replace with new galvanized and painted thermally broken hollow metal doors and frames, and new hardware. Door should be provided with a small security glass vision panel. A new 60" wide x 44" deep landing is to be installed outside the new door, and should be configured to promote sufficient vehicle separation from the egress door to preserve minimum egress widths outside the building.

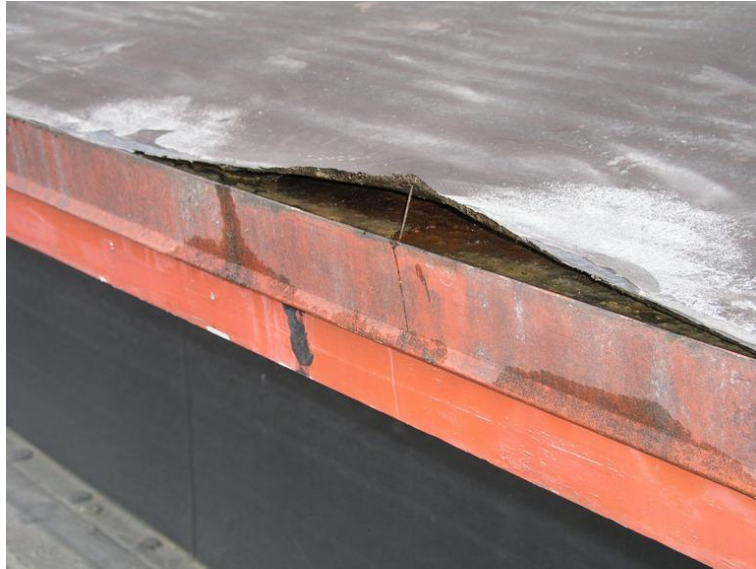
Library: The library roof is in poor condition with numerous penetrations through the outer layer of built-up roofing. Although it does not appear to be leaking yet, delamination of the assembly at its perimeter is evident.

Remaining life expectancy:
1-2 years

Remove existing roof system, install new vapor retarder, 6" of new rigid insulation, new roof sheathing, and a new fully adhered EPDM or PVC roof. Roof replacement will

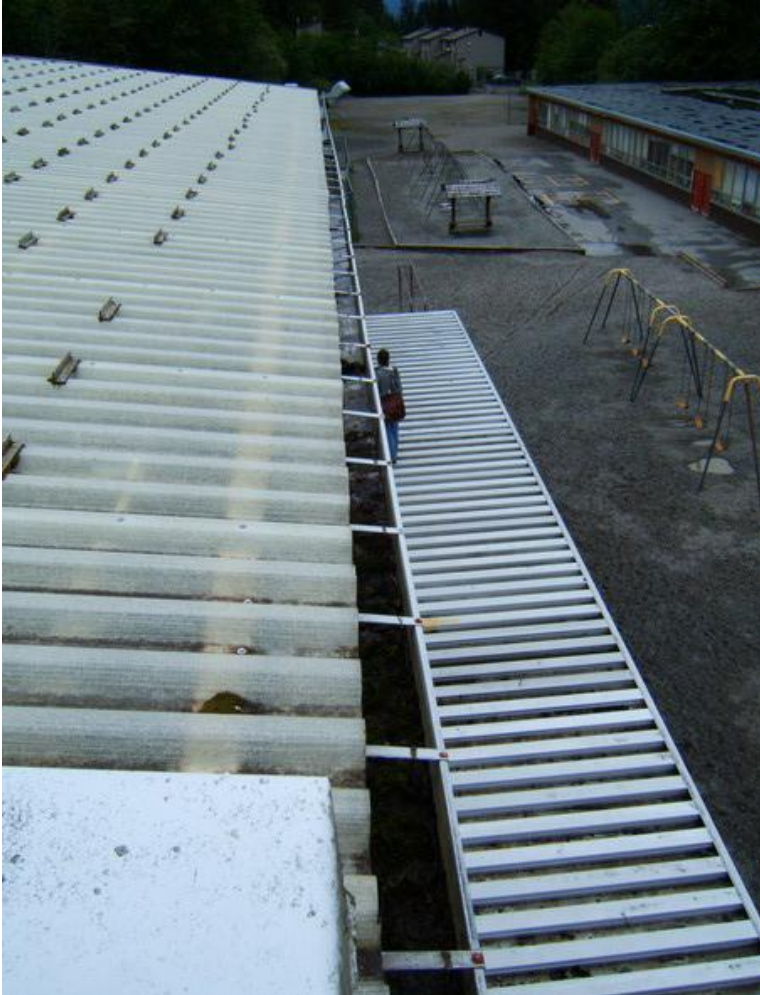
0512-1 Clean debris out of all gutters and down-spouts.

This effort entails cleaning approximately 200 lineal feet of gutter, and should be incorporated in any roof maintenance or replacement project.

Deficiency category: RR

Clean gutters. Re-seal any joints and end caps that appear to be leaking.

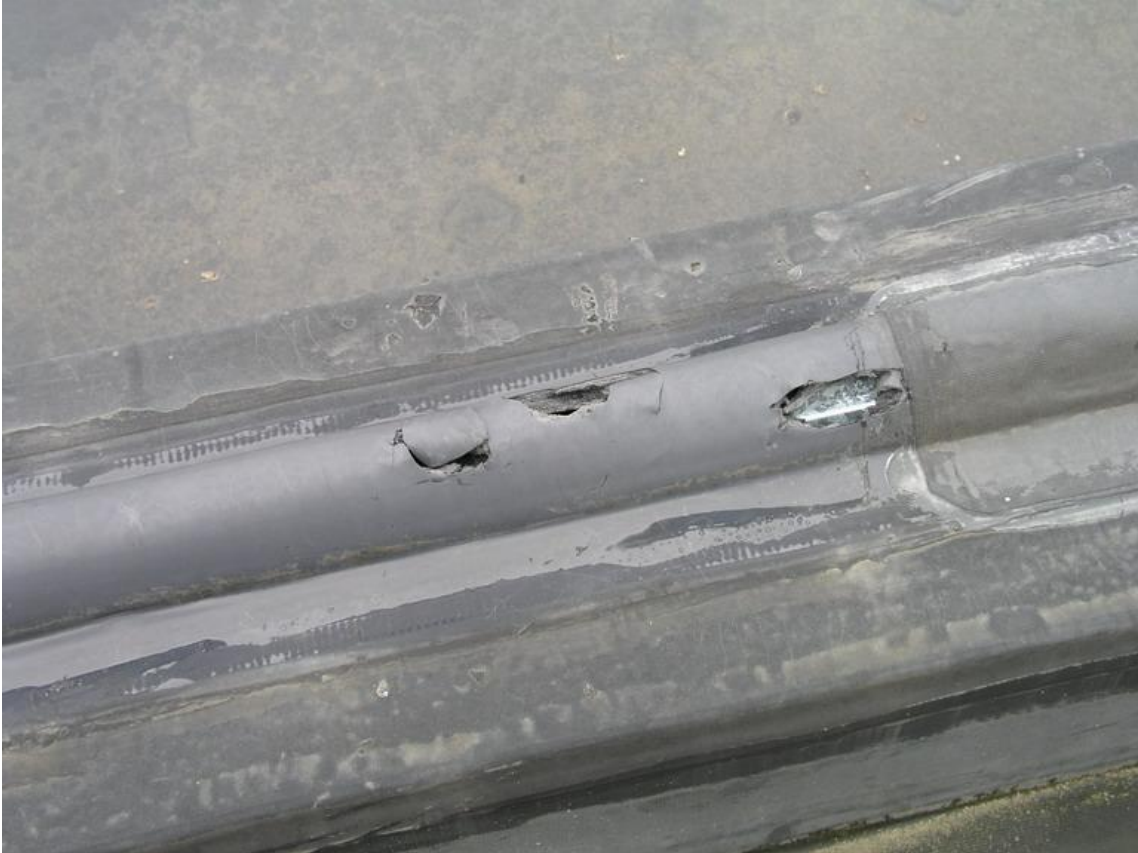
0521-1 Holes in seismic joint cover

In general the EPDM roofing installation is in good condition, with minor maintenance issues (i.e. cleaning roof drain screens - see 0522). In one location a seismic joint cover that did not have the roofing extended across it has sustained some damage that is resulting in leakage into the building.

The seismic joint cover has been damaged in one isolated location.

Deficiency category: RR

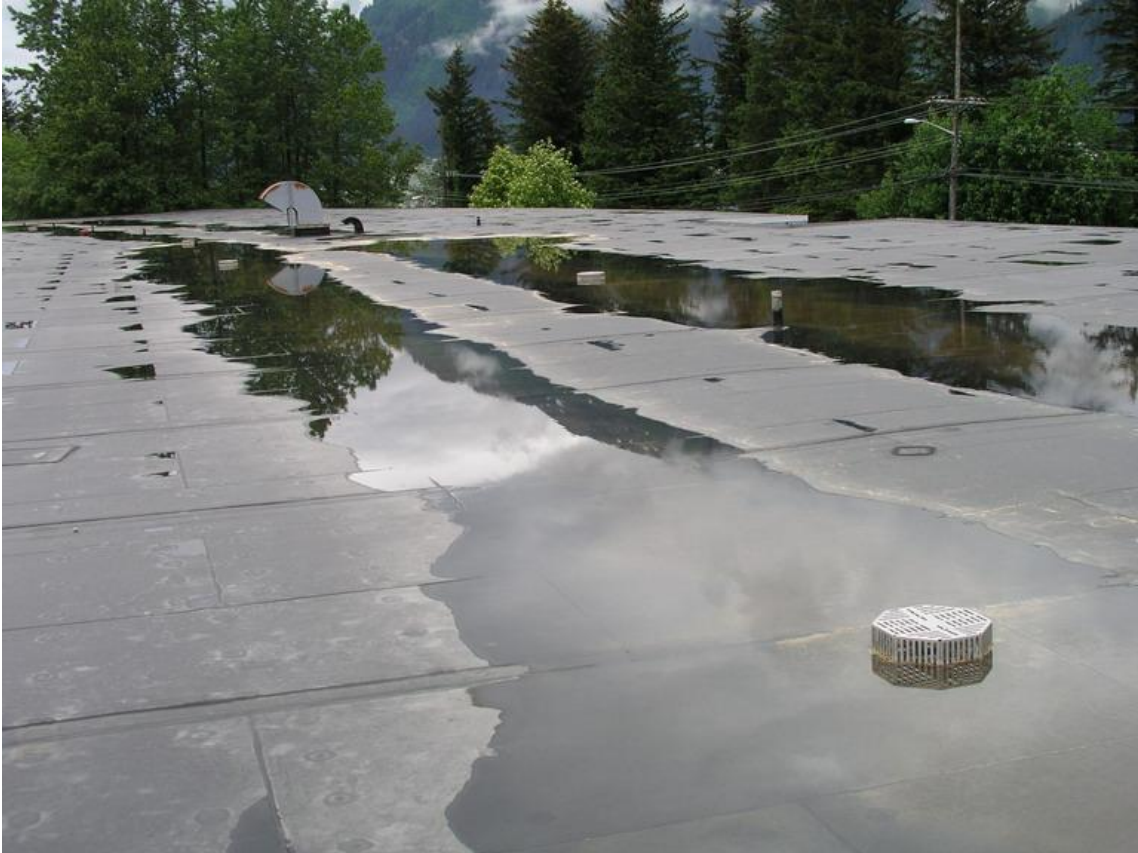
0522-1 Clogged drain screens

Seasonal debris clog lower openings of screens, causing standing water on the roof areas after rainfall.

Deficiency category: RR

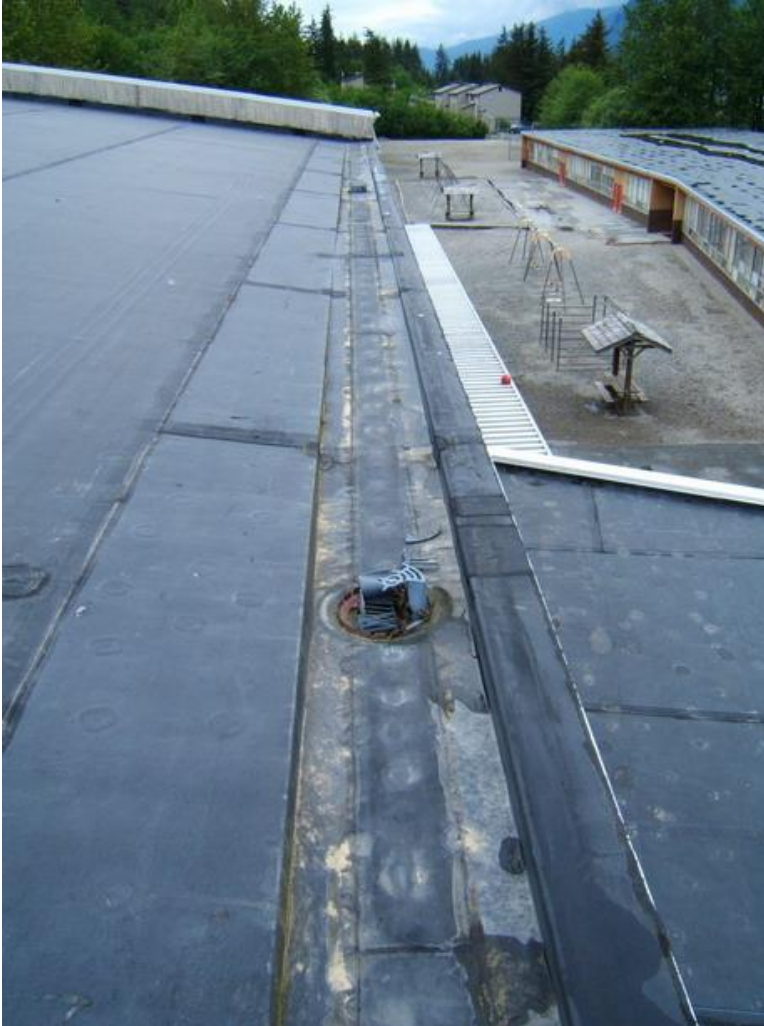
0522-2 Leaking internal roof gutter

The internal gutter at the east side of the Gym roof has experienced leaks and some softness was noted at roof sheathing. The school district was preparing to open up the gutter area and investigate the extent of the leaks and water damage.

Deficiency category: RR

Remove roofing and replaced water damaged roof sheathing and framing. Reinstall roofing and roof drains.

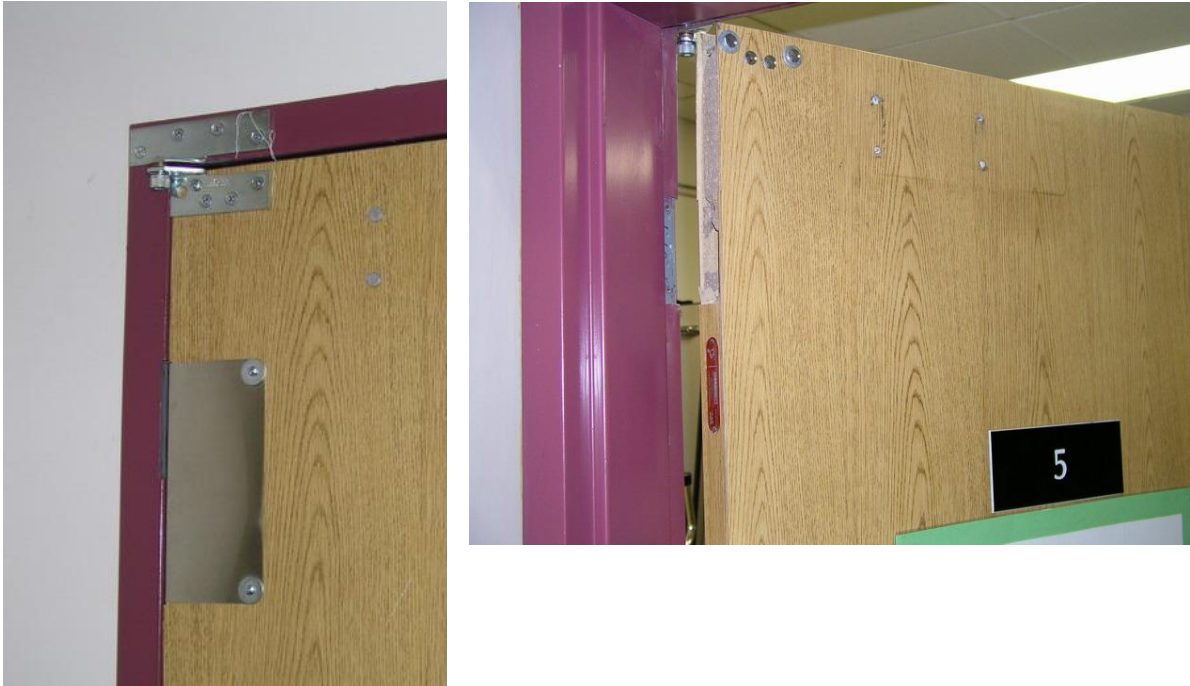
0631-1 Doors damaged at hinge or hardware attachment

The wood-grain print plastic laminate faced doors in the 1991 addition are not holding up well. At five locations the upper door hinge attachment has been stressed and has split apart the door edge. At three of these locations the hinge was removed and a frame face mounted pivot hinge has been installed. At two of these locations (double doors) the hardware associated with locking the inoperable unit (floor and head bolts) have failed, been removed, and replaced with surface mounted head and floor bolts. These doors are all into storerooms and it is suspected they have been closed on and slammed into by carts. Regardless, they are an inferior quality door with particle board edging around the fire resistive core rather than solid lumber, which should typically be seen at hardware attachment points. The installations of this door type at lower traffic locations are in fair condition.

Failure of low quality fire rated doors in 1991 addition in the following locations:

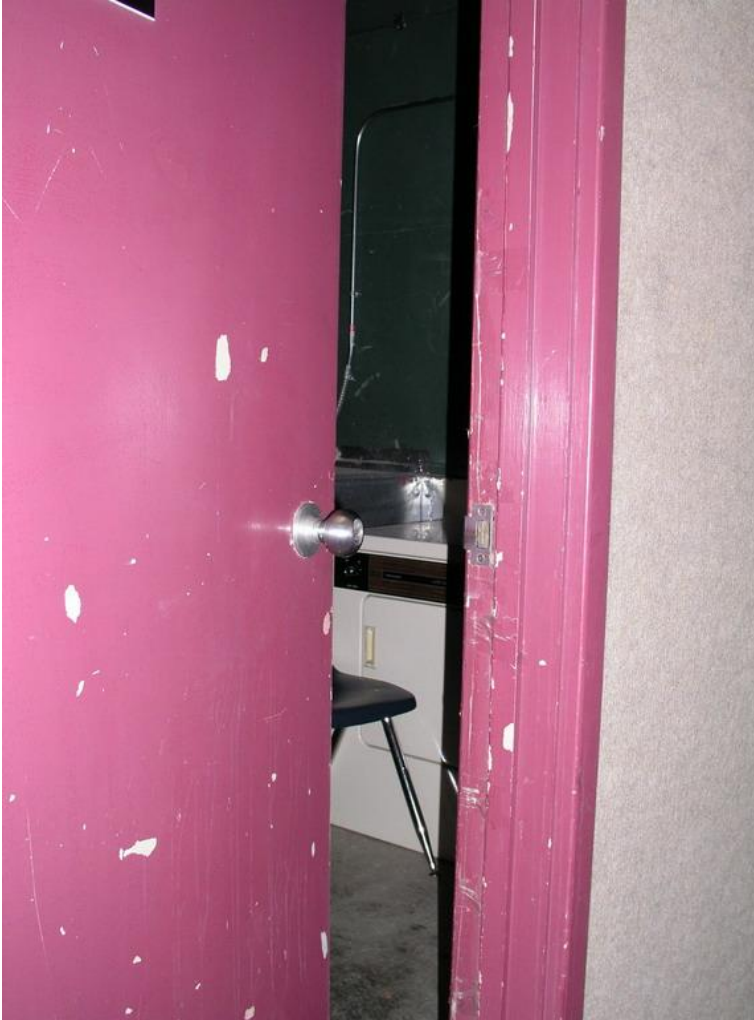
0631-2 Finish damage at room #9 (fan room) door face and frame.

Personnel doors between classrooms and between other rooms in the 1958-65 portions of the building, and associated hardware installations, are in good condition. One exception is the door into room 9, a fan room. The hallway side finish at this door appears to have taken a lot of abuse and is chipped and peeling.

Finish damage at room 9 (fan room) door face and frame.

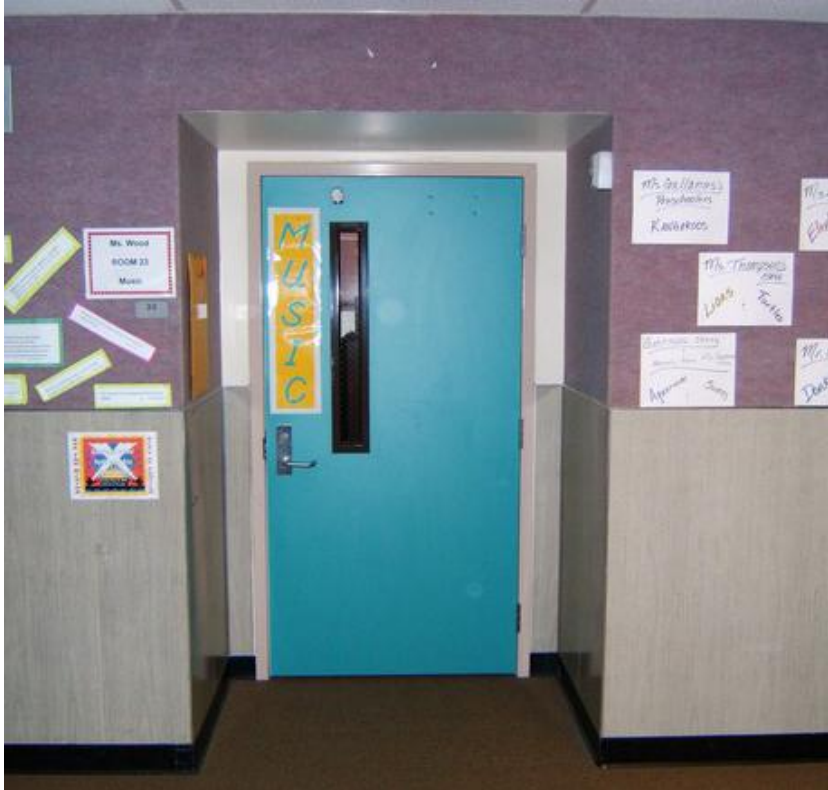
0631-4 ADA clearance requirements at classroom doors

Typical doors into classrooms are situated in a recessed (32" deep) opening off the hallway. The doors swing out, and do not have the clearances required on the strike edge pull side of the opening (18" required, 4" - 11" provided). Typical condition occurs at doors 21, 22A, 23, 24, 25, 26, 27, 28, 31, 33, 34, 35, 36, 37, 38, 39, 40, 41, and 42.

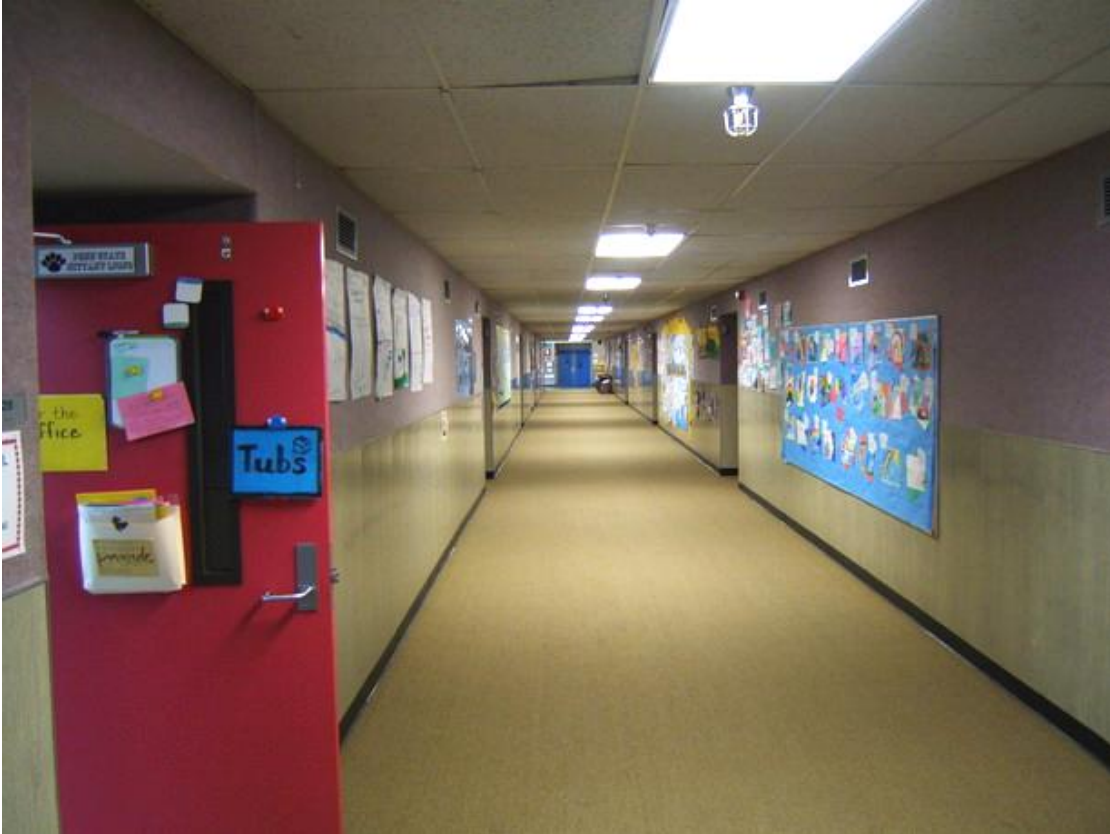
0641-1 Dark wall materials in 1958 building halls restrict educational experience. Hallway finishes are durable, but color and organization are dark and oppressive.

Deficiency category: RR, F

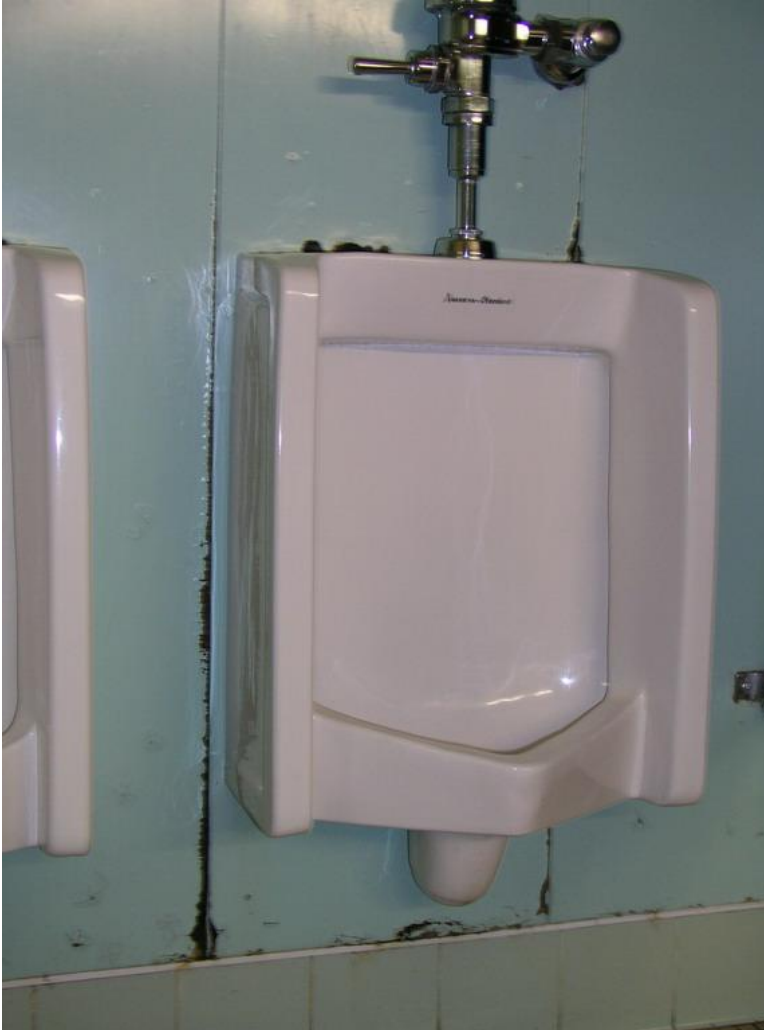
0641-3 Deteriorating Marlite-type panels in 1965 addition bathrooms

Material finish is deteriorating in damp areas such as behind urinals, toilets, and sinks.

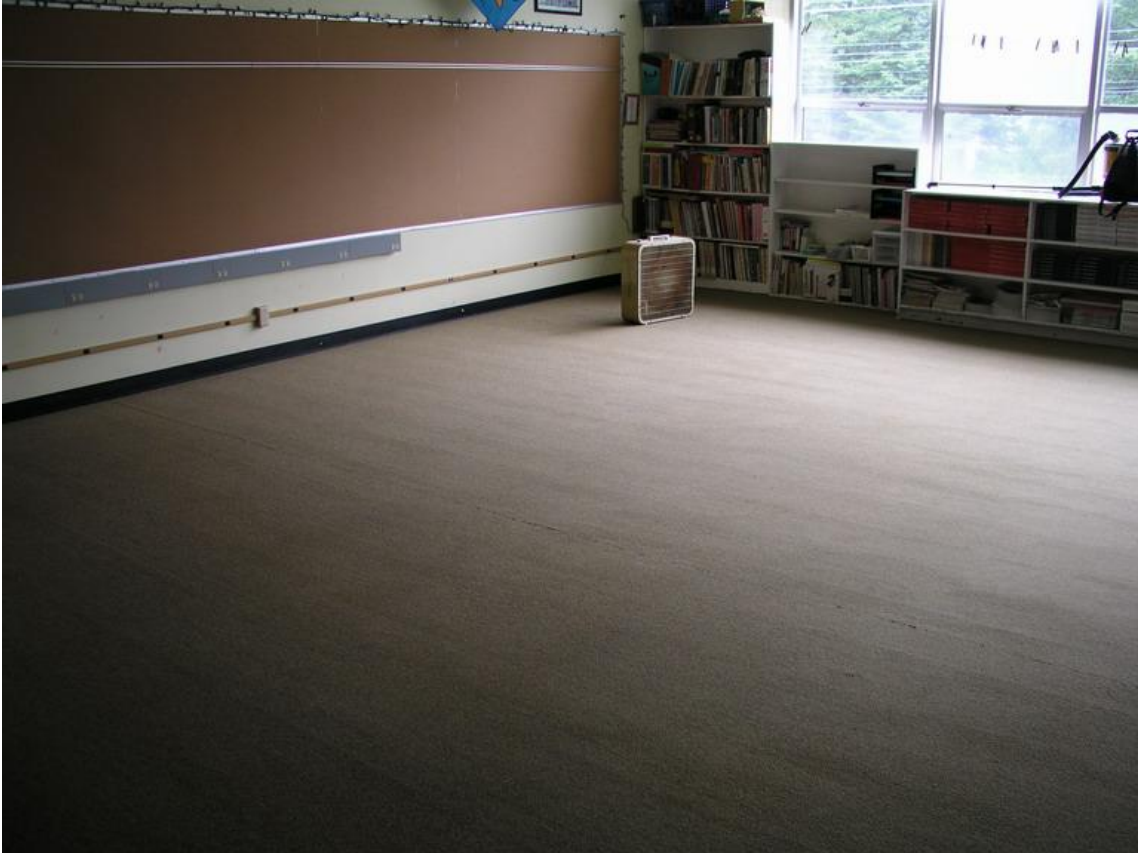
0642-2 Carpet wear at rooms

The carpets at the 1958 and 1965 portions of the building are 15 years old and becoming worn, with seams and ridges becoming more evident with each cleaning.

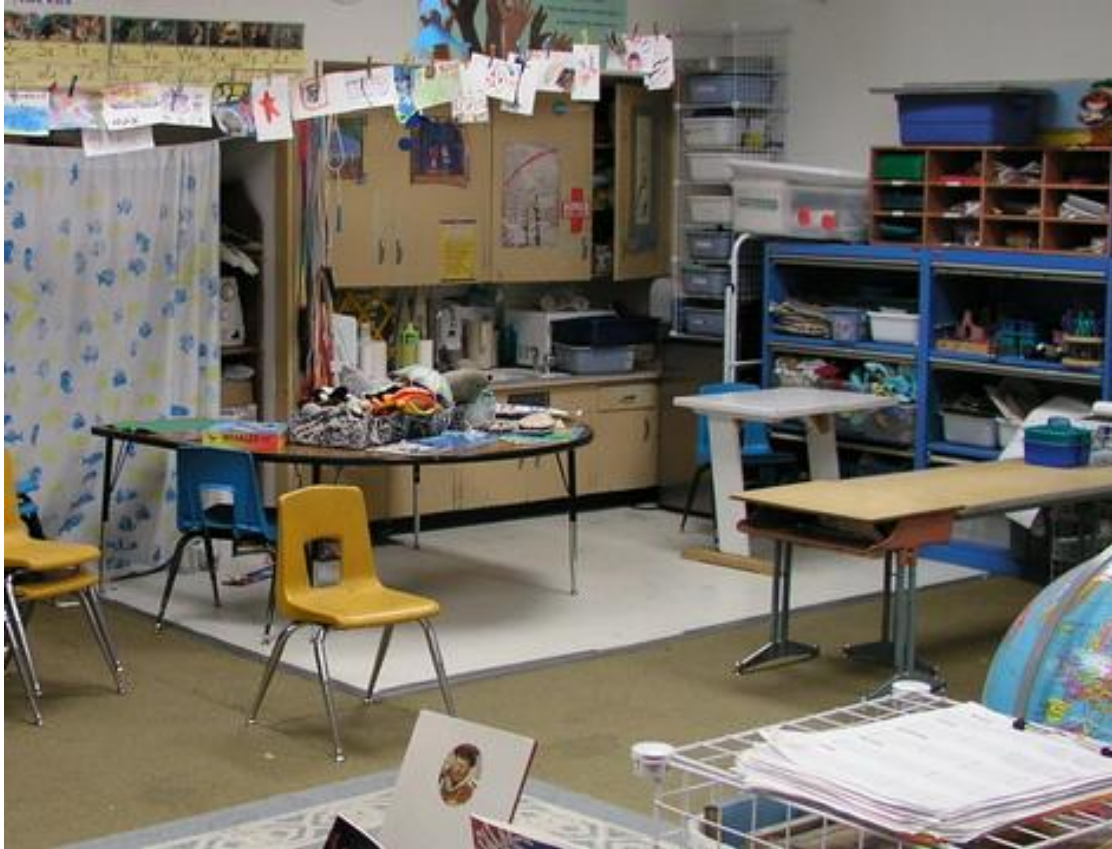
0642-3 Provisions for wet area flooring at sinks in classrooms

Most classrooms in the 1958 and 1965 portions of the building have sink areas, but only the kindergarten classroom #31 has permanently installed sheet vinyl flooring. All sink areas should have a water resistant, easy-clean-up type floor in the sink work area.

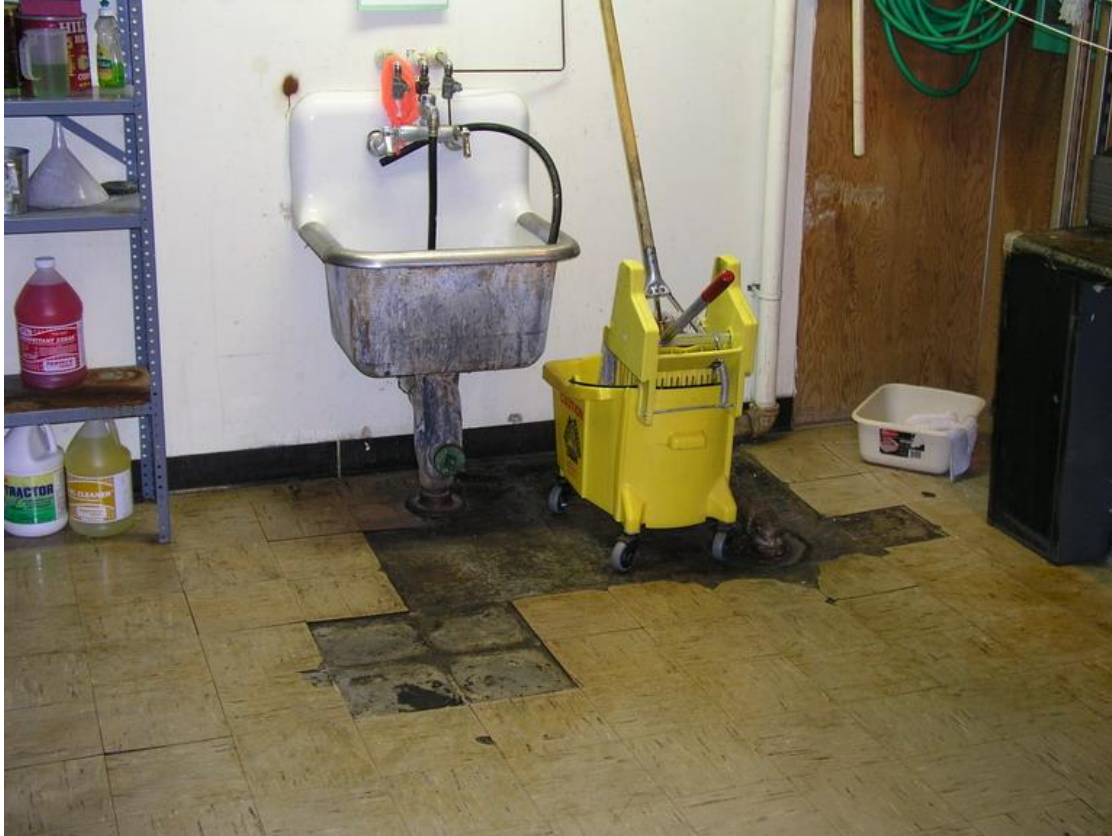
0642-4 Remove ACM floor tile from janitor rooms

9"x9" resilient flooring tile at janitor's spaces is in poor condition is falling apart. These products date from the time of the buildings original construction and are known to be Asbestos Containing Materials (ACMs)..

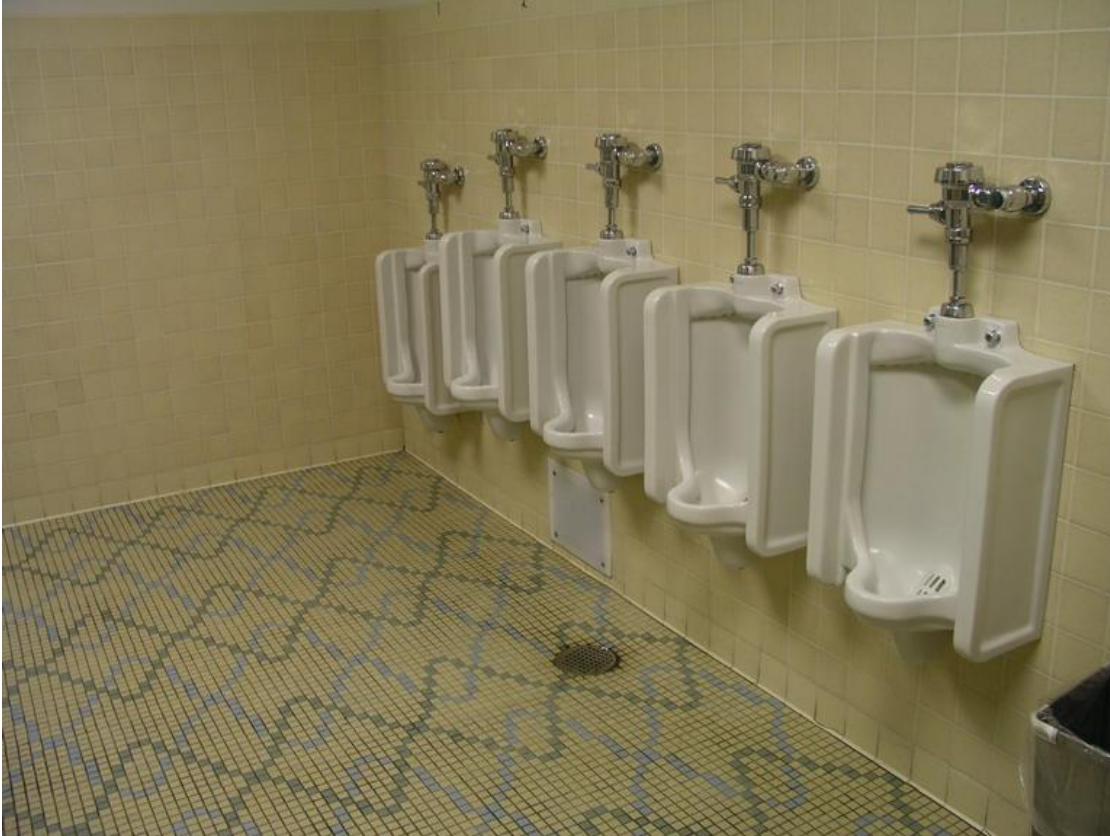
0642-5 Cleaning and sealing of all mosaic tile flooring.

All bathrooms in the 1958 and 1965 additions have glazed mosaic flooring in fair condition. A complaint has been that bathroom smells emanates from the tile grout, and no cleaning method to date has successfully eliminated this emanation. (might be a ventilation issue as well)

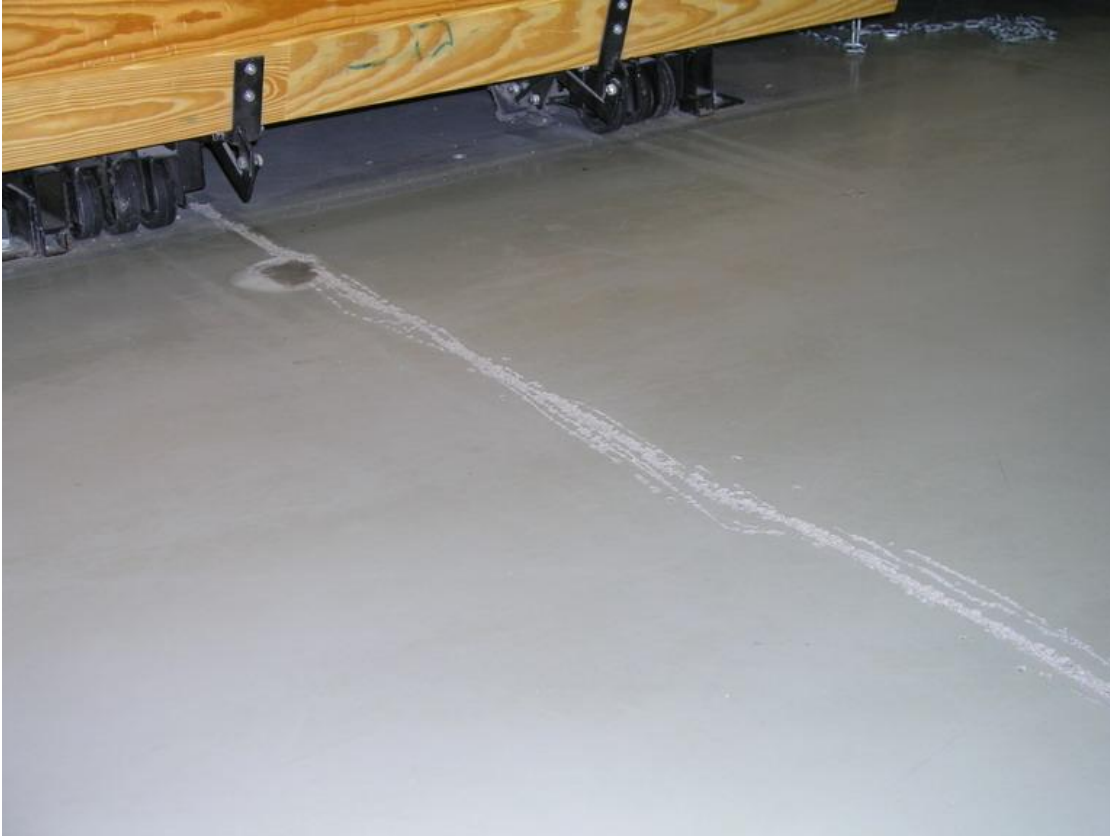
0642-6 Repair to urethane gymnasium flooring.

A large gouge has formed in the location of the folding gymnasium bleachers. The bleacher break shoe drags when bleachers are extended and retracted if the base panel is not lifted completely during operation. This item appears to have been fixed, but damage to the flooring material remains.

Deficiency category: RR

Bleachers: The 5-tier collapsing wood bleachers are in good condition and are equipped with safety rails at open ends. A break shoe that is out of adjustment has caused damage to the gymnasium flooring and should be re-adjusted as a part of the flooring repair.

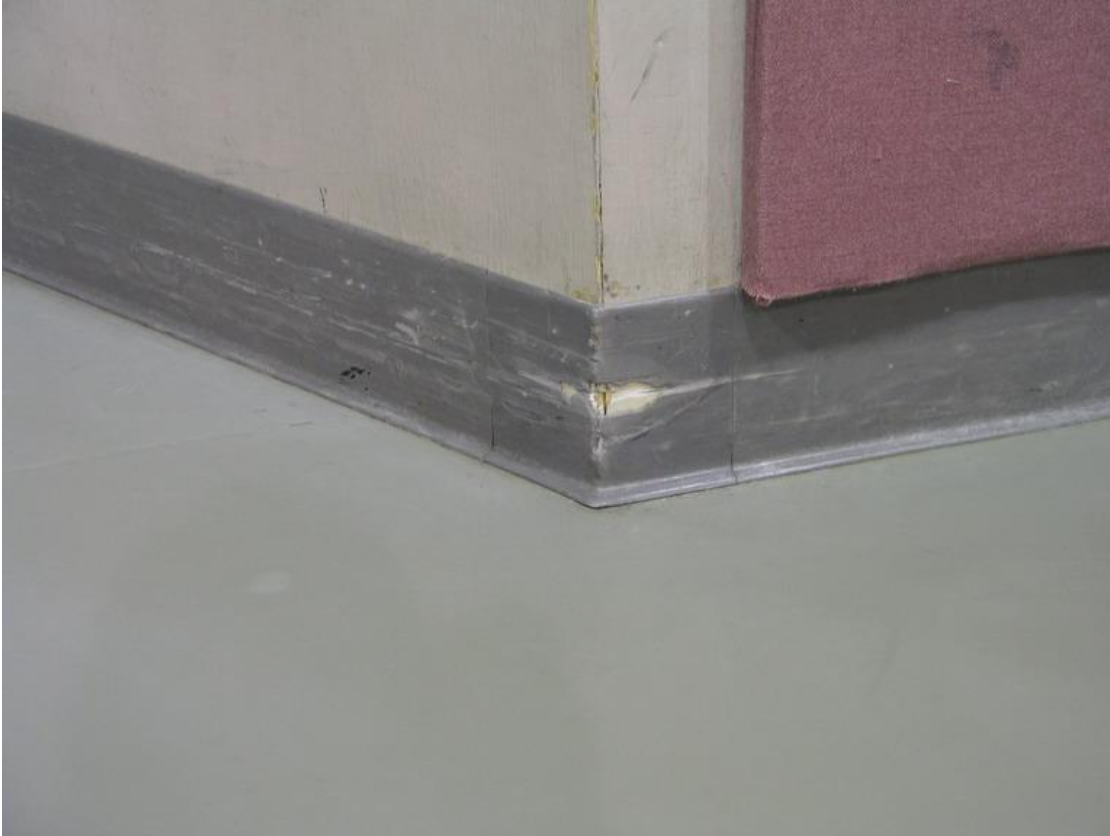
0642-7 Repair damaged rubber base at gymnasium

Four outside rubber base corners are missing or damaged at the gymnasium.

Deficiency category: RR

Replace damaged rubber base area with new to match existing. Use pre-formed rubber base corners.

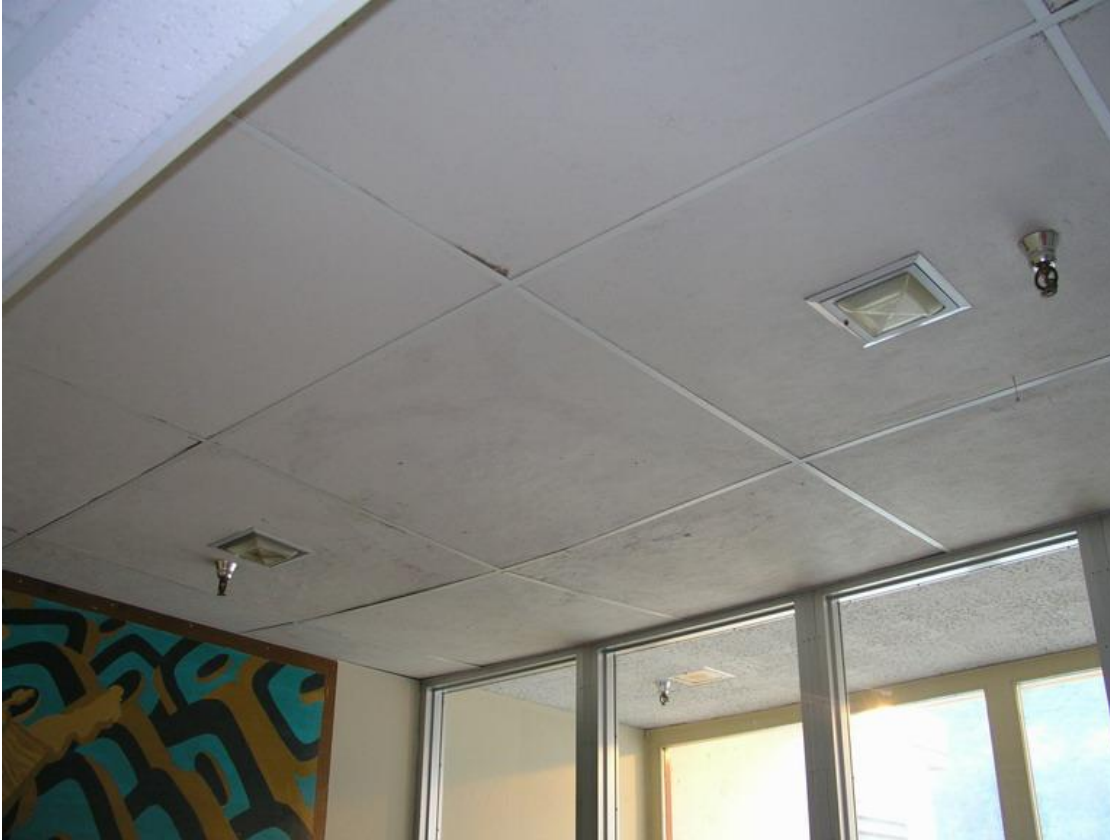
0643-1 ACT replacement at entry area and Commons Hall.

The old large format acoustic ceiling tile at the entry areas and Commons Hall of the 1958 building has been damaged by water in the past, and in some areas is visibly sagging. As part of hallway finish upgrades, the ceiling tile and suspension grid system in this area should be replaced with a new system.

Deficiency category: RR

Remove existing ceiling tile and grid, replace with new suspended acoustic ceiling tile system to complement hallway finish upgrades. Test ceiling tile for asbestos content. If found, handle and dispose of materials in accordance with state and federal environmental law.

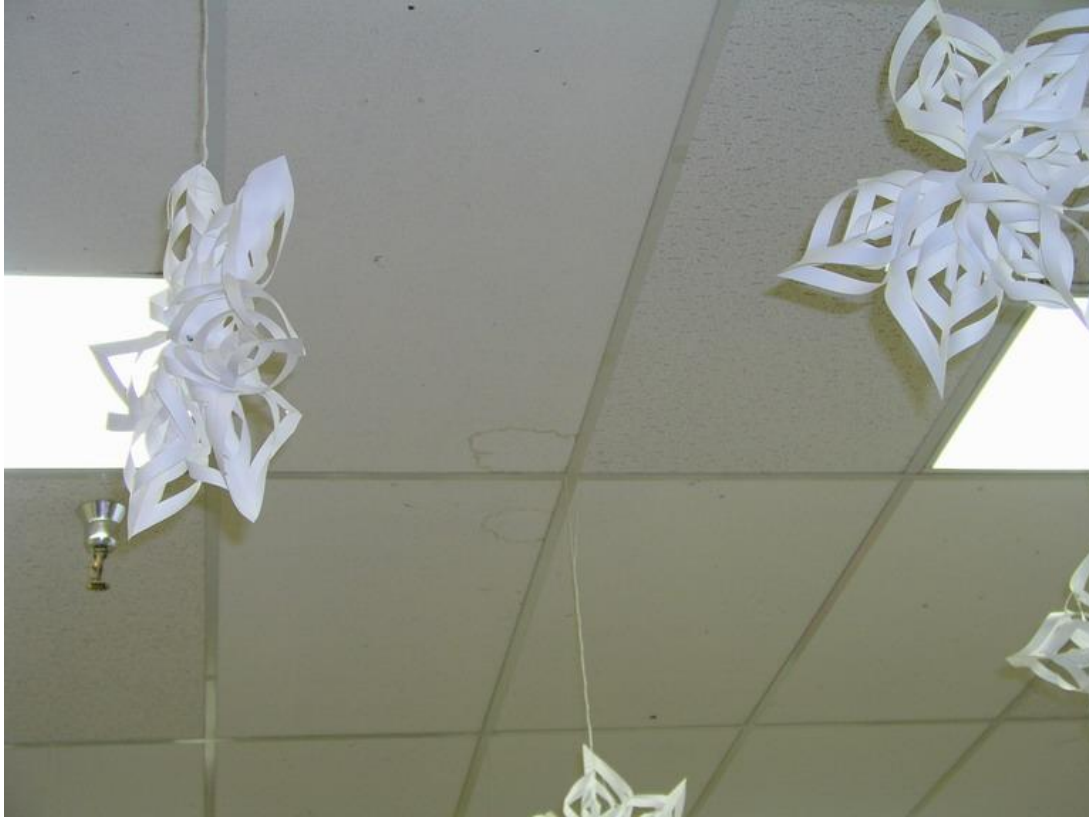
0643-2 ACT replacement at hallways, classrooms and administration areas.

Approximately 15% of the ACT throughout the building is stained, damaged, or missing, and should be replaced. At hallways the ceiling grid may need repair and cleaning as a part of this work.

Deficiency category: RR

Remove damaged ceiling tile in rooms and replace them with sound ceiling tile from the hallways. In conjunction with a hallway finishes renovation, remove all ceiling tile from hallways and replace with new ceiling tile with a fine texture and greater light reflectivity properties..

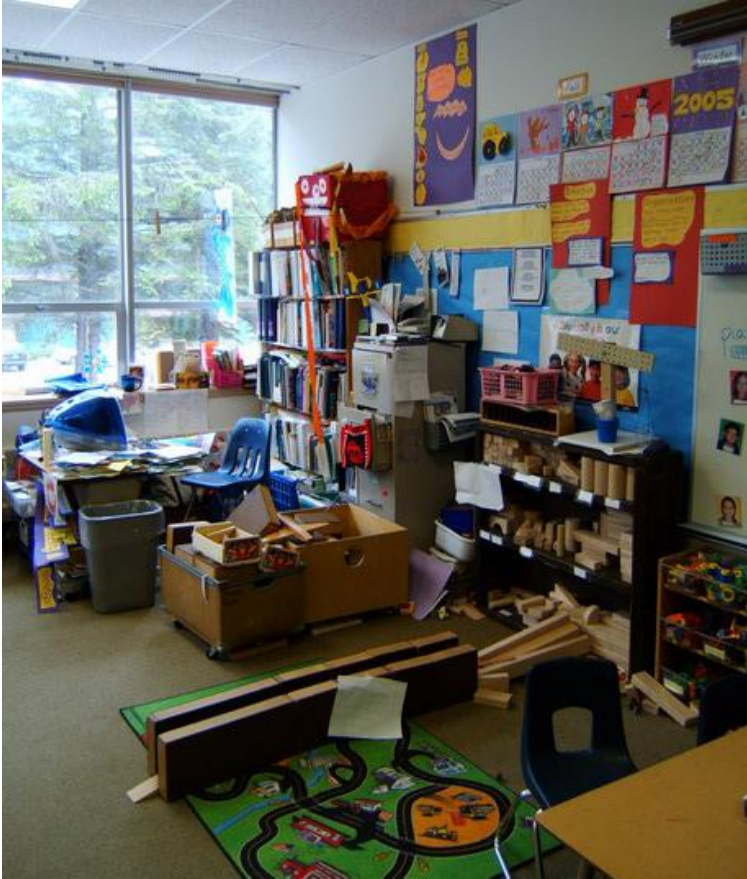
1018-1 Classroom Storage Deficiency

Almost all classrooms suffer from lack of in-classroom storage space, so teachers improvise with open shelves and bins.

Deficiency category: F

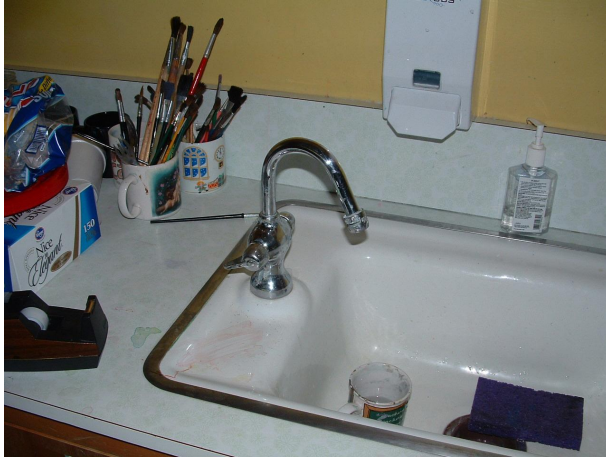
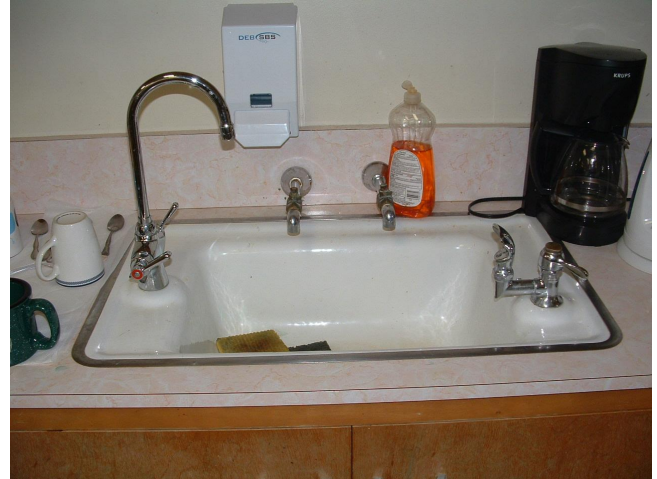
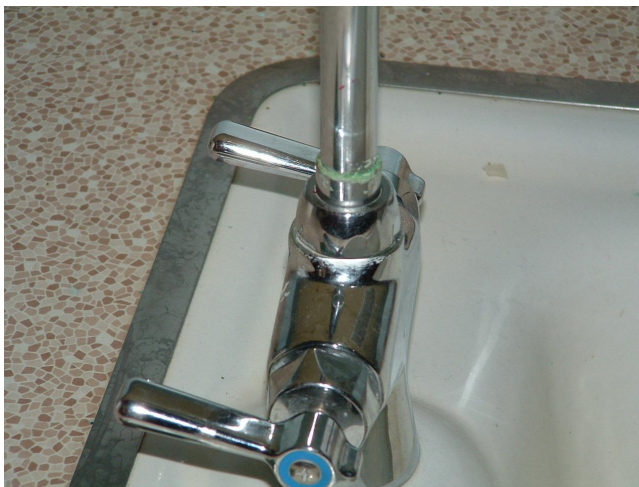
0811-1 Classroom Sinks

Classroom sinks have reached the end of their service life. A few of the faucets have been replaced and are non ADA compliant, a few of the faucets goosenecks are loose and leaking, others have signs of corrosion.

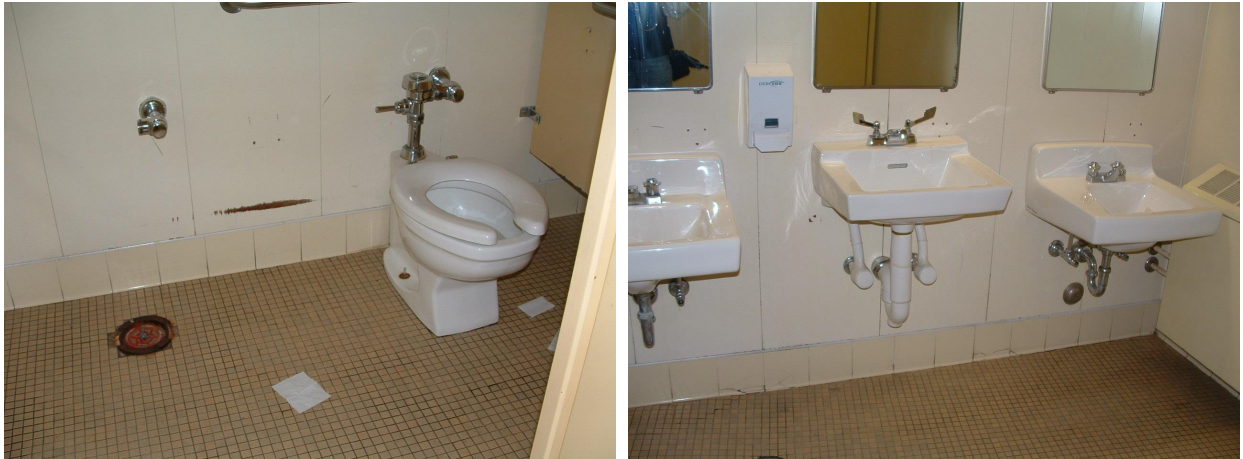
0811-2 North wing girl's toilet room

Teachers have stated these toilet rooms' water closets back up and over flow frequently. ADA stall water closet is not at ADA height. Rough in for water closet removed to make an ADA stall is still present. ADA lavatory is one in from end of lavatory wall because of encroachment of convactor on ADA clearance. Lavatory on either side of this lavatory also encroaches on the ADA clearance.

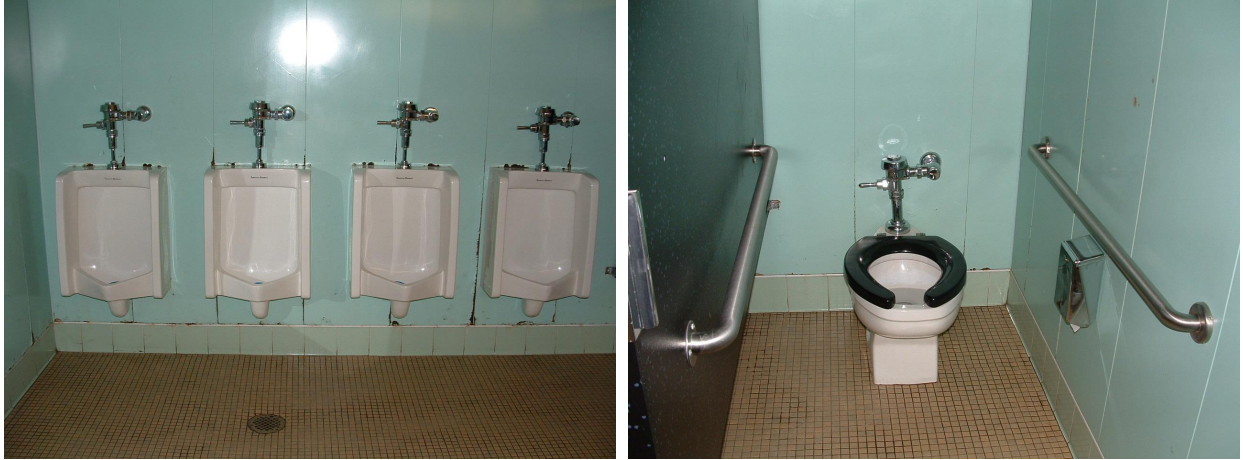
0811-3 North wing boy's toilet room

Teachers have stated these toilet rooms' water closets back up and over flow frequently. ADA stall is not ADA compliant. Water closet is not at ADA height nor does it have clearances. No ADA urinal or lavatory in toilet room.
