Gastineau Elementary

Douglas, Alaska

Facility Condition Survey Report Prepared June 2005

By NorthWind Architects, LLC, PN&D Inc., Haight & Associates,
Murray & Associates, and City & Borough of Juneau Engineering
Department

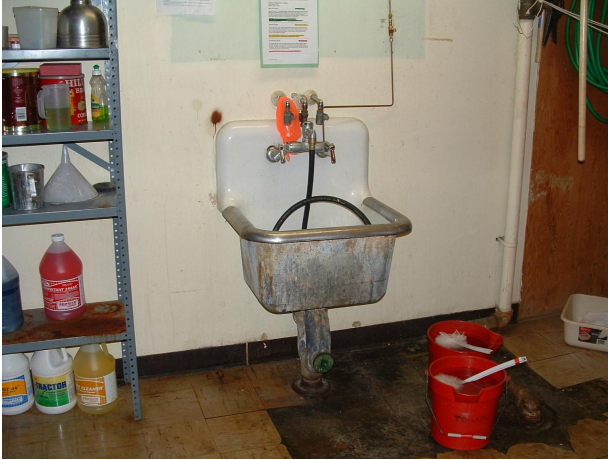
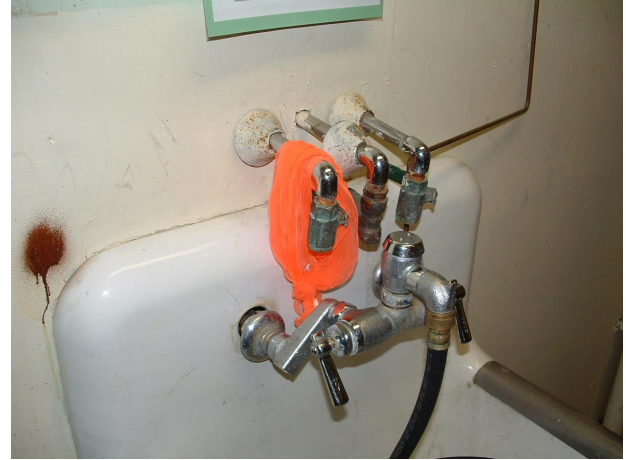
0811-5 North wing janitor closet service sink

Enameled cast iron service sink is very dirty. Faucet trim has been replaced and old rough in is still above service sink. Service sink has reached the end of its service life.

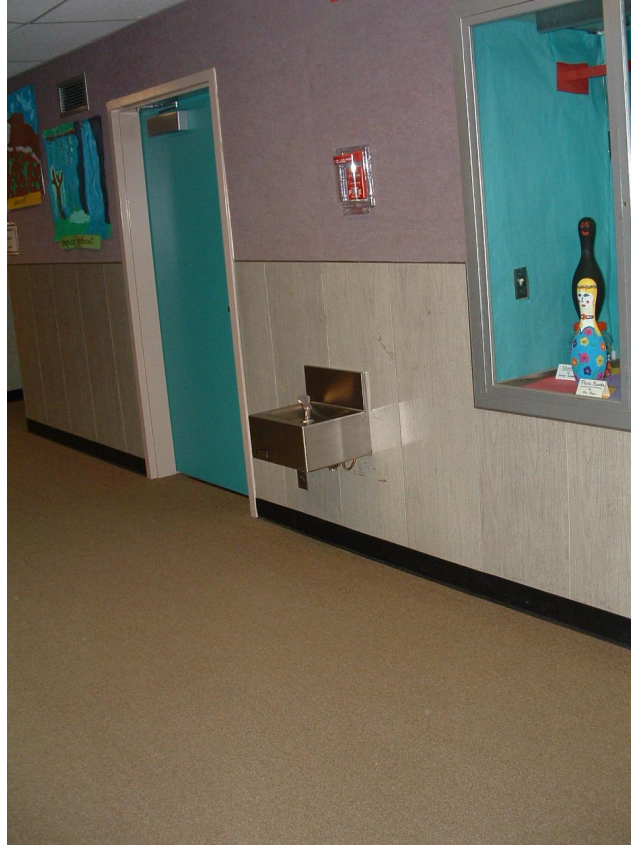
0811-6 South Wing Drinking Fountain

Drinking fountain is a single drinking fountain mounted at kindergarten height. No ADA drinking fountain in corridor.

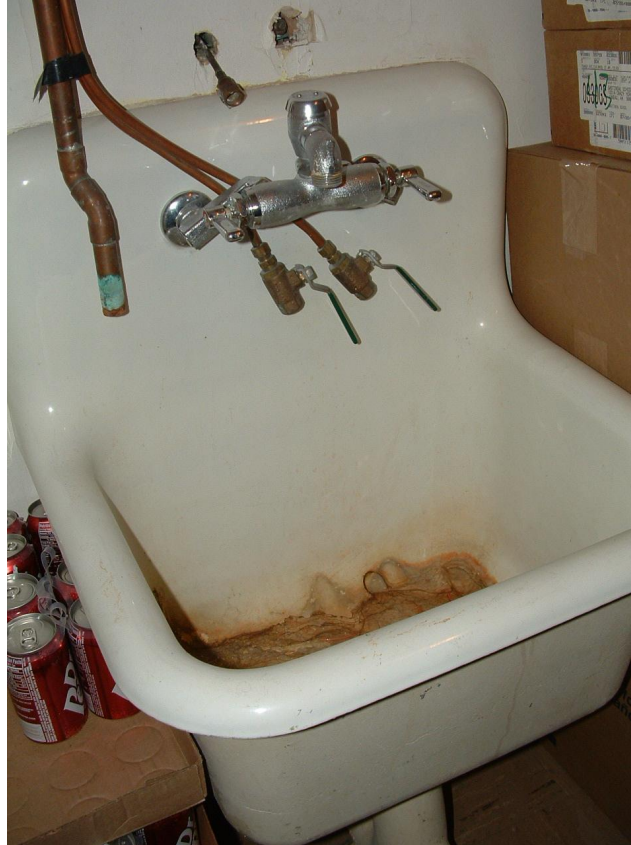
0811-7 Janitor Closet/Server/Paper Storage

Service sink is located in a server rooms with computer equipment, paper storage. Remove service sink. Service sink has reached the end of its service life.

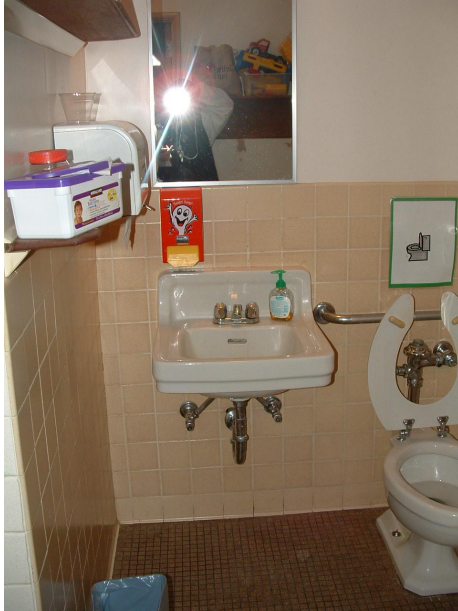
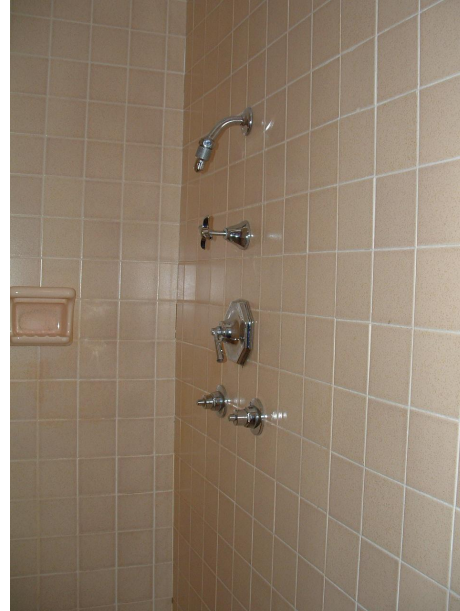
0811-8 Classroom 22 Shower/Toilet Room

This area is now a pre-school program for the school district. Shower is used for storage and the toilet and lavatory are at ADA heights. Suggest using space as intended for nurse's station. Fixtures were installed in the original construction in 1956 and have reached the end of their service life.

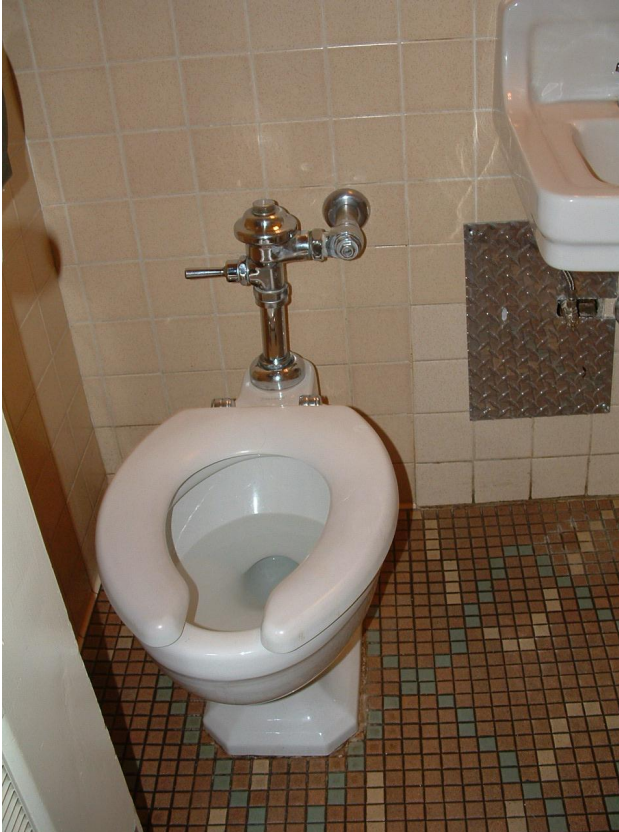
0811-10 Teacher's Toilet Room

Fixtures are not at adult ADA heights. Fixtures were installed in the original 1956 construction and are past their service life.

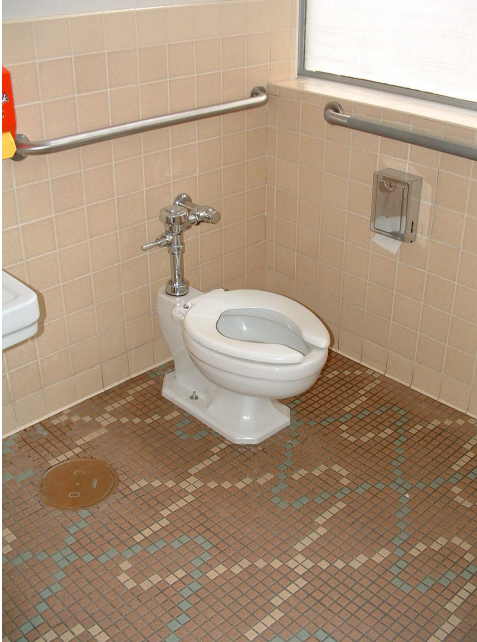
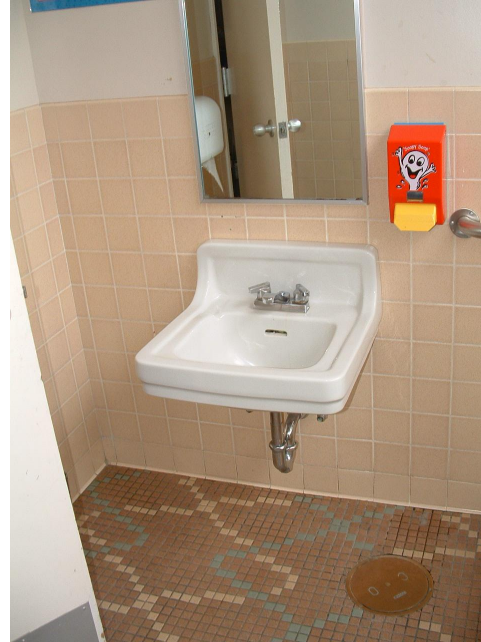
0811-12 Kindergarten Classroom Toilet Rooms

Fixtures have reached the end of service life.

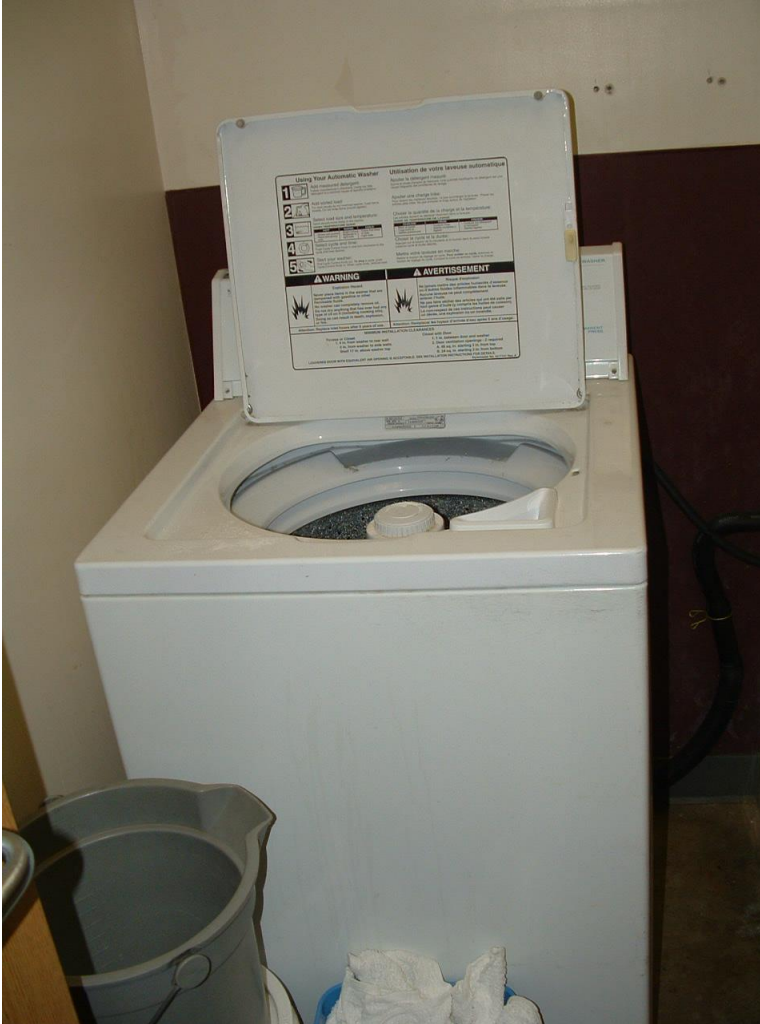
0811-16 Multipurpose Wing Janitor Closet

Cloth washer has reports of overflowing.

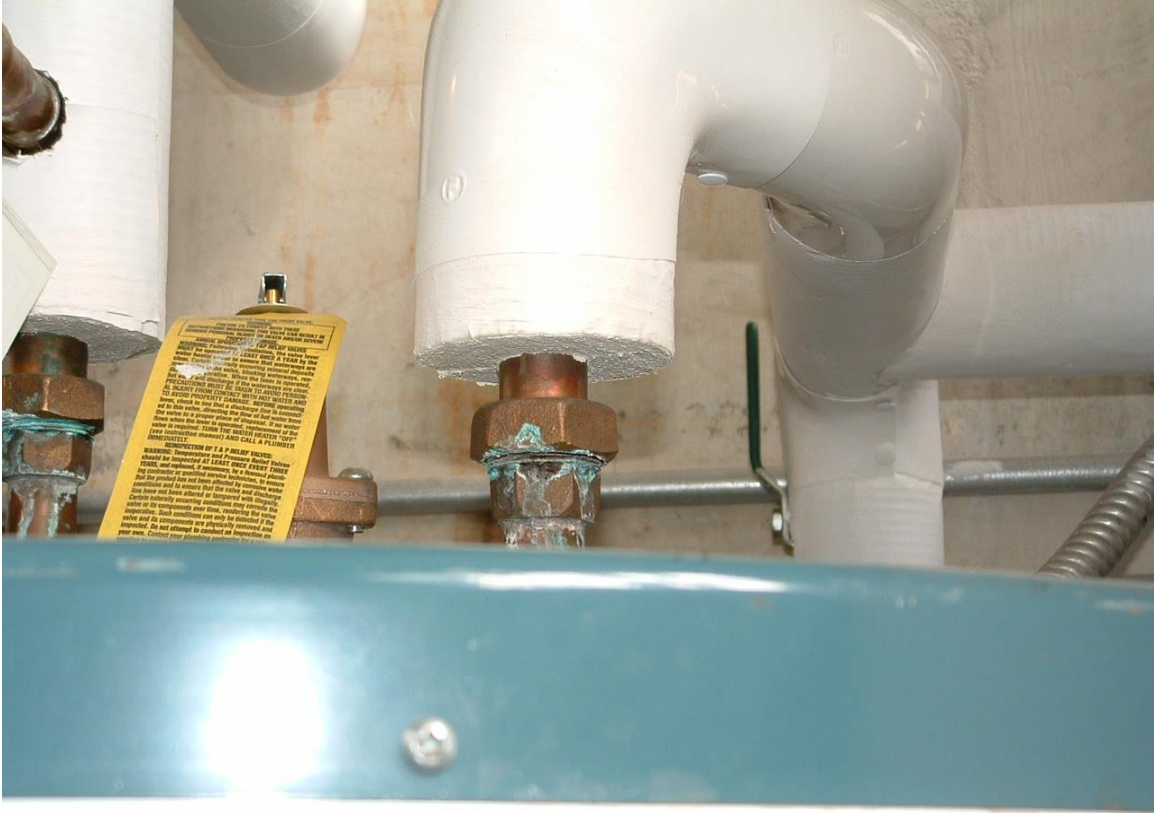
0812-1 Electric Hot water heater:

Piping to 120 gallon electric hot water heater shows signs of corrosion.

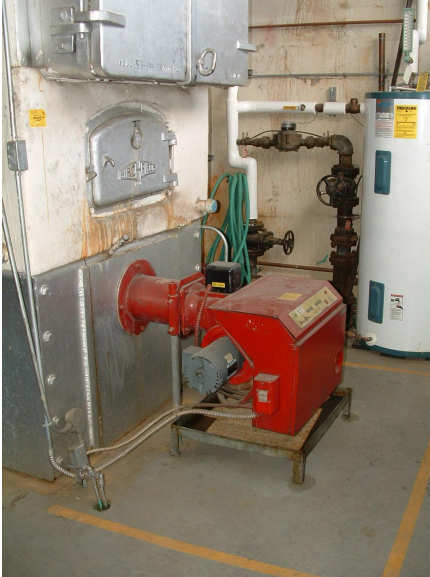
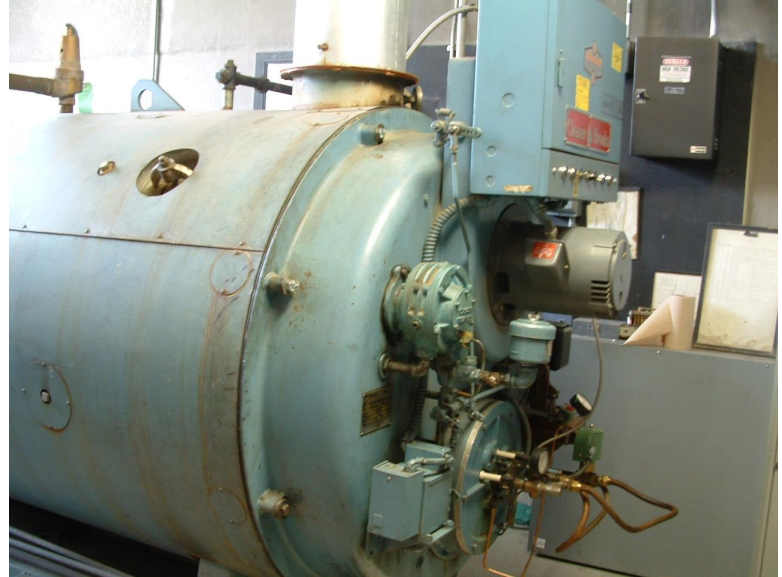
0821-1 Boilers are past service life

Boilers are 40 and 47 years old and well past their service life.

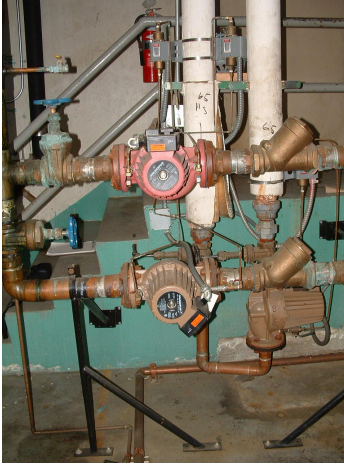
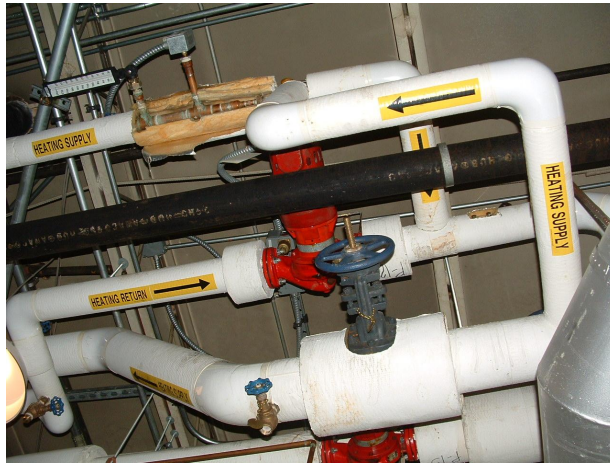
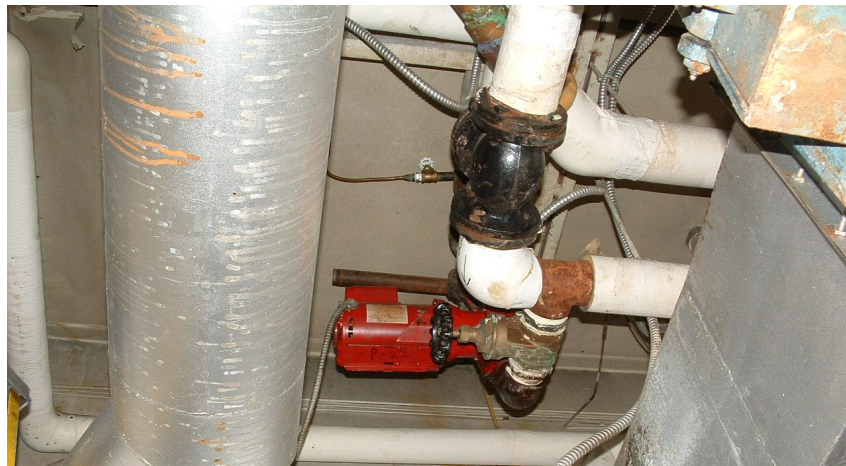
0821-2 Redundant Pumps

Multiple redundant pumps exist through out the building. Waste of energy to operate multiple pumps.

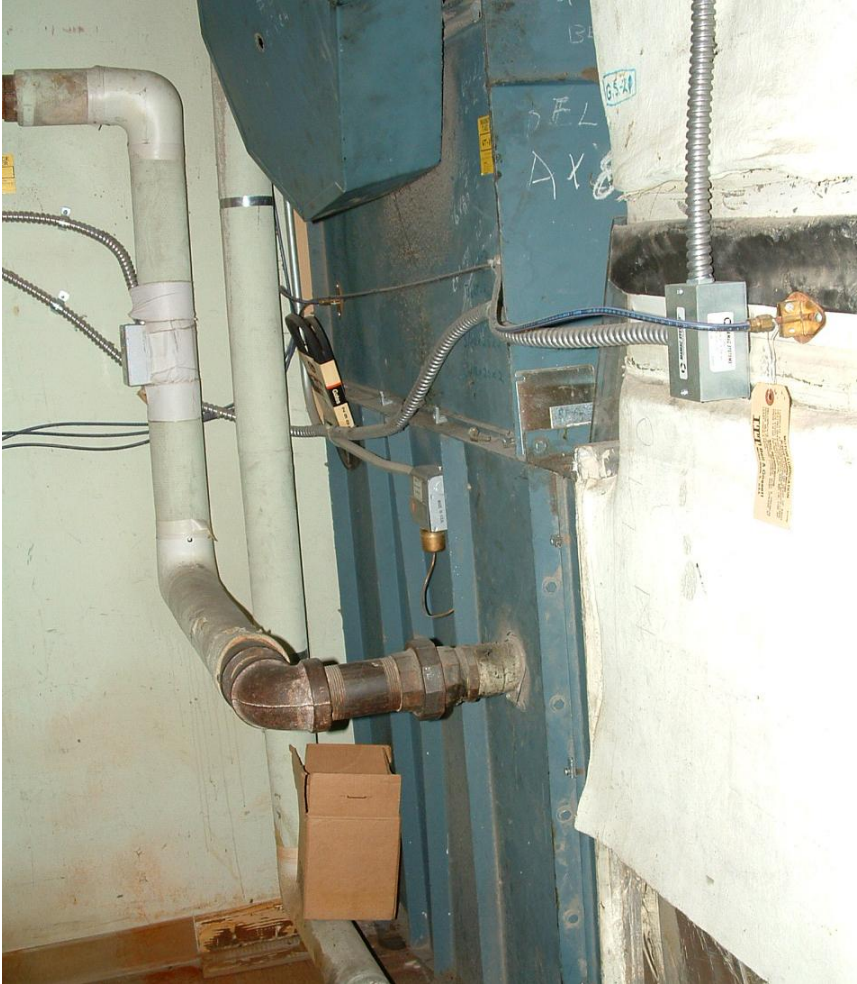
0823-3 VU-3

VU-3 fan unit is approximately 40 years old and has exceeded its service life. The heating coil is caked with dirt. Inside of fan casing is dirty. No access to dampers. Holes exist in connecting ductwork. Return air opening was installed in outside air duct that allows air from adjacent storage rooms to enter fan system.

Deficiency category: RR

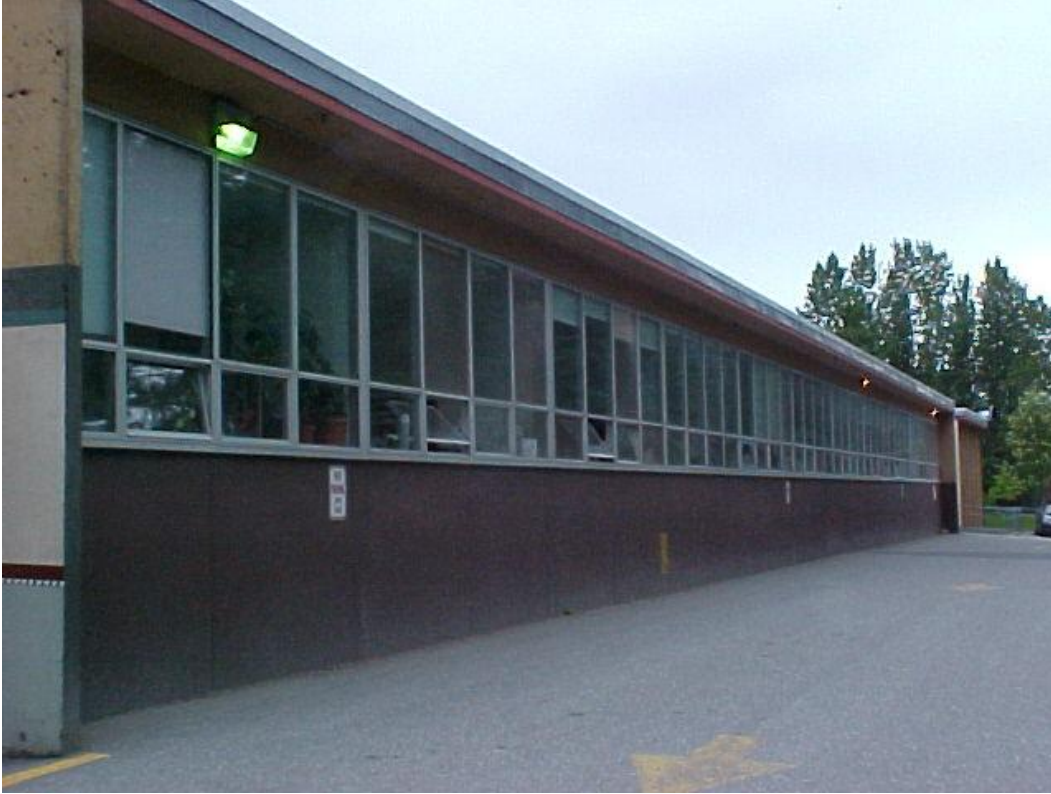
0162-1 Upgrade lighting on east side of school

These luminaries are predominately original and past their service life. It appears a couple of the fixtures failed and were replaced different fixture types, thus the fixture styles are not consistent. The lenses are discolored, decreasing light output. Upgrading the lighting along this side of the school is critical to achieve acceptable light levels along the main drive to the site.

Deficiency category: RR, F

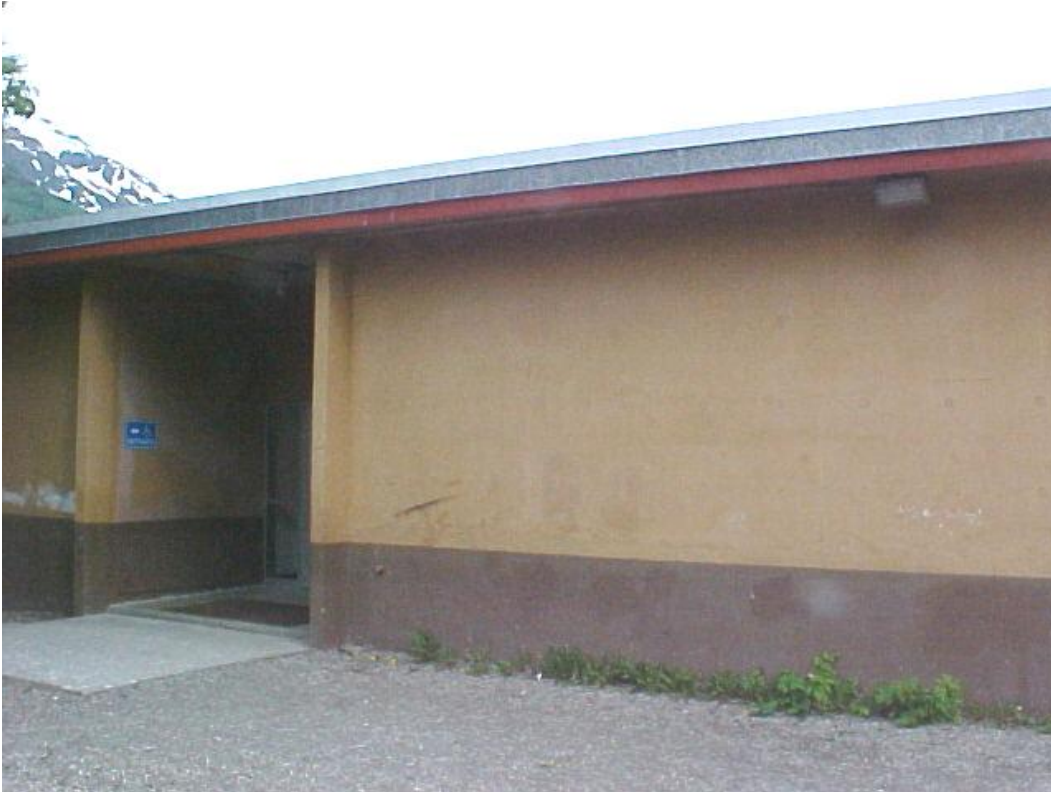
0162-2 Replace lighting on north side of 1965 addition

The surface mounted fixture at the entry is 40 years old, beyond its service life, and in poor condition. The wall packs were likely added as a maintenance upgrade to deter vandalism on this secluded and dark end of the building. It is unknown when the wall packs were installed. They are in fair condition and due for replacement.

Deficiency category: RR

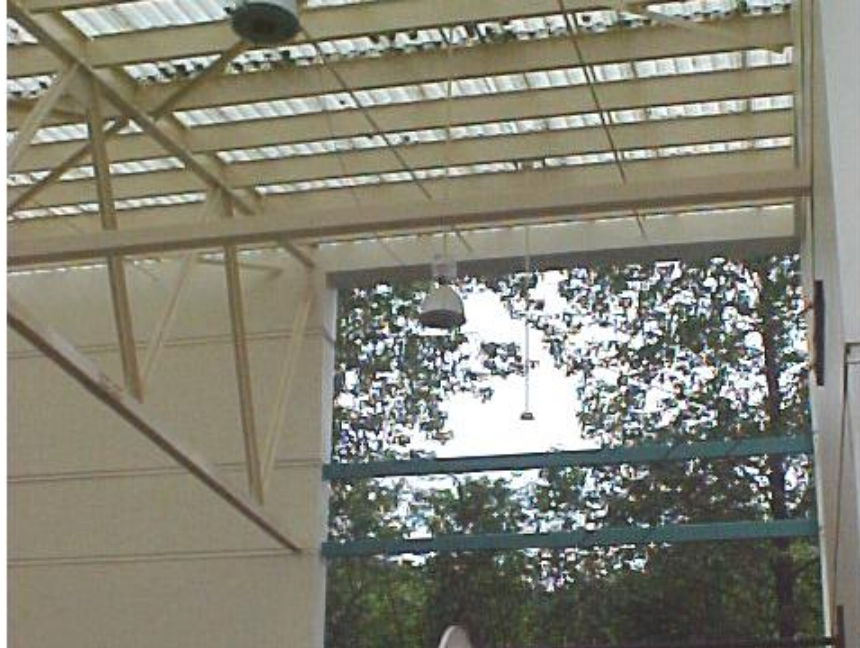
0162-4 Replace covered play area high bay fixtures

High bay pendant mounted fixtures appear to have been consistently battered with balls during the last ten years. Some of the fixtures are completely missing; while others have just the ballast housing still intact.

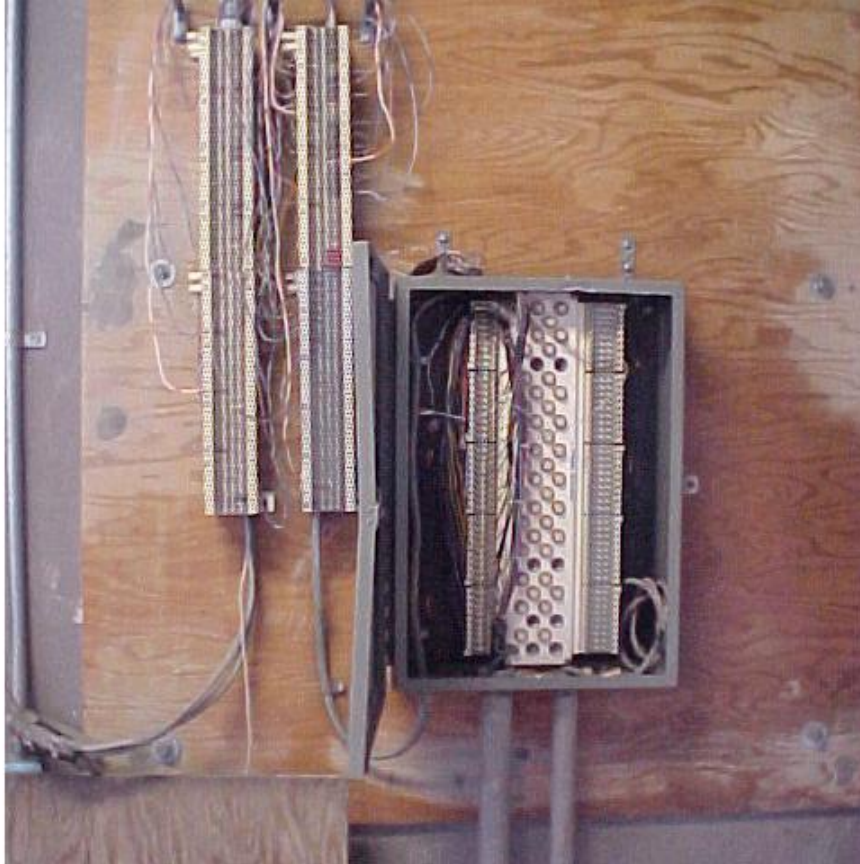
0163-1 Replace antiquated telephone system

A 25-pair cable is inadequate for a school of this size. The primary protection and punch down blocks are in poor condition. This system is antiquated with very limited infrastructure.

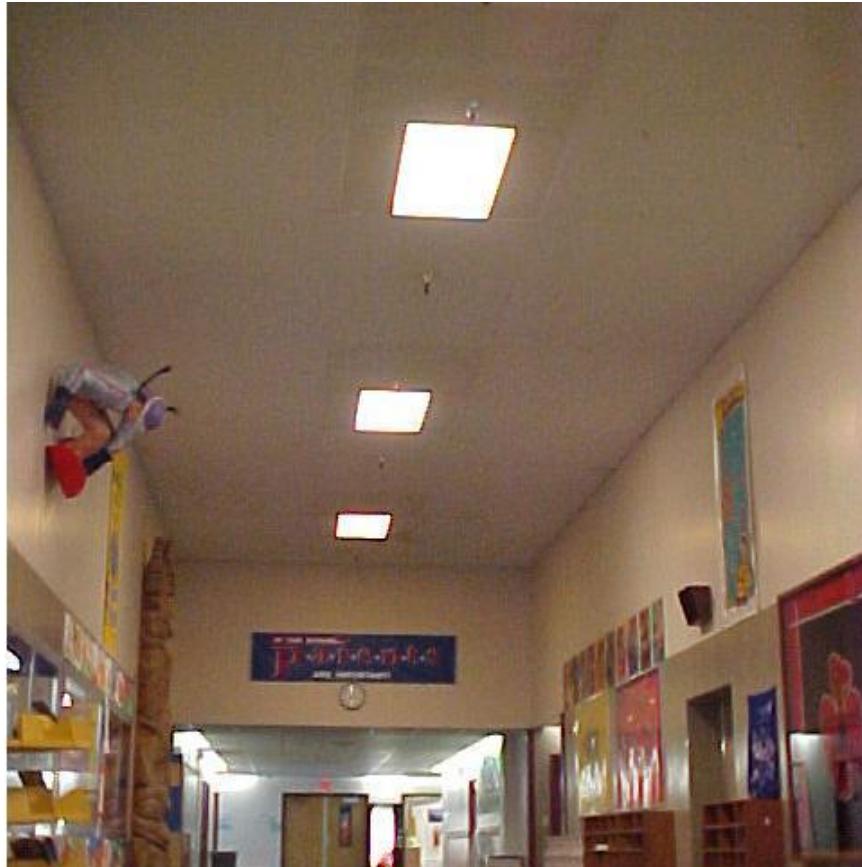
0921-1 Replace lighting system in high portion of main corridor

Light levels through this portion of the corridor system are low due to the inefficiency of the fixtures and because the present gray floor finish does not provide much reflectance.

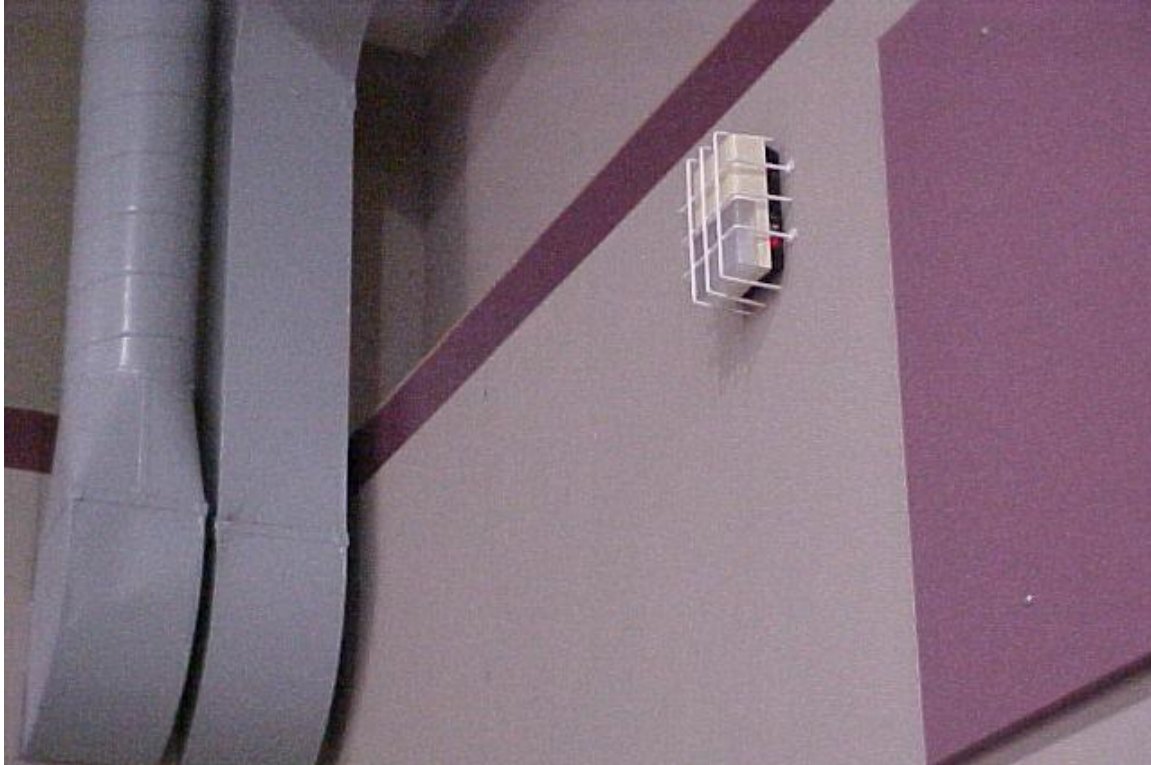
0921-9 Supplement egress lighting

Egress lighting throughout the facility is very limited. Fixtures that are installed do not comply with current International Building Code requirements of a minimum of 1 foot-candle along the path of egress.

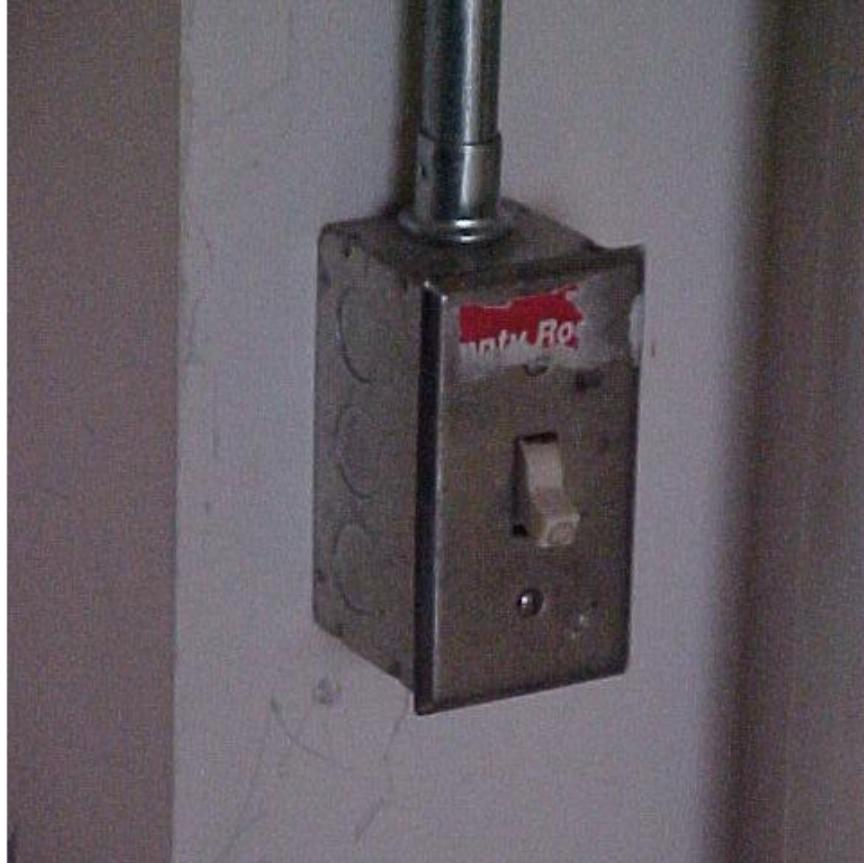
0921-10 Replace lighting controls

The hard wired switches are due for replacement as fixture replacement occurs. The keyed switches in the gym no longer function so the panel board is used to control lighting. Switches are not provided for corridor lights, which are controlled by panel boards.

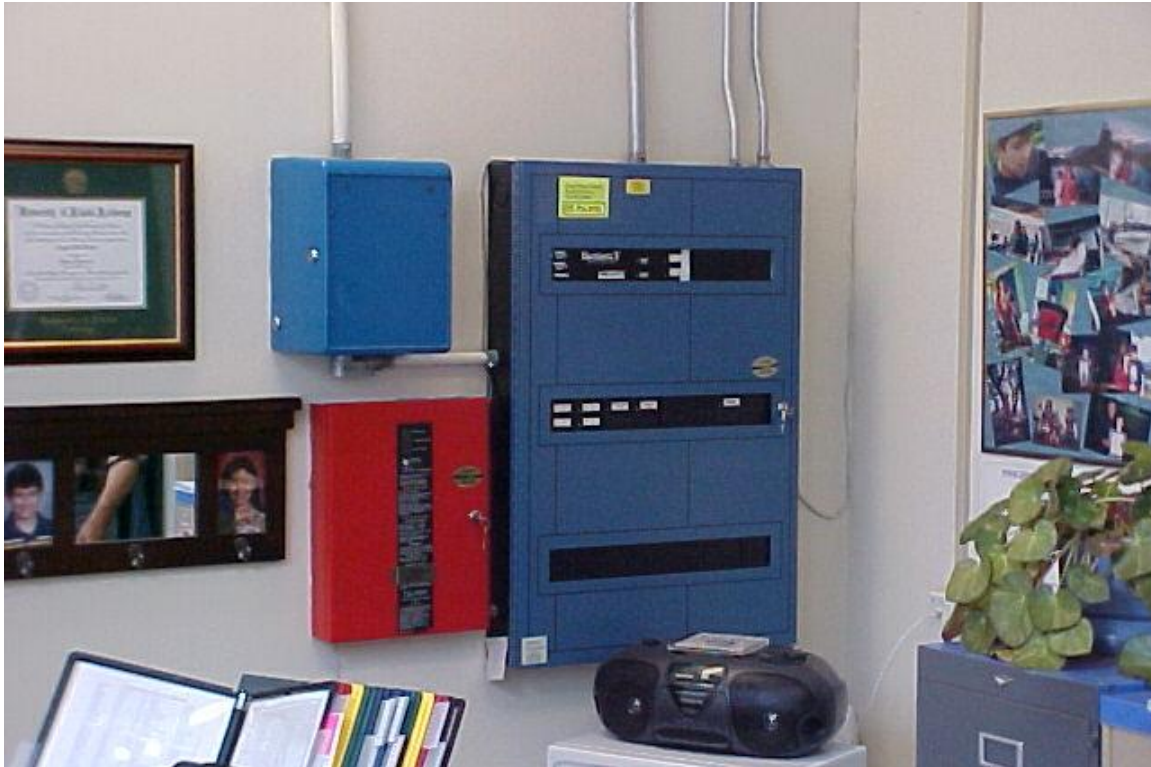
0941-1 Replace fire alarm system

The fire alarm control panel is old technology, and parts for these panels are becoming more and more difficult to obtain. The manual pull stations are mounted too high to comply with the American's with Disabilities Act. Shut down of mechanical equipment upon the detection of smoke is required to be accomplished through the fire alarm control panel. The present configuration utilizes the building management system, which is not a UL-Listed product for fire alarm use. Spacing of the combination horn/strobe units does not comply with National Fire Protection Association codes. Strobe-only units are not located in common spaces as required by the American's with Disabilities Act. The fire alarm system is antiquated and non-compliant with several codes.

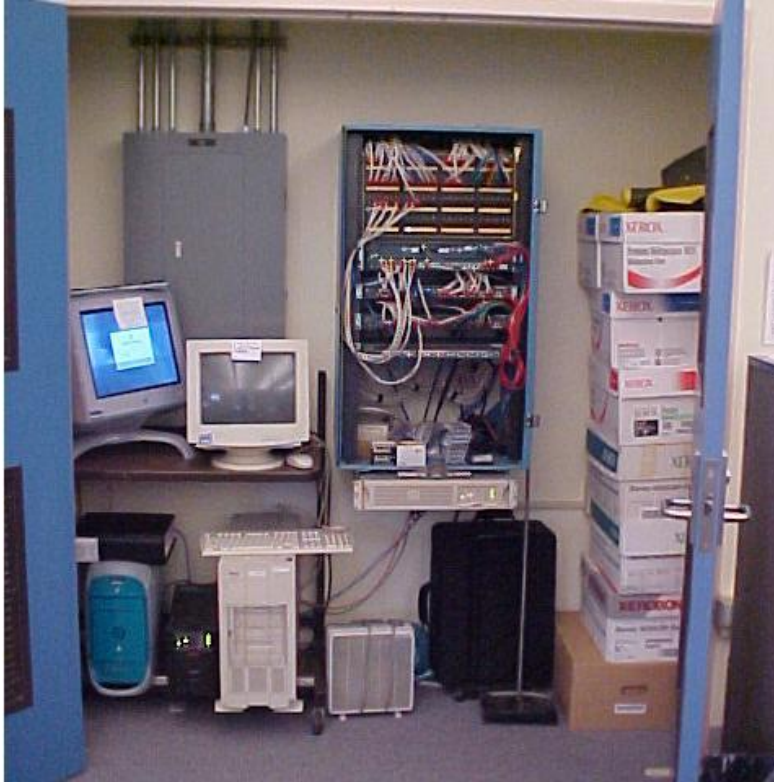
0942-2 Develop media center

The limited availability of space probably forced the application of the wall mounted data racks. These racks are difficult to maintain, and are not installed in a manner that allows future cabling to be easily integrated into the system.

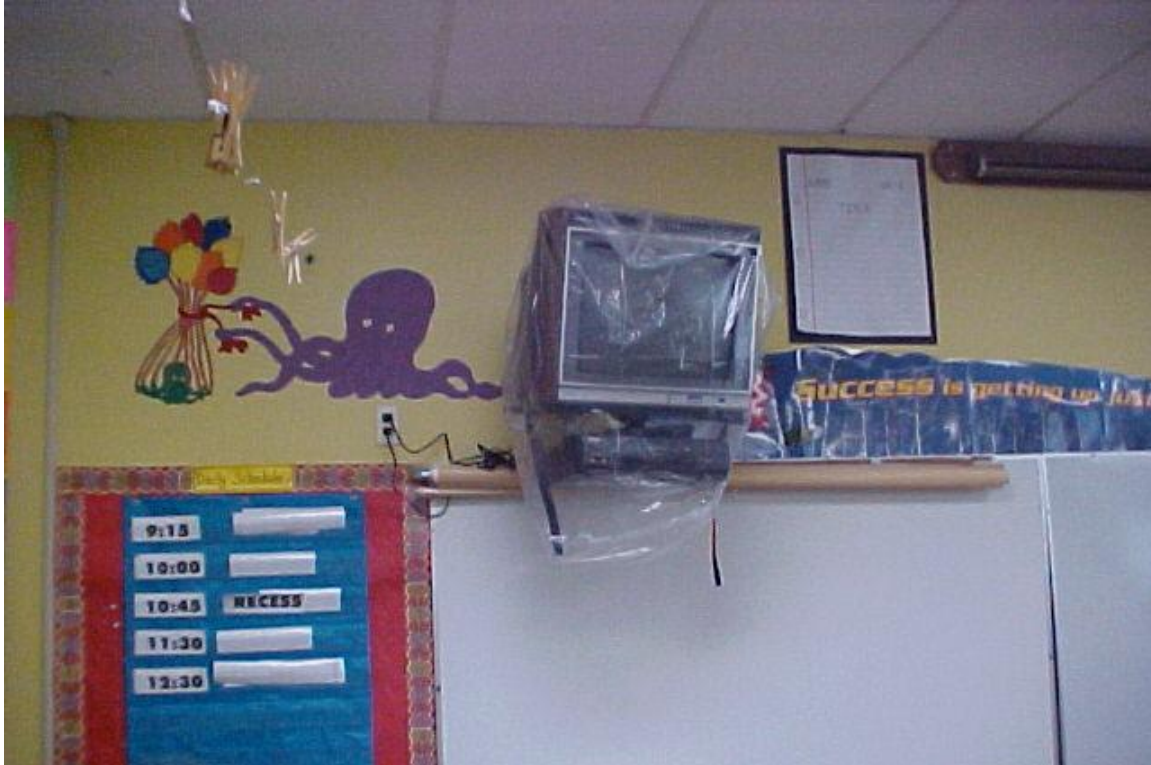
0942-4 Install television system

Some of the classrooms are equipped with televisions and video cassette recorders mounted to a wall bracket. However, the school is not equipped with an integrated cable television system.

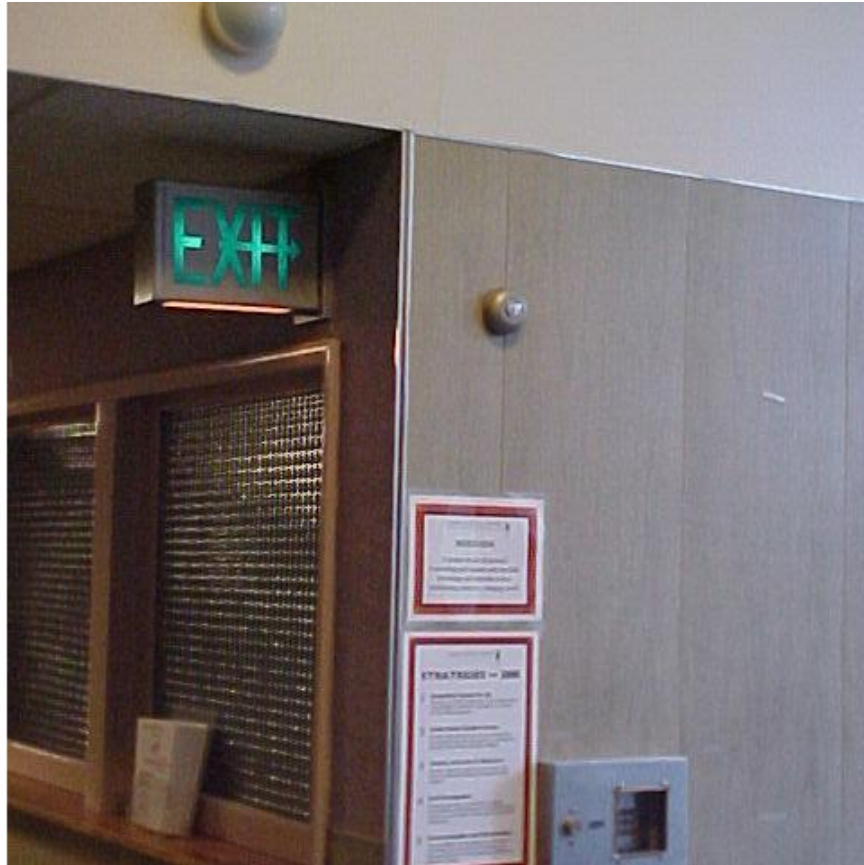
0943-1 Replace security system

The security system is old technology and does not comply with current school district standards.

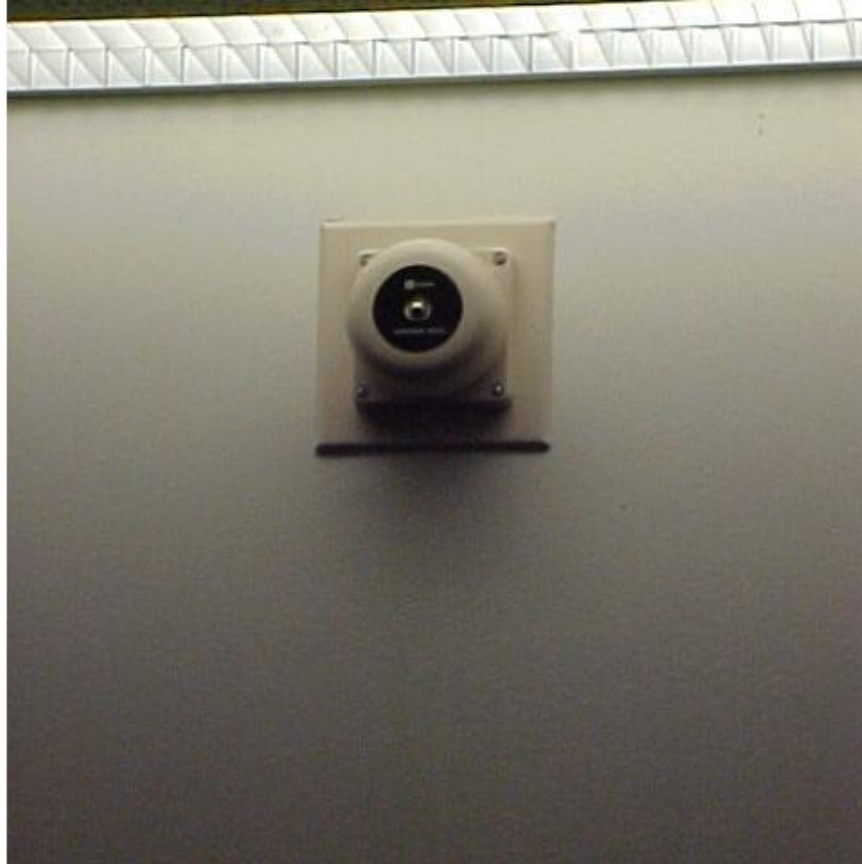
0945-1 Replace program bell system

The program bells are probably original and at the end of their service life.
