City and Borough of Juneau Aurora Harbor

PHASE III - FLOATS H & J MUNICIPAL HARBOR FACILITY GRANT APPLICATION

August 1, 2018

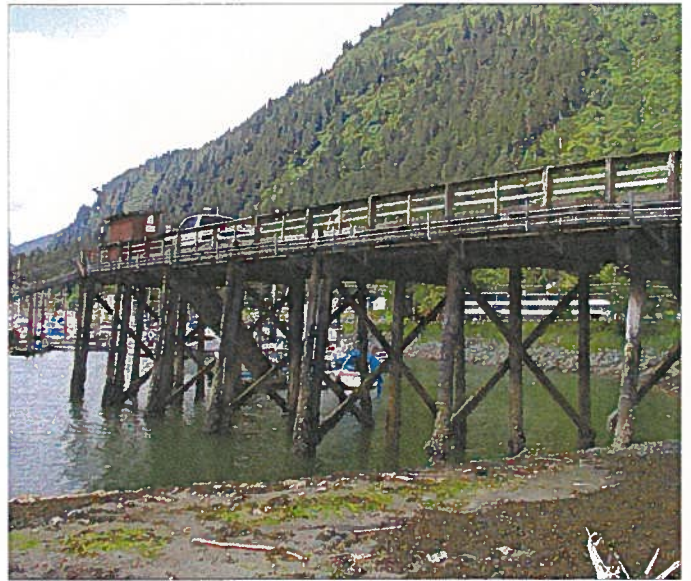
AURORA 002.jpg
WEST SIDE OF "A" GANGWAY APPROACH DOCK

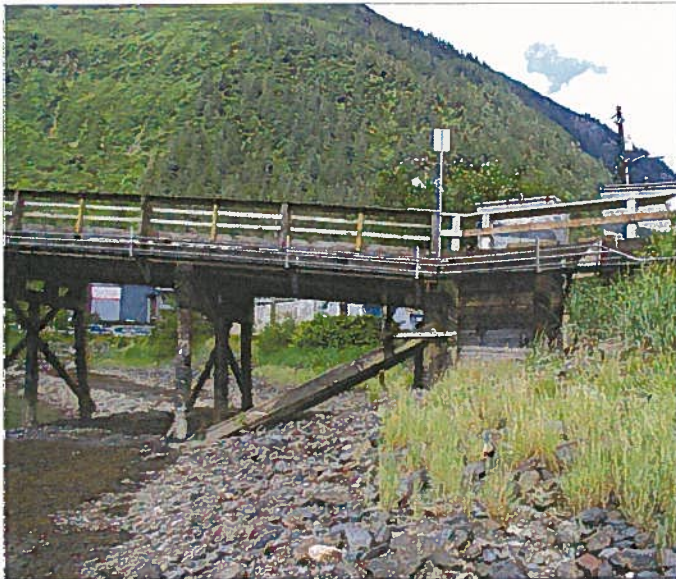
AURORA 003.jpg
"A" GANGWAY APPROACH DOCK ABUTMENT

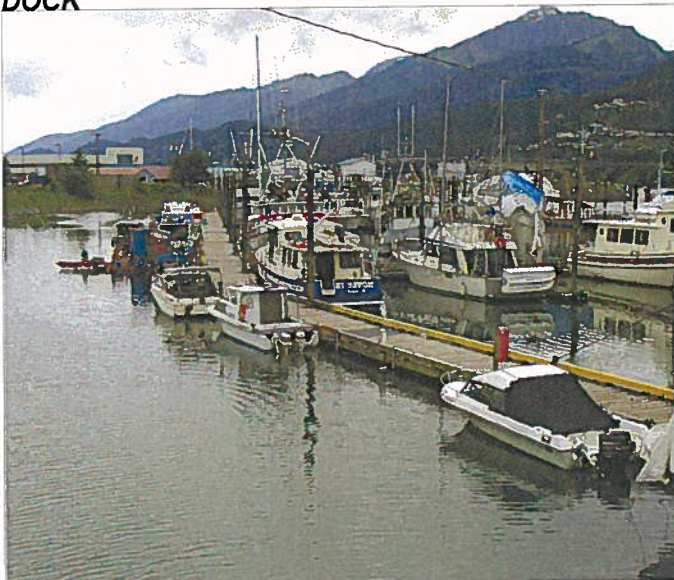
AURORA 011.jpg
VIEW SOUTH DOWN HEADWALK FLOAT BETWEEN "B" FLOAT AND "A" FLOAT

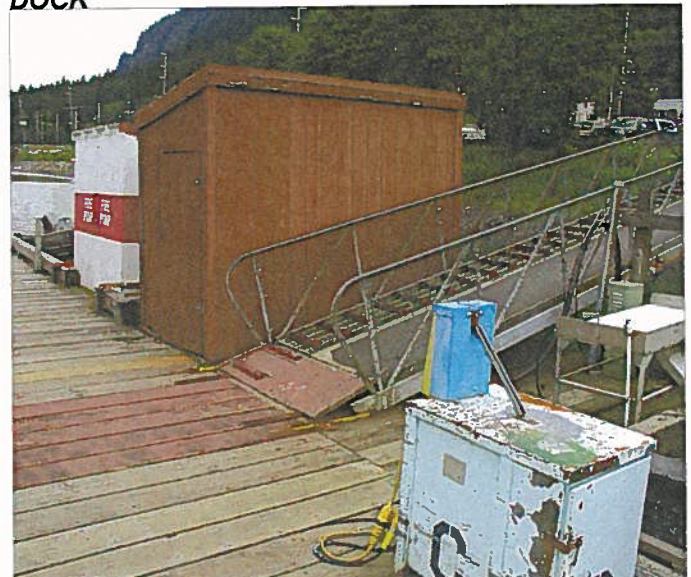
AURORA 012.jpg
"C" GANGWAY SKIDS AND TRANSITION TO HEADWALK FLOAT

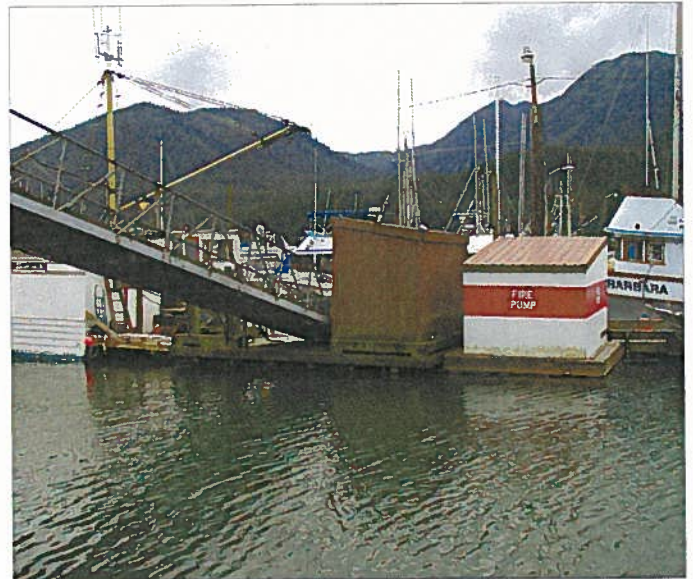
AURORA 016.jpg
"C" GANGWAY LANDING FLOAT

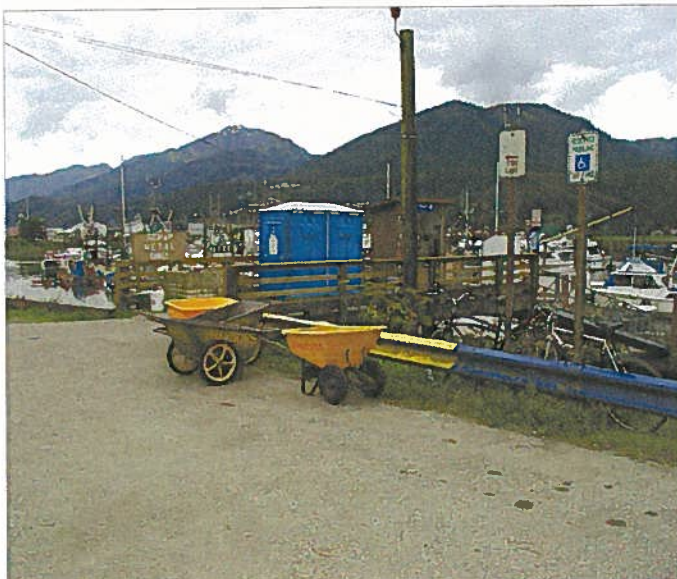
AURORA 017.jpg
UPLANDS AND APPROACH DOCK AT "C" GANGWAY

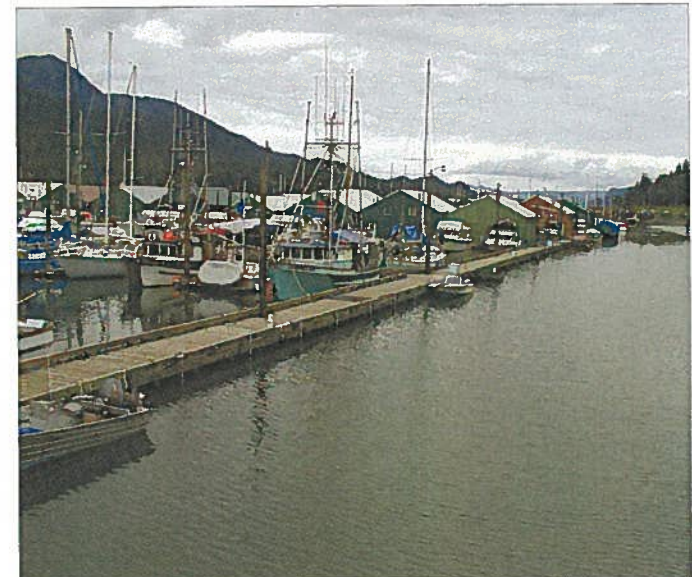
AURORA 024.jpg
VIEW NORTH DOWN HEADWALK FLOAT BETWEEN "C" FLOAT AND "D" FLOAT

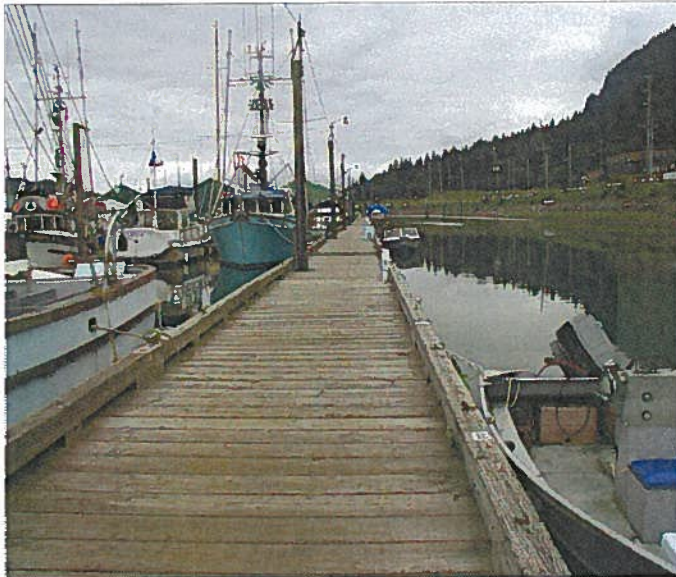
AURORA 025.jpg
VIEW NORTH DOWN HEADWALK FLOAT BETWEEN "C" FLOAT AND "D" FLOAT

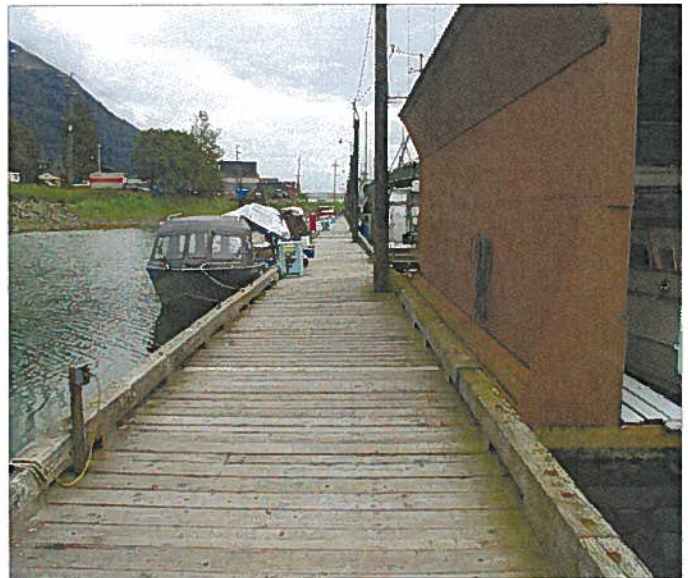
AURORA 026.jpg
VIEW DOWN HEADWALK FLOAT FROM "G" FLOAT SOUTH

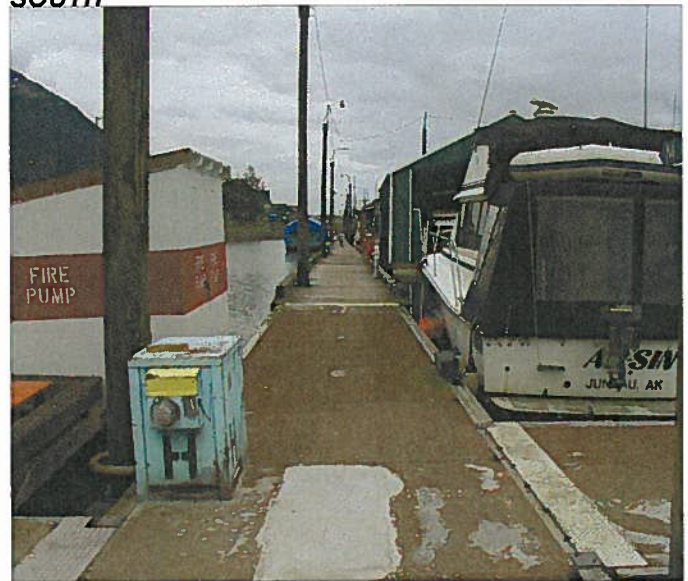
AURORA 028.jpg
VIEW SOUTH DOWN HEADWALK FLOAT FROM "H" FLOAT

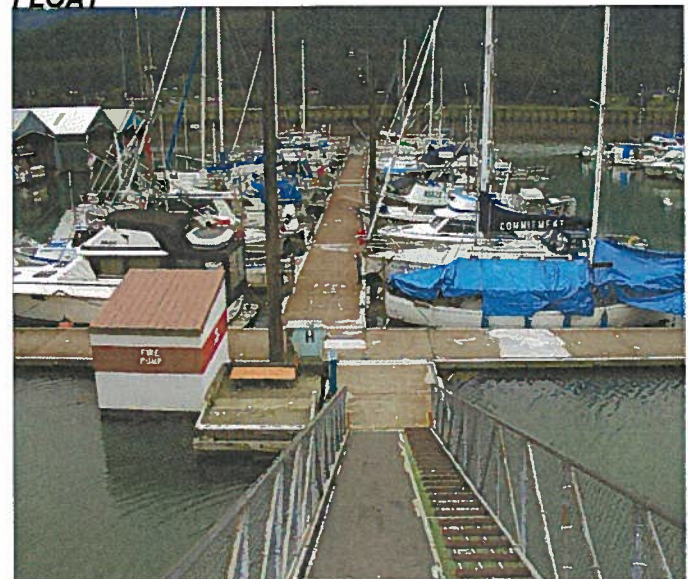
AURORA 030.jpg
VIEW WEST AT "H" FLOAT GANGWAY LANDING FLOAT

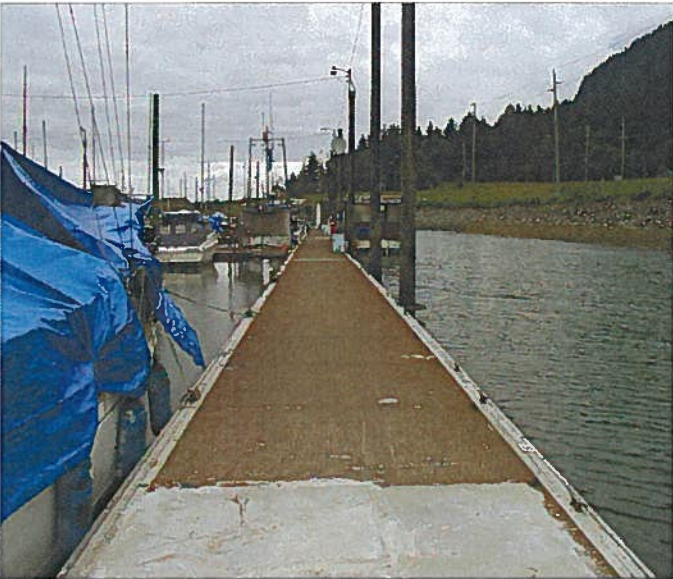
AURORA 039.jpg
VIEW NORTH DOWN HEADWALK FLOAT FROM "H" FLOAT

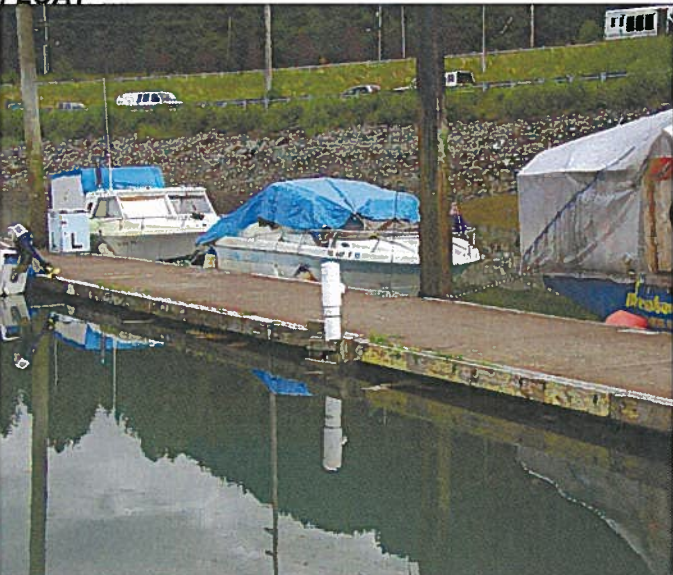
AURORA 041.jpg
ROTTED TIMBER WALERS ON HEADWALK FLOAT BETWEEN "K" AND "L" FLOAT

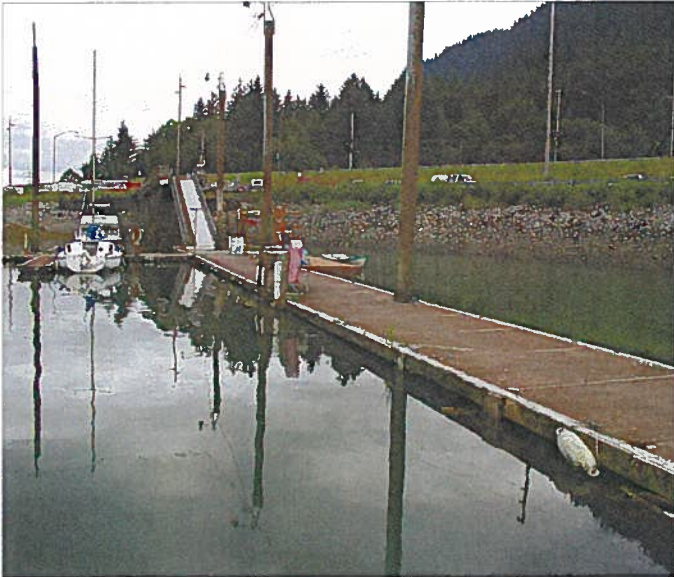
AURORA 043.jpg
VIEW NORTH DOWN HEADWALK FLOAT FROM "L" FLOAT

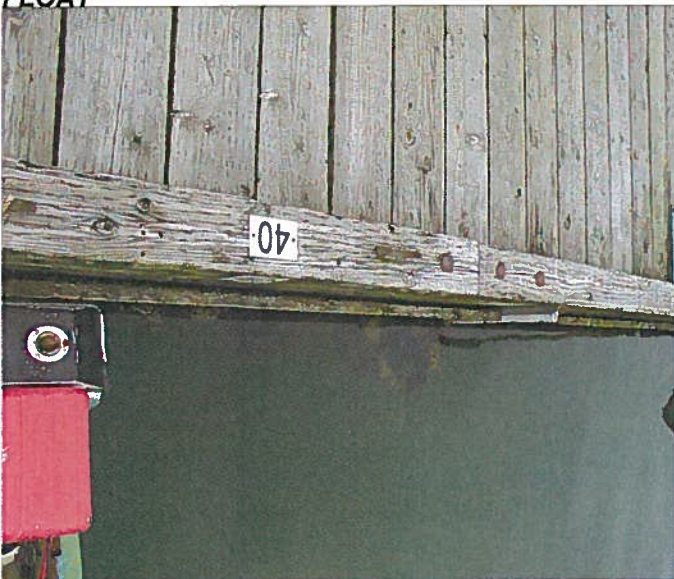
AURORA 045.jpg
ROTTEN, DETACHED RUBSTRIP ALONG HEADWALK FLOAT. NEAR "D" FLOAT

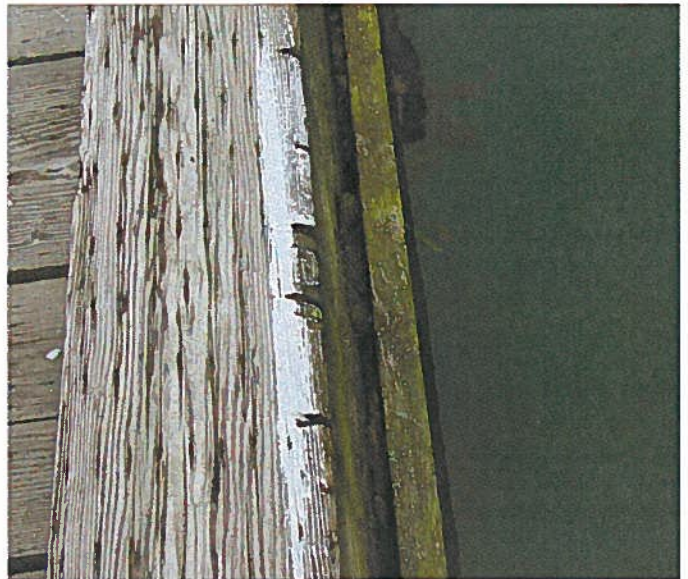
AURORA 046.jpg
ROTTEN, DETACHED RUBSTRIP ALONG HEADWALK FLOAT. NEAR "D" FLOAT

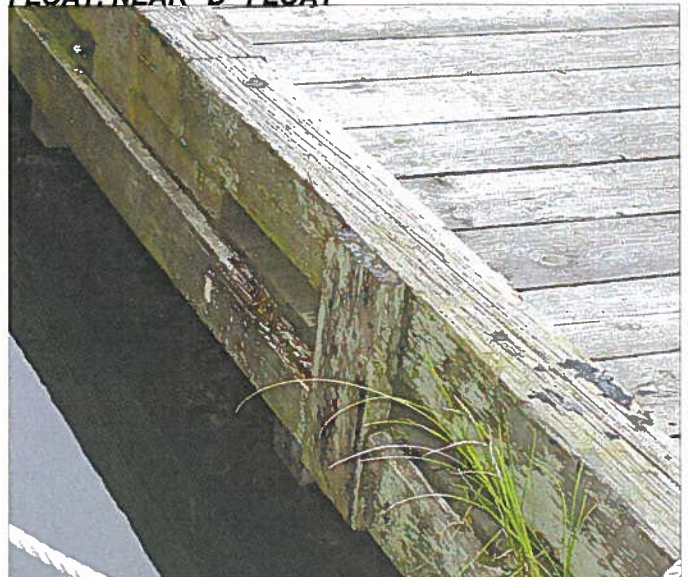
AURORA 048.jpg
ROTTEN RUBSTRIP ALONG HEADWALK NEAR "A" FLOAT

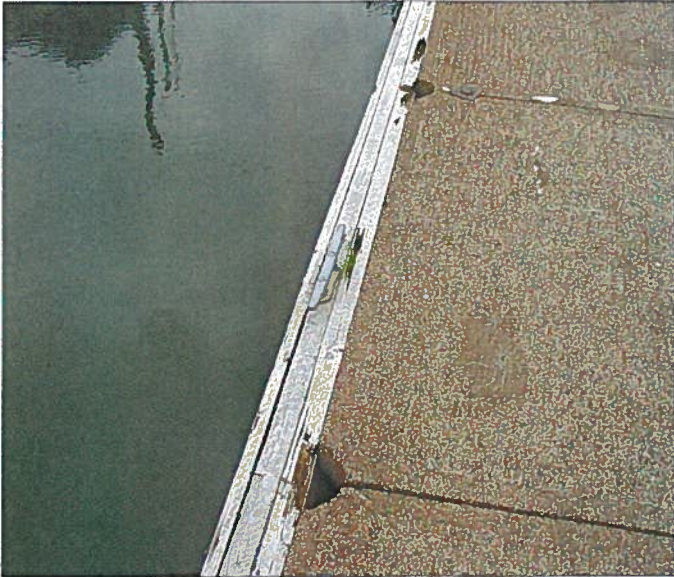
AURORA 049.jpg
ROTTEN TIMBER WALERS ON HEADWALK FLOAT
BETWEEN "H" AND "J" FLOAT

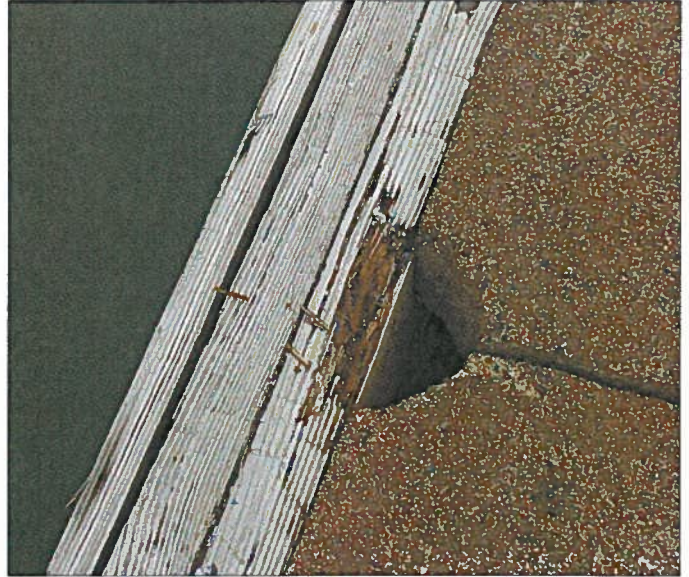
AURORA 050.jpg
ROTTEN TIMBER WALERS ON HEADWALK FLOAT
BETWEEN "H" AND "J" FLOAT

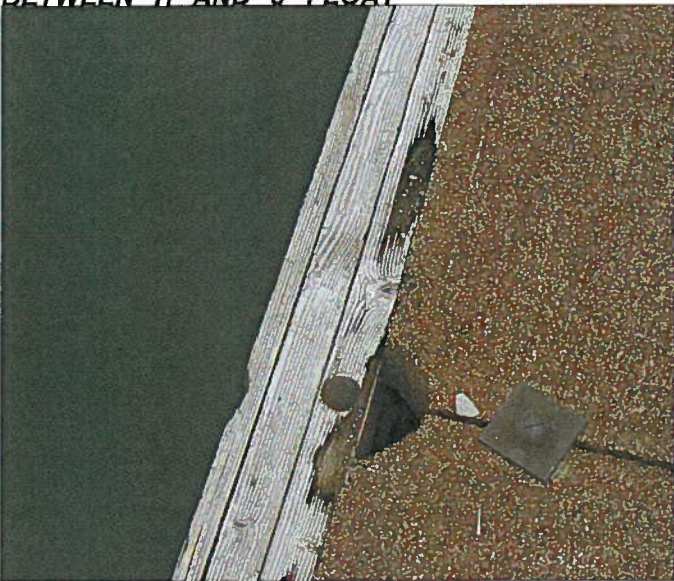
AURORA 051.jpg
ROTTEN TIMBER WALERS ON HEADWALK FLOAT
BETWEEN "H" AND "J" FLOAT

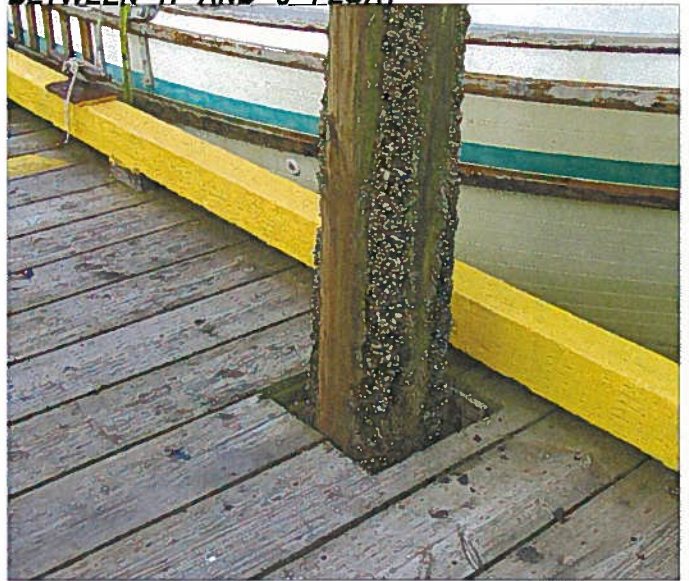
AURORA 052.jpg
TYPICAL ABRADED HEADWALK PILE

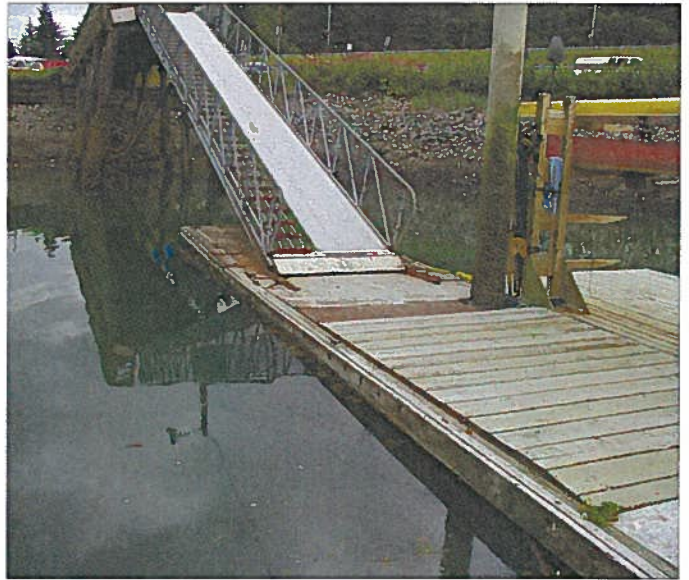
AURORA 056.jpg
LOW FREEBOARD AT "N" GANGWAY

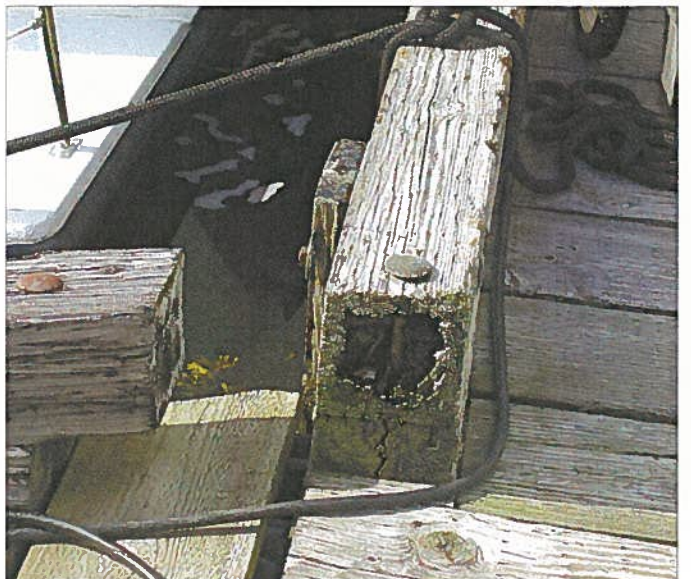
AURORA 066.jpg
TYPICAL ROTTEN HEADWALK BULLRAIL

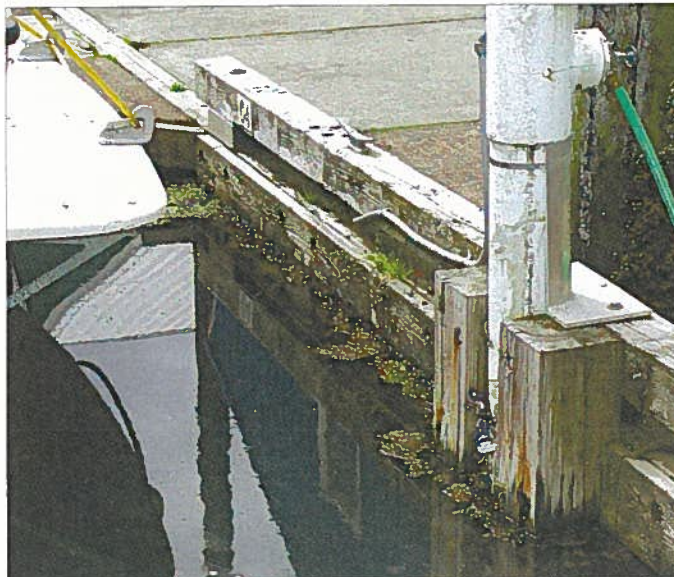
AURORA 083.jpg
LOW FREEBOARD ON "G" FLOAT

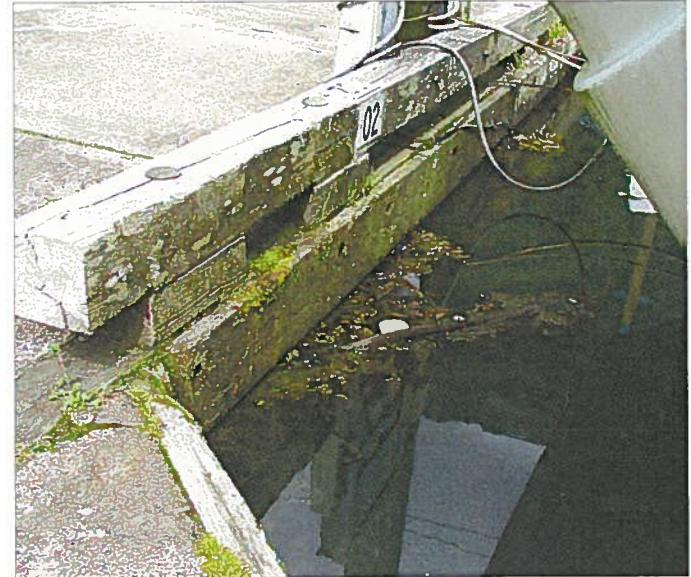
AURORA 084.jpg
LOW FREEBOARD ON "G" FLOAT

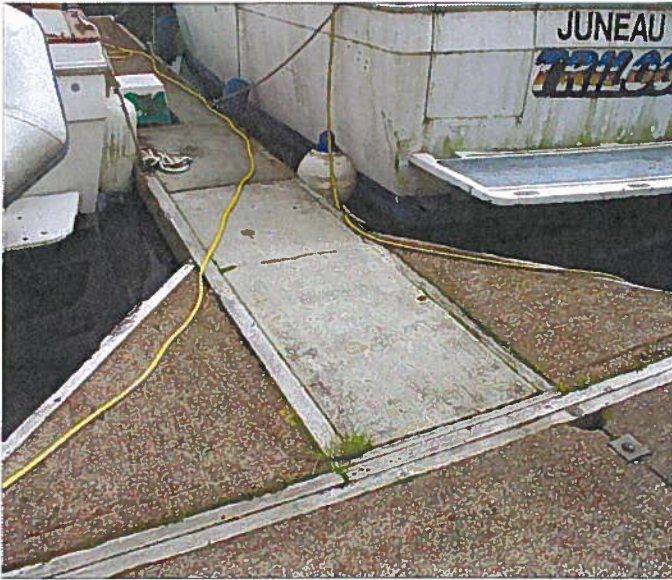
AURORA 085.jpg
RESURFACED FINGER ON "G" FLOAT

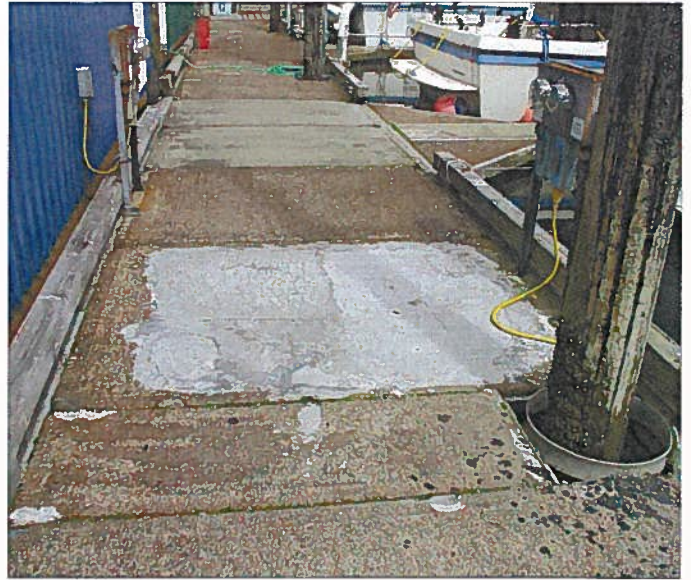
AURORA 086.jpg
RESURFACED MAINWALK FLOAT UNIT ON "G" FLOAT

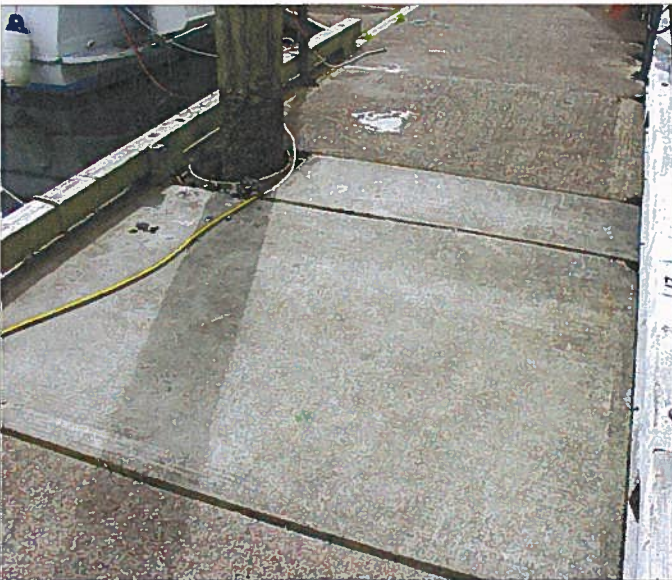
AURORA 087.jpg
RESURFACED MAINWALK FLOAT UNIT ON "G" FLOAT

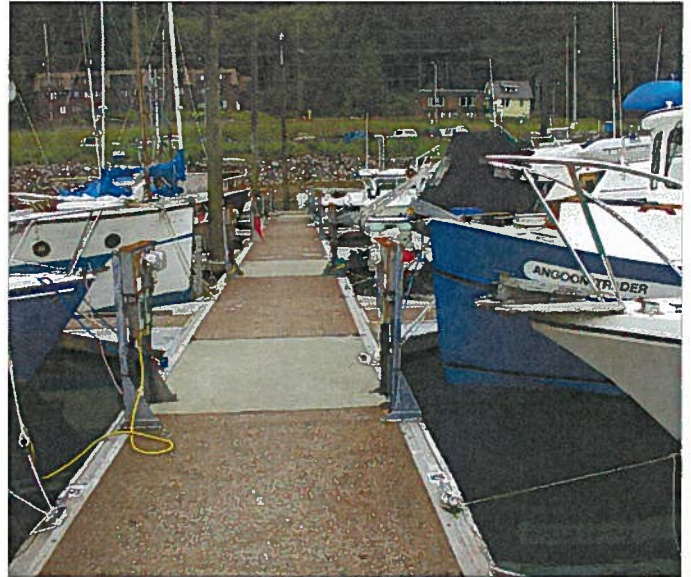
AURORA 092.jpg
VIEW EAST ON "J" FLOAT
