Subject: FY 11 Marine Passenger Fee Proceeds Recommendations

AUGUST 19, 2009

# JUNEAU CENTENNIAL HALL ROOF CONDITIONS ASSESSMENT

Jensen Yorba Lott, Inc 522 W 10<sup>th</sup> St. Juneau, AK 99801 907-586-1070

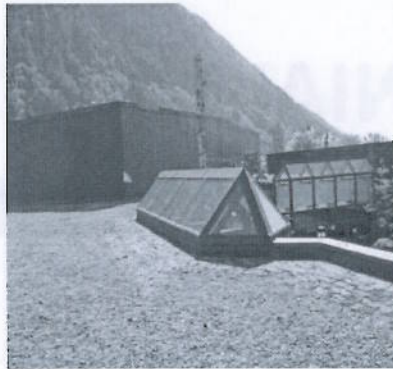
The roof structure consists of steel beams and trusses supporting a variety of steel deck types. The main assembly hall roof, the northwest and the southeast mechanical room roofs are 1-1/2" deep, 18 gage steel deck sloped at approximately 2% to perimeter roof drains. The lower roof is mostly 3" deep, 20 gage steel deck with 2.5" concrete slab, all installed dead level.

The exception is the relatively small roof areas to the north and south of the main exhibition

hall, which are 1-1/2" deep, 18 gage steel deck, sloped at 2%.

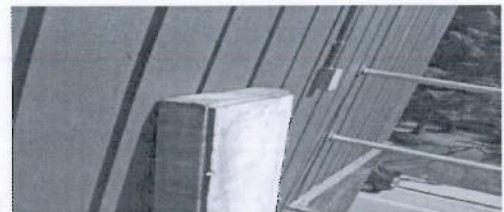
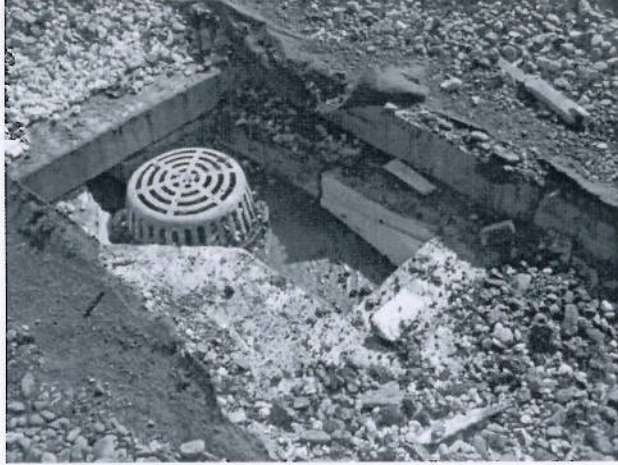
The original roof assembly consists of approximately 10 pounds per square foot

of washed, round rock approximately 1.5" diameter installed over filter fabric over two layers of extruded polystyrene insulation, 6" thick total. The insulation is assumed to be installed over a loose laid roof membrane over a loose laid ½"

gypsum sheathing where the roof deck is installed over steel deck. It is assumed that the gypsum sheathing is omitted at the concrete slabs. Because the roof is installed in an inverted roof membrane (IRMA) configuration, there is no vapor barrier. Channels are provided in the roof insulation to promote drainage to the existing roof drains. The entire roof perimeter is lined with 6

rows of 8x16x1.5 concrete ballast pavers.

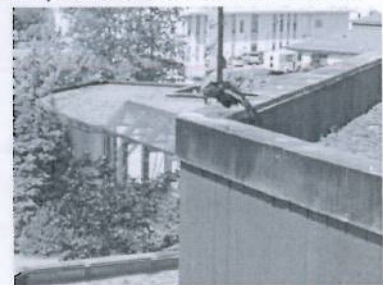
Other similar buildings have experienced significant damage due to bird activities on both horizontal and vertical EPDM membranes to the point that the roof had to be replaced.
