PHASE I ENVIRONMENTAL SITE ASSESSMENT

**5871 CHURCHILL WAY
JUNEAU, ALASKA**

JULY 3, 2012

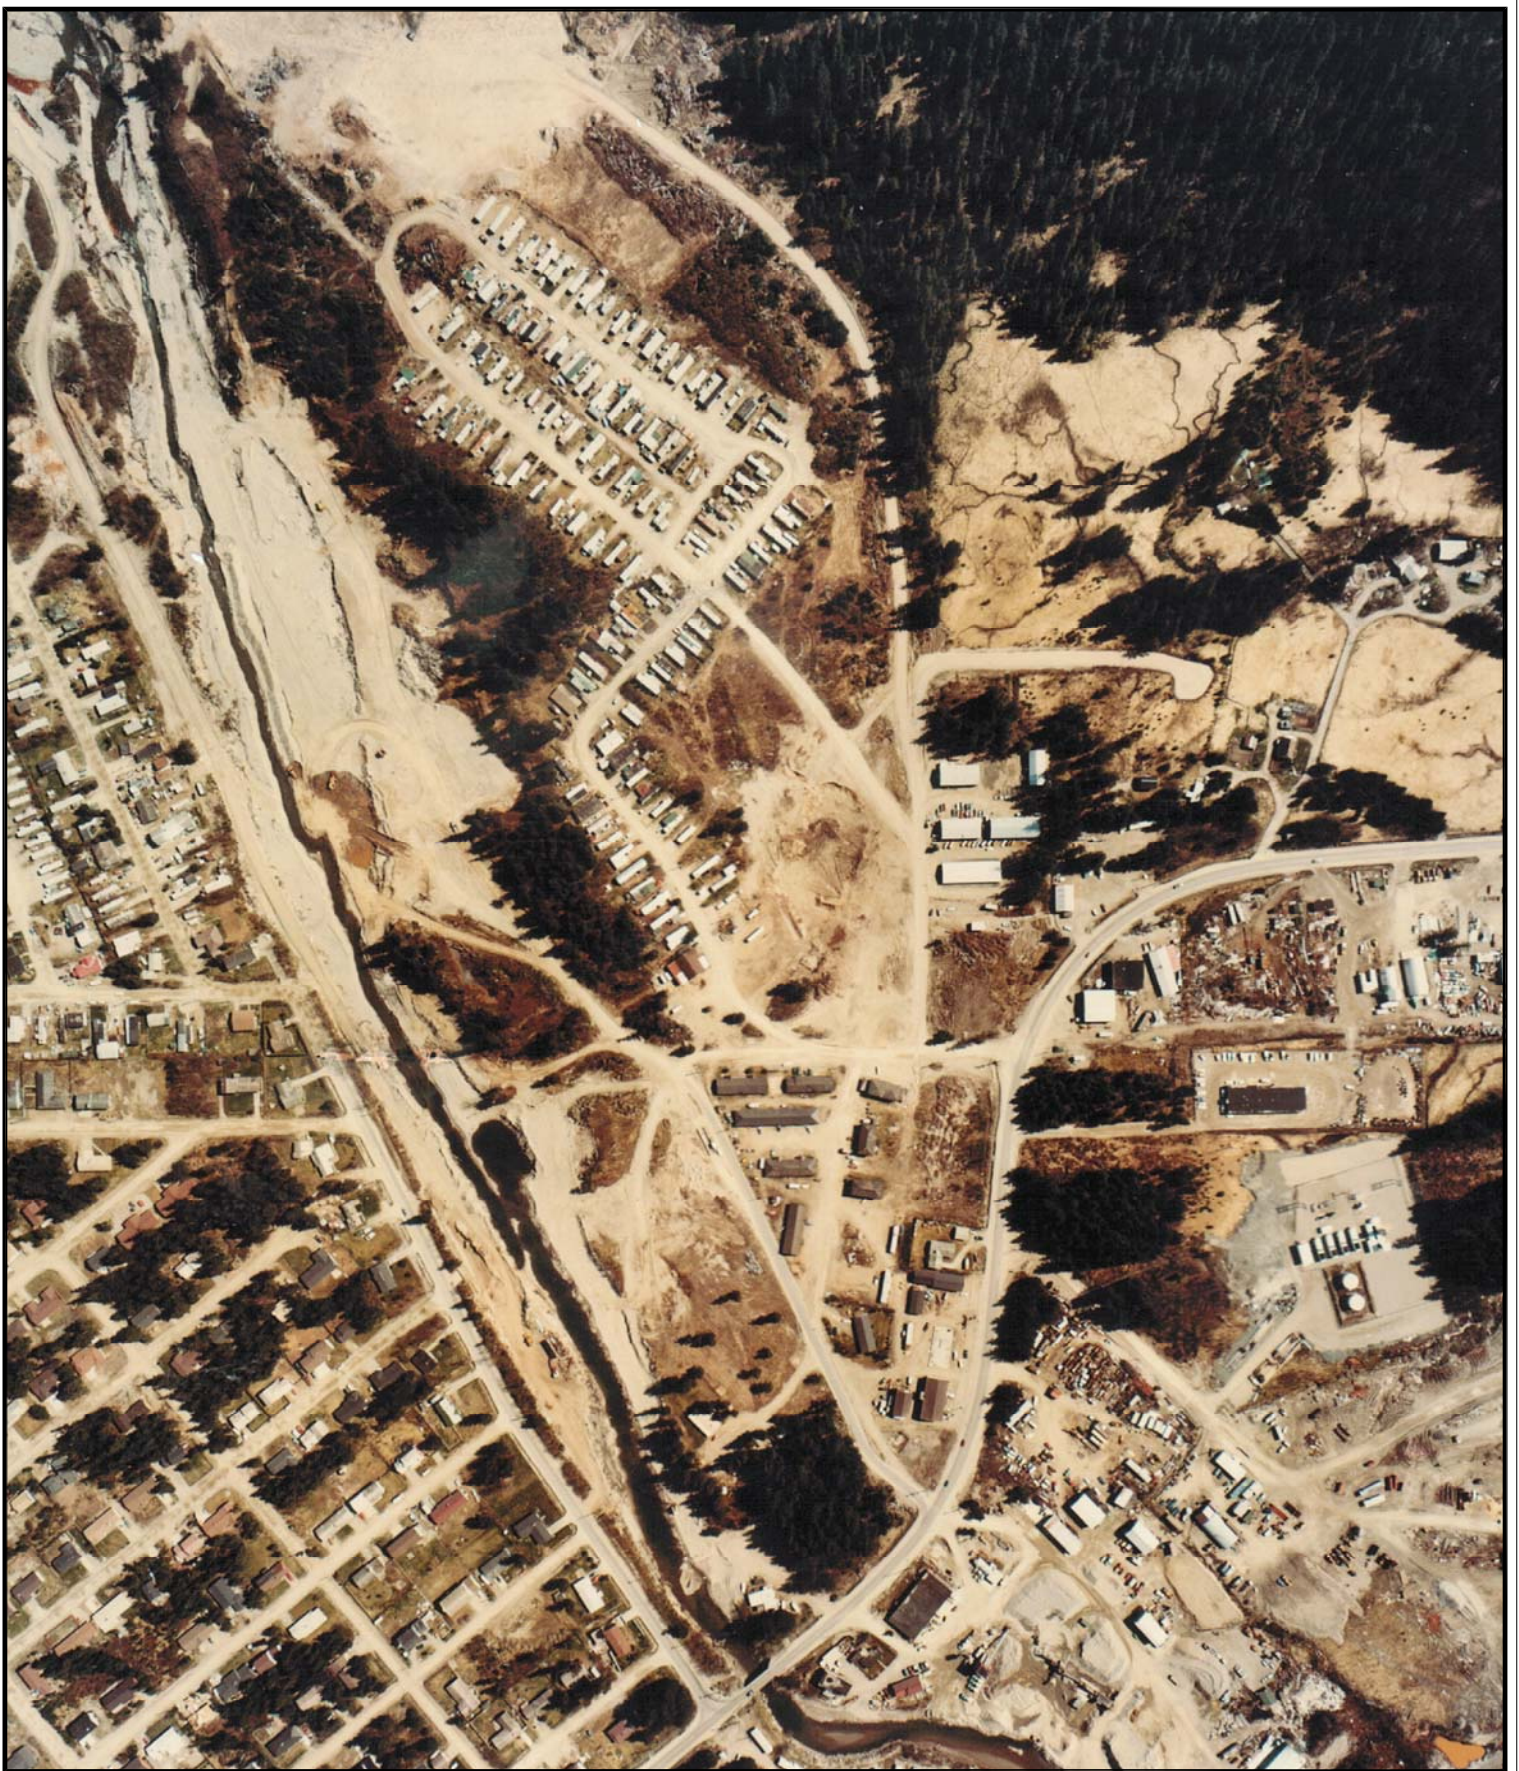
SCALE: 1" = 8'	FIGURE: 3
DESIGN: TR	
DRAWN: CMR	
PROJECT NO: 12-1055	
DWG: 121055a	
DATE: 8/28/2012

Aerial photographs from were reviewed for past development/uses of the Site and general vicinity. Photographs from 1981, 1998, and 2006 have been reproduced and are included as Figures 3 through 5 in Appendix A. The subject property appears similar in all photos reviewed.

1981 Lemon Creek Aerial Photo
5871 Churchill Way
Juneau, Alaska

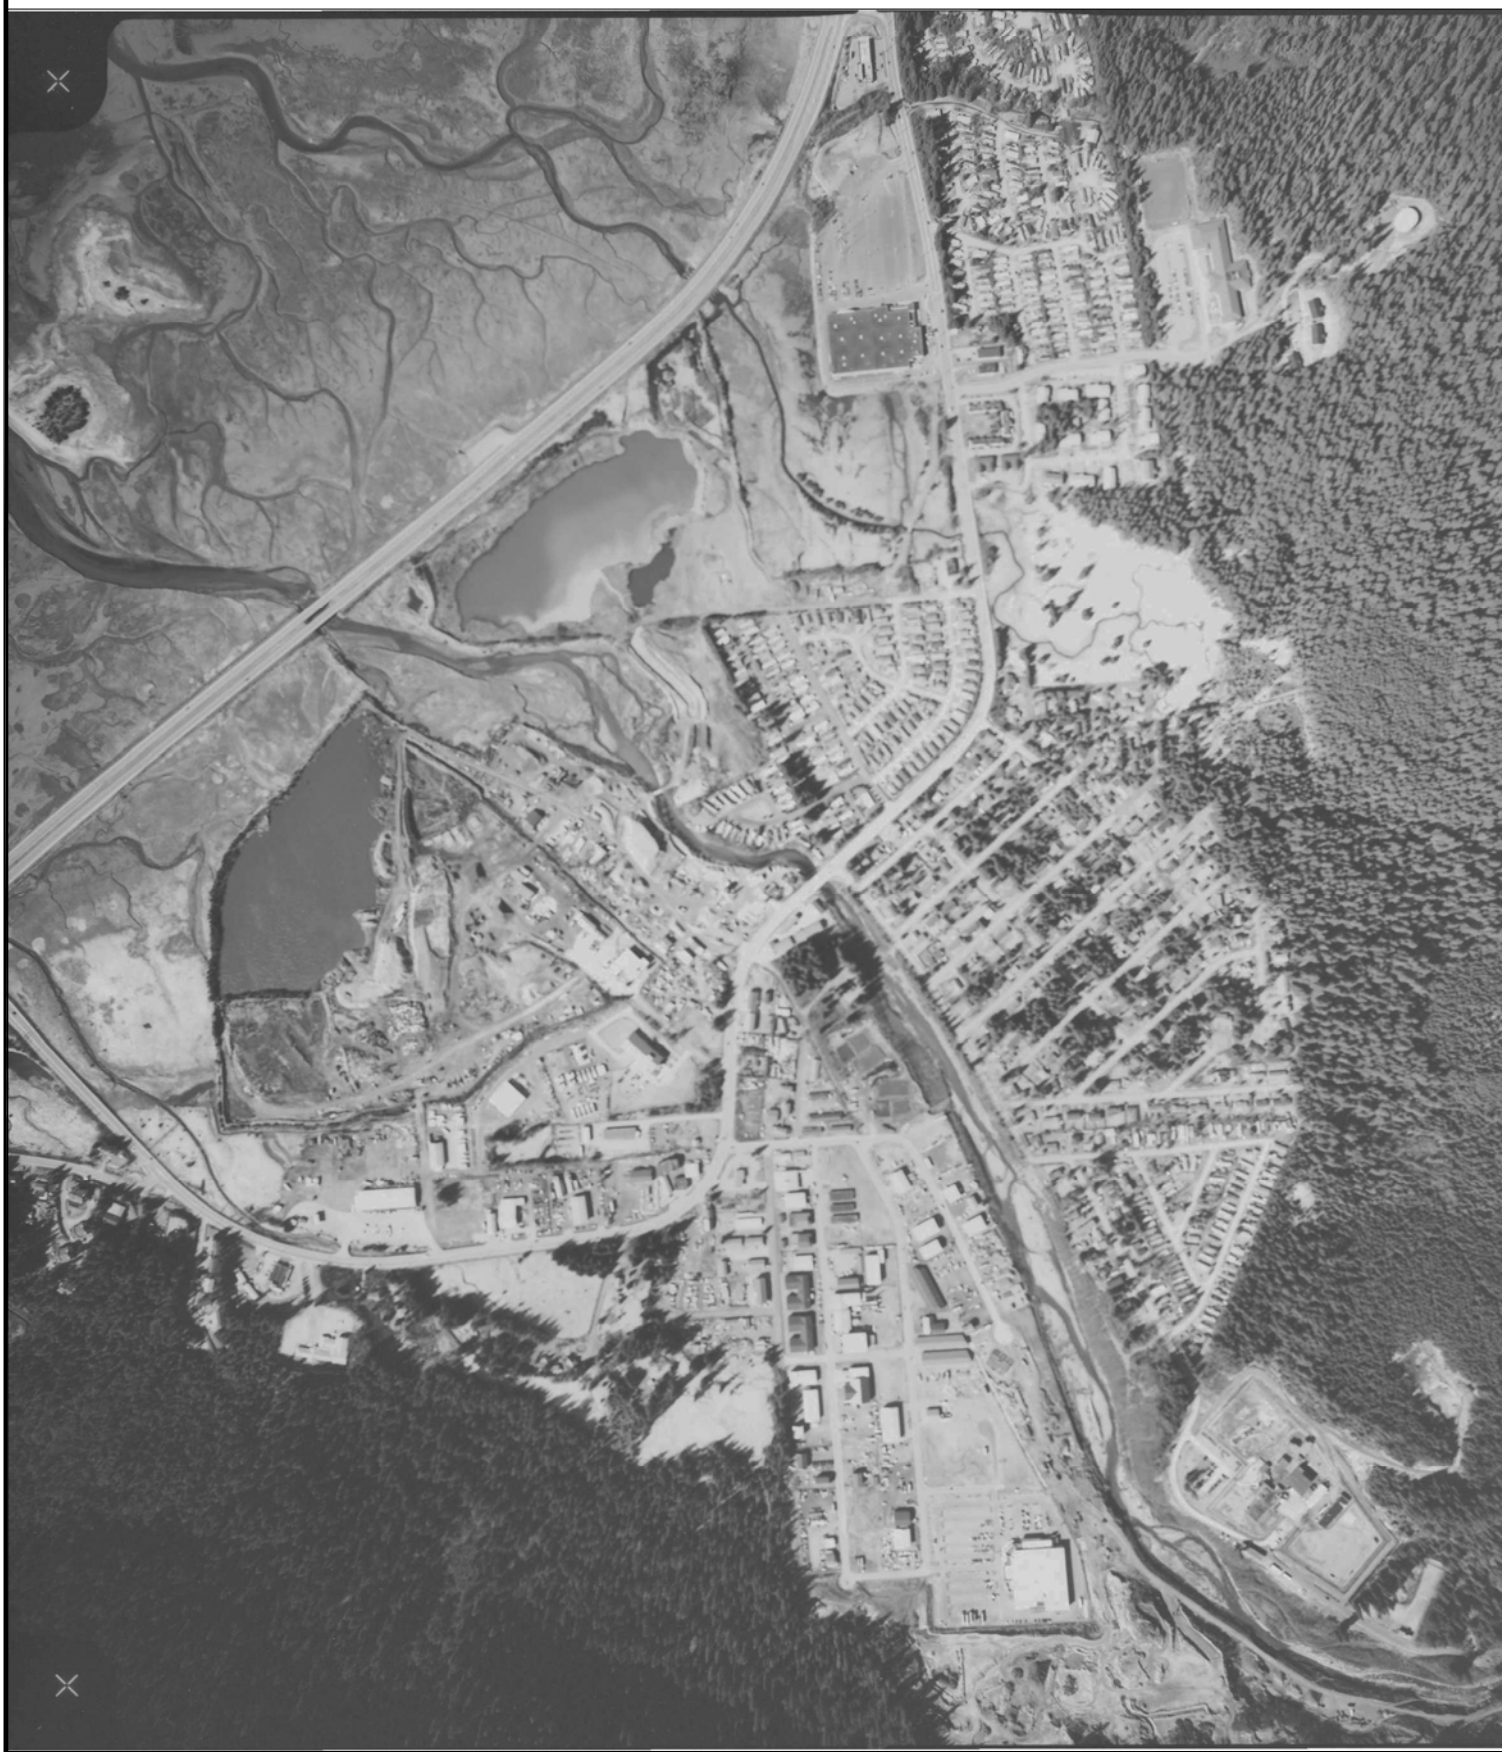
SCALE: 1" = 10'	FIGURE: 4
DESIGN: TR	
DRAWN: CMR	
PROJECT NO: 12-1054	
DWG: 121054a	
DATE: 8/28/2012

1998 Lemon Creek Aerial Photo
5871 Churchill Way
Juneau, Alaska

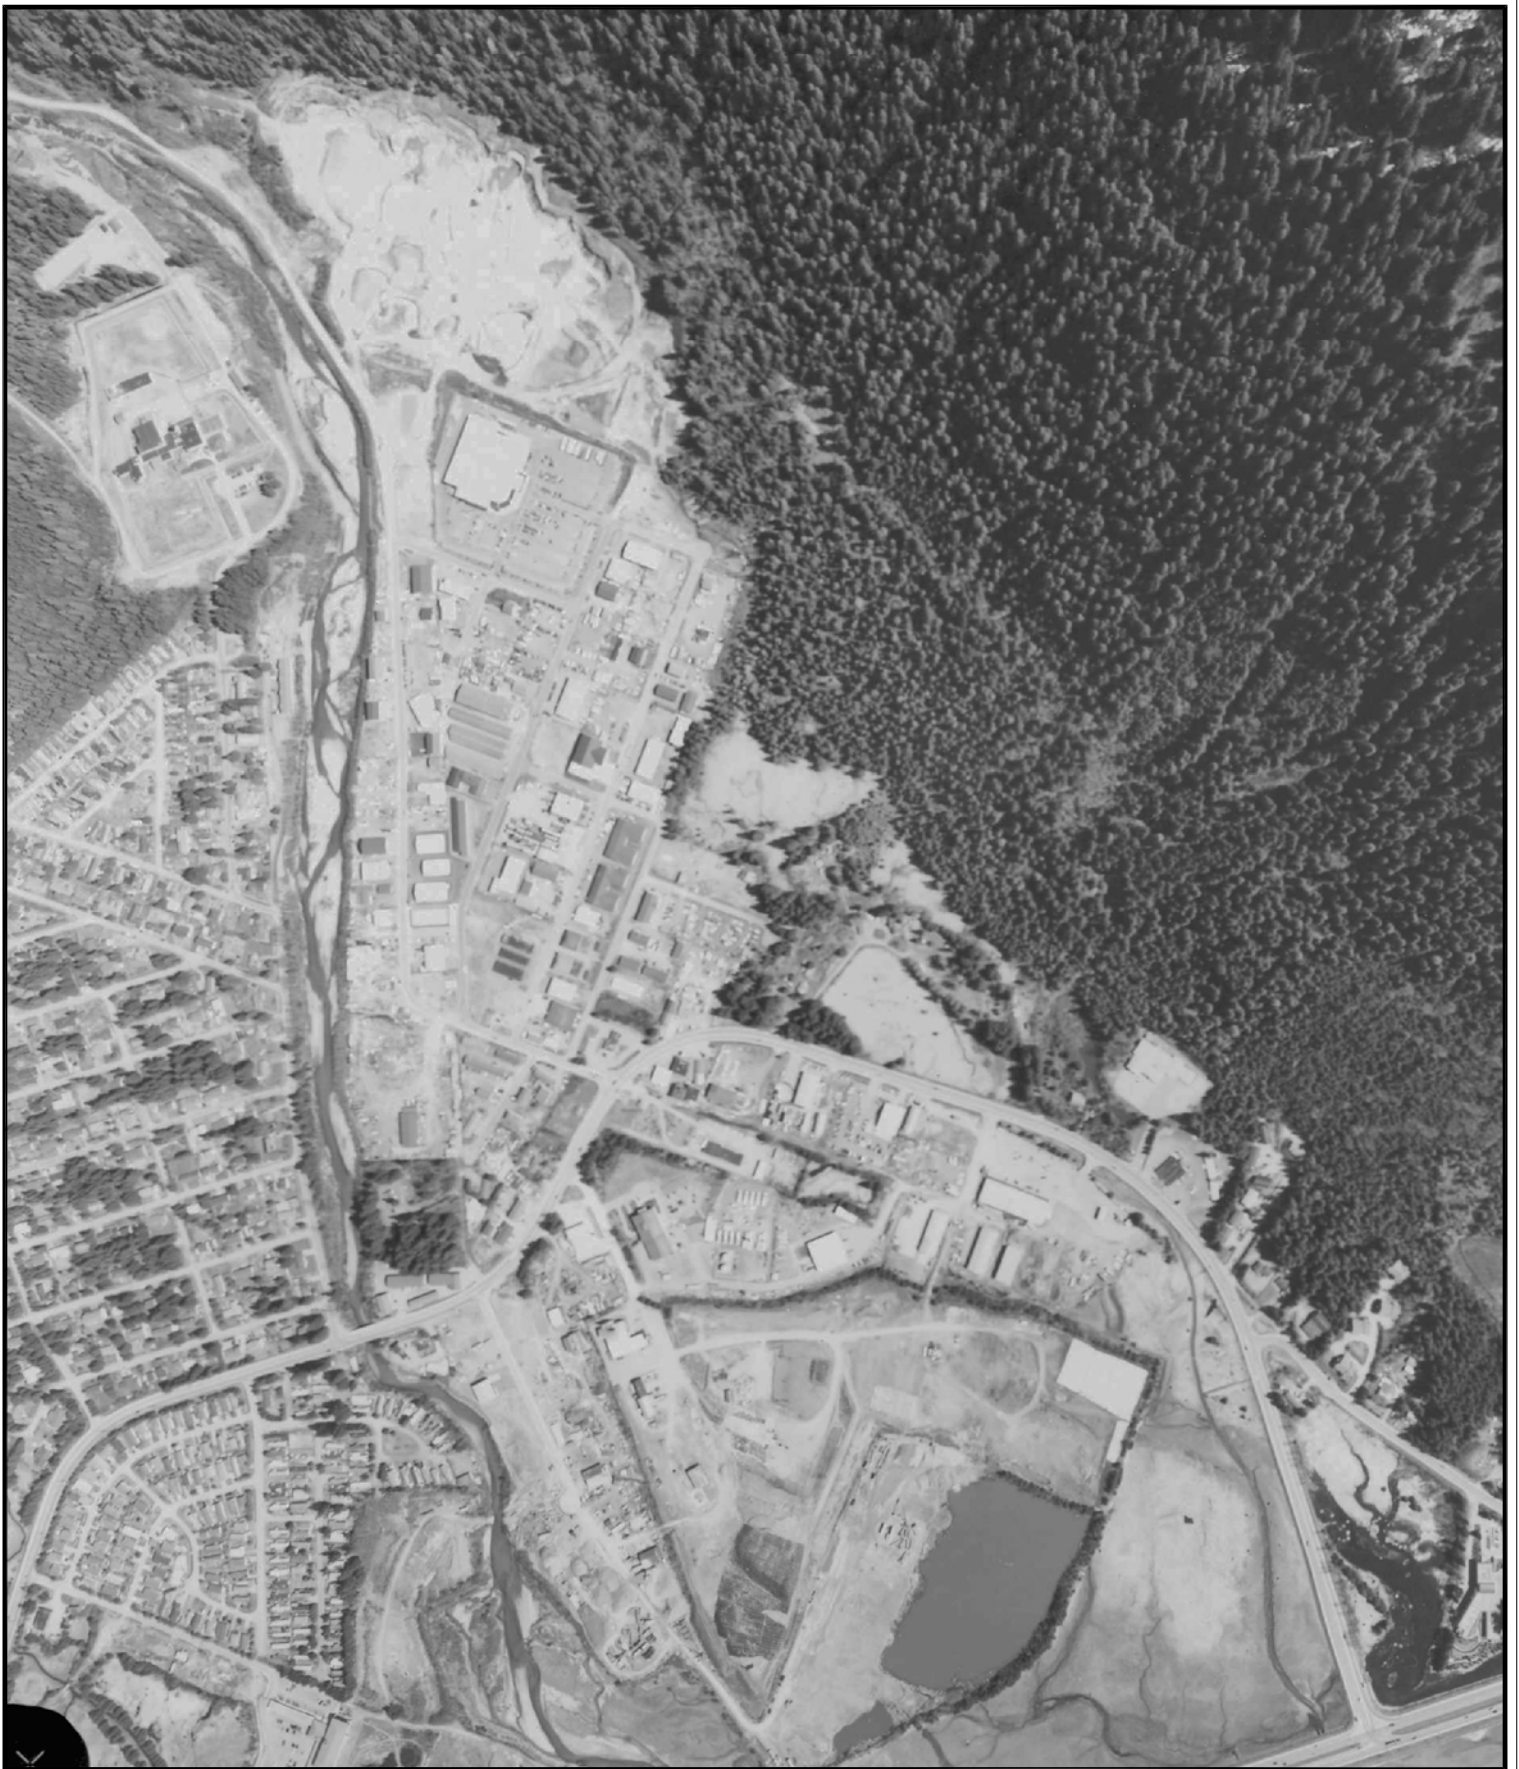
SCALE: 1" = 8'	FIGURE: 4
DESIGN: TR	
DRAWN: CMR	
PROJECT NO: 12-1054	
DWG: 121054a	
DATE: 8/28/2012

2006 Lemon Creek Aerial Photo
5871 Churchill Way
Juneau, Alaska
