**MENDENHALL VALLEY WASTE WATER TREATMENT PLANT SBR BUILDING ROOF
REPLACEMENT**

Condition Assessment Report

Project: MR E13-156 Mendenhall Valley Waste Water Treatment Plant
Roof Condition Assessment

Date: 06/26/15
07/23/15
10/02/15

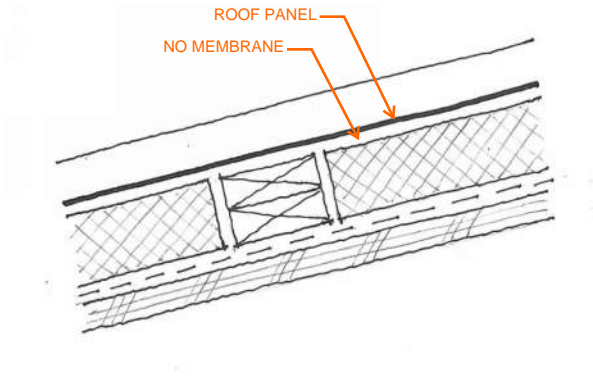
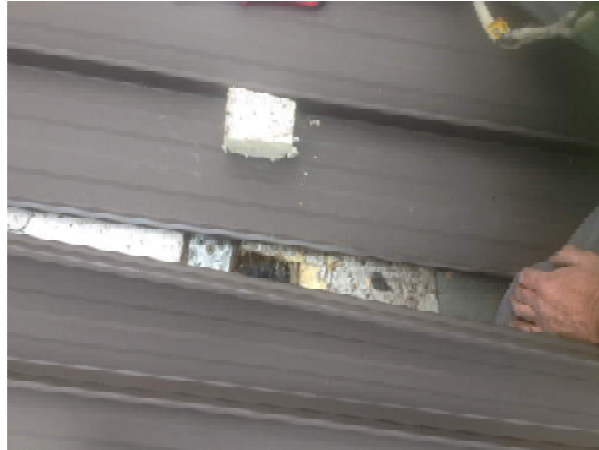
Roof Assembly

The existing roof assembly consists of 22g clip lock style standing seam metal roof panels on clips on ~ 4x or double 2x horizontal furring on an ~4mil plastic, paper backed air/vapor retarder sheet on ~1" plywood sheathing. Insulation is 3" foil faced polyisocyanurate foam insulation. The foil facing is oriented up, and the insulation is tight-fit between furring members. There is no underlying weather/air barrier membrane.

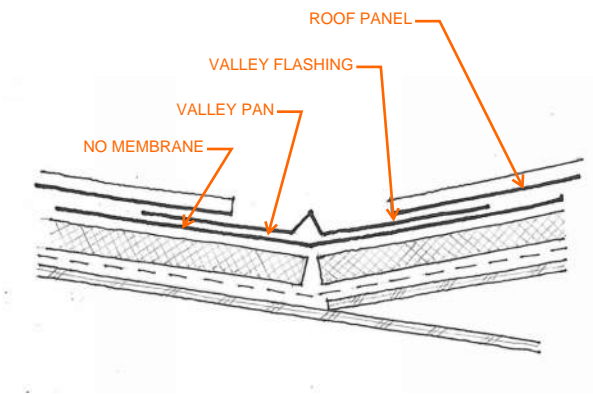
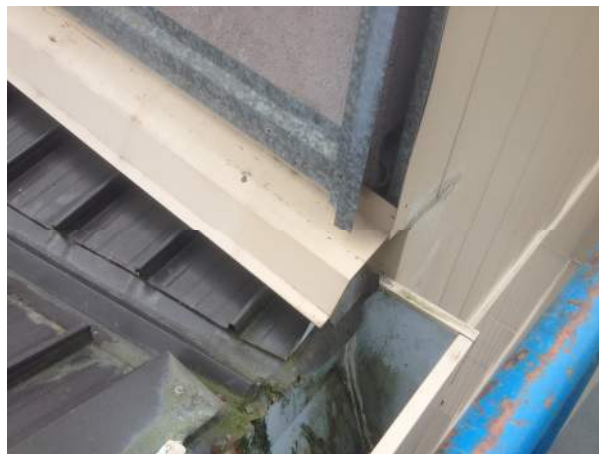
Valley at Grid F

The existing valley at grid F consists of an ~ 22g W profile valley flashing overlaid on a galvanized sheet steel valley pan. The galvanized pan extends 24" in each direction from the centerline of the valley, and appears to turn up where it intersects the rake wall near the collector head.

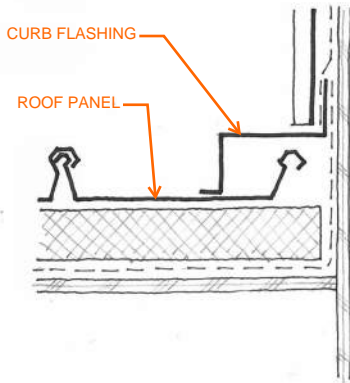
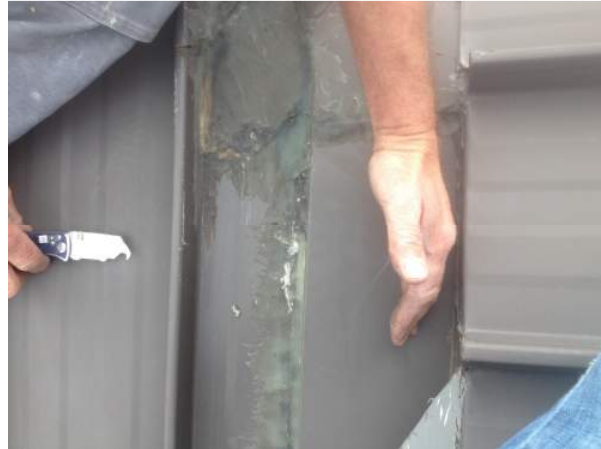
Rake Wall Valley– Grids 7 and 8

The existing rake wall valley assembly on grids 7 and 8 at the entry gable consists of a continuation of the ~22g clip-lock roof panel system under and lapped by rake-wall curb flashing under which it turns up into its rib. The curb flashing in turn is lapped by the vertical roof panels cladding the rake wall.

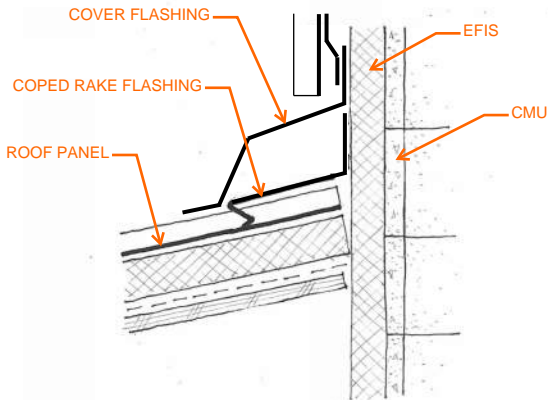
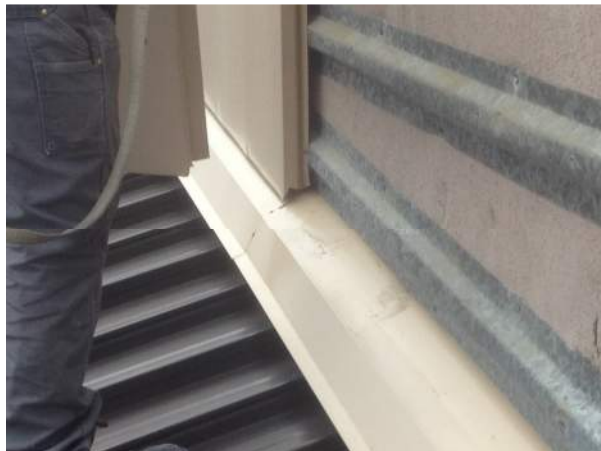
Rake Wall Assembly – Grid F

The existing rake wall assembly on grid F at the tea cup wing consists of ~ 26g gasketed, vertically oriented interlocking, blind fastened metal wall panels on ~18g horizontal, galvanized hat channel, pinned through an ~2.5" Exterior Insulating and Finish System (EIFS) composed of Expanded Polystyrene (EPS) foam insulation with a troweled cement/acrylic finish directly applied to the Concrete Masonry Unit (CMU) wall structure.

Adjacent roof panels terminate as shown below with coped rake flashing which laps under cover flashing and in turn metal siding panels. The coped rake flashing is not well sealed to the roof panel.

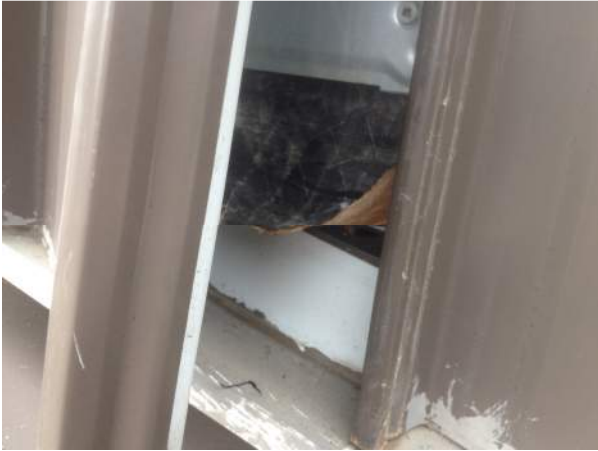
Rake Wall Assembly – Grids 7 and 8

The existing rake wall assembly on grids 7 and 8 at the entry gable consists of the ~22g clip-lock roof panel system, vertically oriented on ~4mil plastic, paper backed air/vapor retarder sheet on plywood wall sheathing of stud framing.

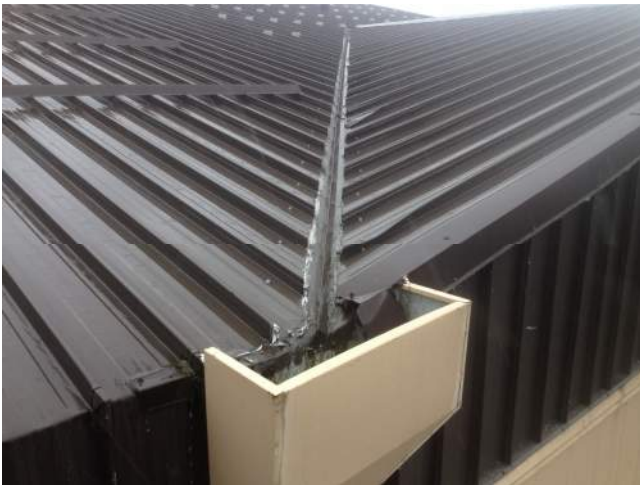
The opportunities for moisture infiltration increase significantly at valleys, particularly where they terminate at the roof edge where the chances that water may pond are increased. Ponding is much more likely to occur on a low-slope roof and is due to ice and/or debris damming, or due to the volume of water in the valley exceeding the flow capacity of scuppers during heavy rain.

Moisture can also infiltrate at valleys when there is force on it – from wind, gravity, and/or negative pressure.

Infiltration occurs when the valley is improperly detailed or installed such that it is not water tight.
