Downtown Juneau Landslide and Avalanche Assessment

Presentation for Public Meeting July 21, 2021

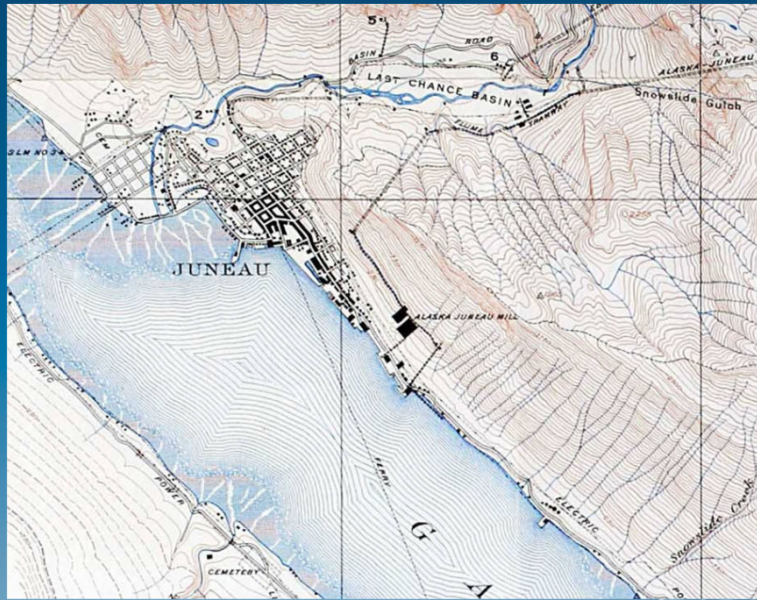
Historical Map - 1914

This is a 1914 map of Juneau that shows the old Alaska-Juneau flume and mill. These structures, and how they relate to some of the old landslides, can still be seen on some of the historical photos and more-detailed maps of the community.

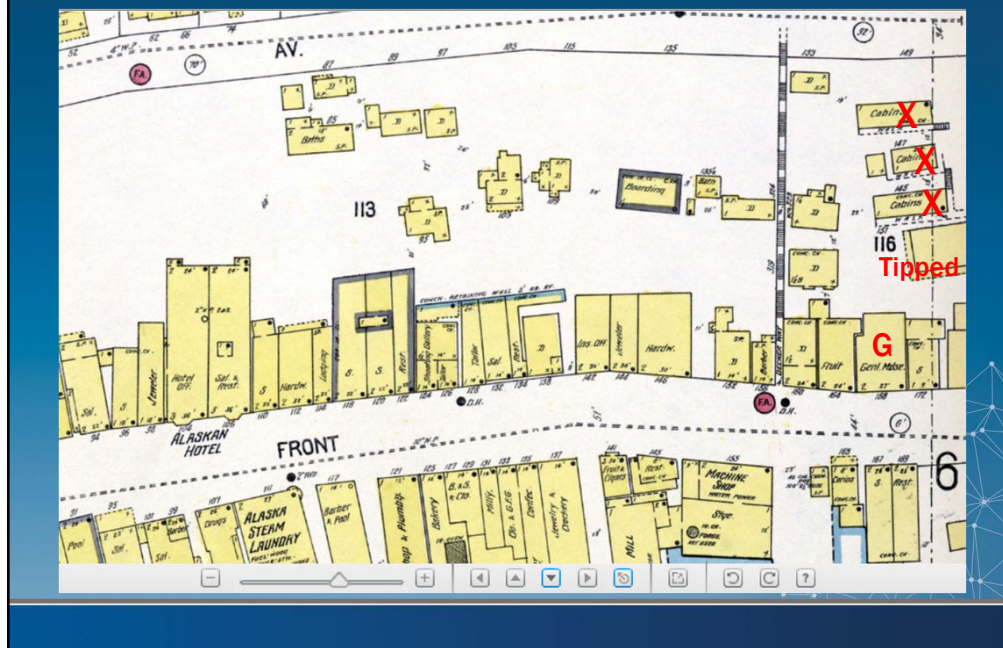
1914 Survey Plan of Juneau – Plate 5

Here's an excerpt from the 1914 survey plan for Juneau from the Sanborn Map Company. Notice the main street was called Front St. in 1914. There still is a Front St. in Juneau, further to the northwest. But this part of the old Front Street is now called South Franklin Street. Here's the Alaskan Hotel, which still exists. And marked with a red G, was Goldstein's Store, which is now the Filipino Community and Bingo Hall. These are important locations, because both buildings were landmark structures that were hit by debris slides and that news reports of the time specifically reported on.

Debris slides on January 2nd, 1920, killed 4 people, injured eight, and destroyed 16 buildings. Some buildings were destroyed by the debris directly, and others from buildings being pushed into them. Debris broke through into the back of Goldstein's Store. The 3 buildings marked with red X's seem to have been destroyed, and the next one downslope was apparently tipped over.

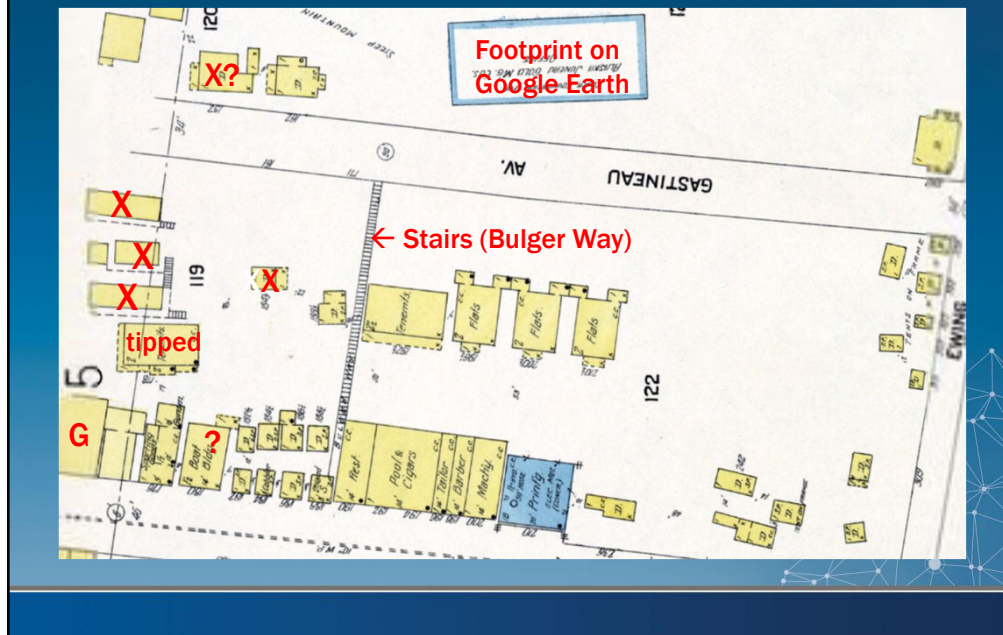
1914 Survey Plan of Juneau – Plate 6

Continuing onto the adjoining survey plan, we can see a few more structures that were damaged or destroyed in 1920, including a couple of “maybe’s”. We can also see the outline where the old mine office used to be. You’ll see what I mean about “maybe’s” when we go to look at the photos. It can be challenging to decide exactly which buildings were destroyed when some of them are partly covered by debris from other buildings. But we can see the approximate boundaries of the disaster, since the stairs survived and so did the buildings to the southeast.

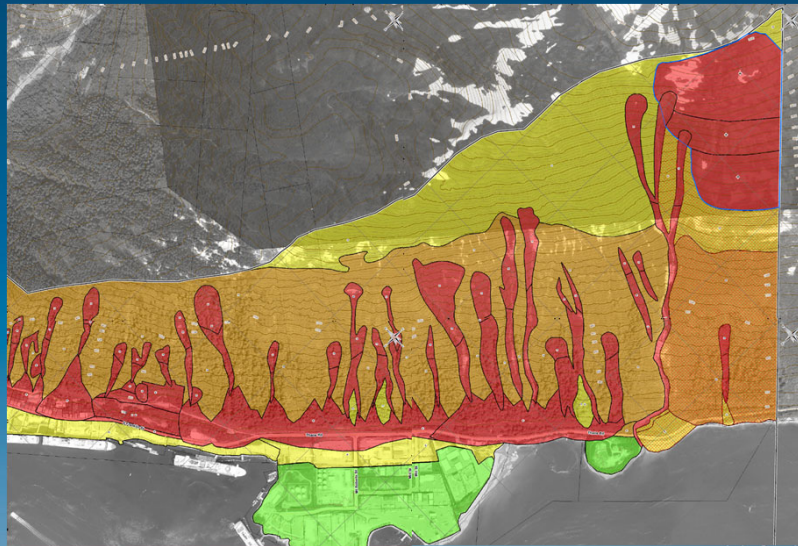
Landslide Hazard Mapping – Mt. Roberts

Based on the mapping of slide features from the aerial imagery and the locations of the debris slides that happened before there were air photos, we can map the landslide hazard designations for the Mt. Roberts slope. The first cone on the left is where the debris slide at Goldstein's happened in 1920, and the second big cone is where the slide at Juneau Cold Storage happened in 1936, so we can see that the mapping from the air photos captured this area quite well.

The main adjustment in the mapping was that the lower boundary was moved out slightly towards the channel in a few places, so that it at least covers South Franklin Street, and further in some areas. That's a logical change, since we know that streets will be cleaned up after debris slides or flows, and typically the air photos won't reveal the runout unless the slide goes past the road. One more important thing to notice on this image – at the top right, the bedrock feature (purple on the geology map) looks like it might become a deep-seated failure. It hasn't happened yet, but if it does, it has the potential to go all the way into Gastineau Channel, taking a lot of slope material with it. Let's look at a few photos.
