**To:** Teri Camery (CBJ) **Date:** September 16, 2021  
**c:** Alix Pierce (CBJ) **Memo No.:** 3  
**From:** Rita Kors-Olthof, Vladislav Roujanski, Shirley McCuaig **File:** 704-ENG.EARC03168-01  
**Subject:** Responses to Public Comments Arising from Issued-for-Review Report (3<sup>rd</sup> Draft) and Landslide and Avalanche Hazard Public Meeting – July 21, 2021  
Downtown Juneau Landslide and Avalanche Assessment

This technical memo addresses some of the comments and questions that arose from Tetra Tech’s Issued-for-Review (3<sup>rd</sup> Draft) Report, Downtown Juneau Landslide and Avalanche Assessment, dated May 28, 2021, and the Landslide and Avalanche Hazard Public Meeting that took place on July 21, 2021.

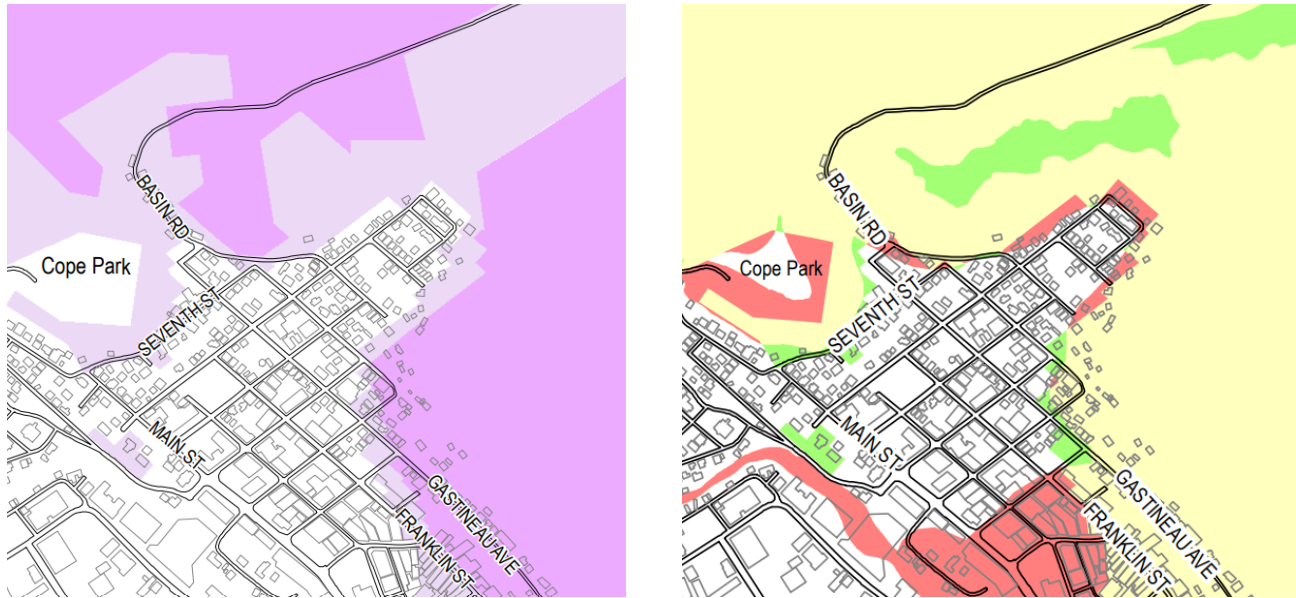
As seen in Figure 1 below, the main difference between the 1987 adopted hazard mapping and the new 2021 proposed hazard mapping is that many of the former Moderate areas surrounding Starr Hill (colored in pale lavender on the left) are now designated High or Severe (colored in dark pink on the right).

The 1987 adopted hazard mapping is understood to have been based on Swanston (1972). However, the 1987 mapping follows property lines, resulting in numerous right-angle corners in the hazard boundaries. The 2021 mapping does *not* follow property lines. It follows hazard designations based on terrain features, such as surficial geology, geomorphology (evidence of past and more recent slope movement types accentuated by vegetation patterns) and activity levels for slope instabilities as seen from the air photos and confirmed by field observations. For instance, along 6<sup>th</sup> Street, between East Street and Nelson Street, the lower boundary of the new 2021 proposed hazard zone does *not* arbitrarily stop at the upslope property lines of the affected properties as it does in the 1987 mapping. The same is true upslope of Nelson Street, and upslope of 5<sup>th</sup> Street, where the lower boundary of the 2021 proposed hazard mapping does *not* arbitrarily stop at the upslope property lines of the affected properties.

**Figure 1:** Excerpts from CBJ’s 1987 adopted hazard mapping (left) and comparison of 1987 adopted hazard mapping and 2021 proposed hazard mapping (right) at the Starr Hill subdivision.

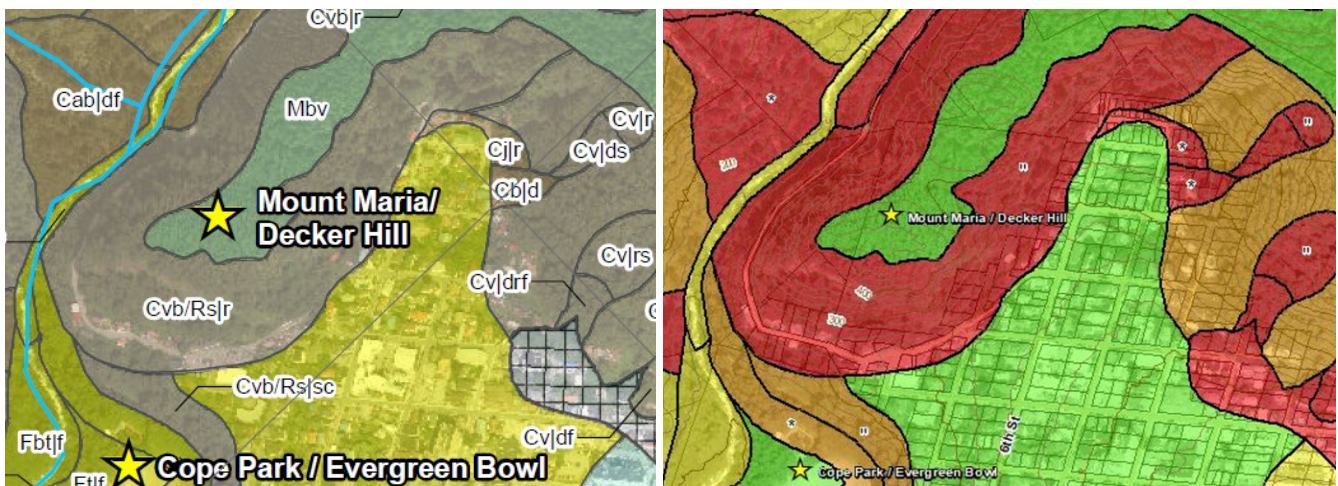
A summary of Tetra Tech’s mapping of the Starr Hill area and the adjacent portion of Basin Road is shown below in Figure 3, with surficial geology on the left and landslide hazard designation mapping on the right. There is a clear correlation between the shapes of the surficial geology units and the associated landslide hazard designations.

**Figure 3:** Excerpts from Tetra Tech Figure 1.3b Surficial Geology (left), and Figures 1.6c and 1.6h Landslide Hazard Designation Mapping (right).

Severe hazard designations are assigned to the areas subject to rockfall, debris slides, and debris flows, as shown on the surficial geology map in Figure 3 (left). Areas with a High hazard rating were assigned based on the results of the semi-quantitative analysis. These areas are expected to experience rockfall that damages but does not always knock out trees, and as such are a less severe hazard than a debris flow or debris slide that removes everything in its path. Evidence of this type of rockfall activity was identified during the field investigation.

**Answer:** The boundaries between the different landslide hazard designation zones are closely related to the surficial geology mapping terrain unit boundaries (Figure 3). The reason for this relationship is that the different soil and rock features have a large influence on how the slopes behave. If there is a shape that doesn't seem to make sense, it is helpful to look at the features beside that odd shape. Usually, it will be a terrain feature whose characteristics will govern the shape of the boundary between the two units, like a bedrock outcrop, or a terrain unit that overlaps a previous unit. Sometimes, the odd-looking boundary is only because there is a corner or curve in the slope, so that debris from one side falls down in one direction, and material from the other side falls down in a different direction. These two debris areas might then meet at the bottom of the slope. One example is at the southeast corner of the Starr Hill subdivision, where debris can fall or slide from above Nelson Street, and it can also fall or slide or flow from above 5<sup>th</sup> Street. Since this part of the subdivision is essentially the shape of a bowl, the mapping of the unit boundaries can also reflect slope contours and fall-lines, as well as the surficial geology unit boundaries. See also Technical Memo #2, Question #3, for more explanation on how apparently odd-shaped boundaries are determined.

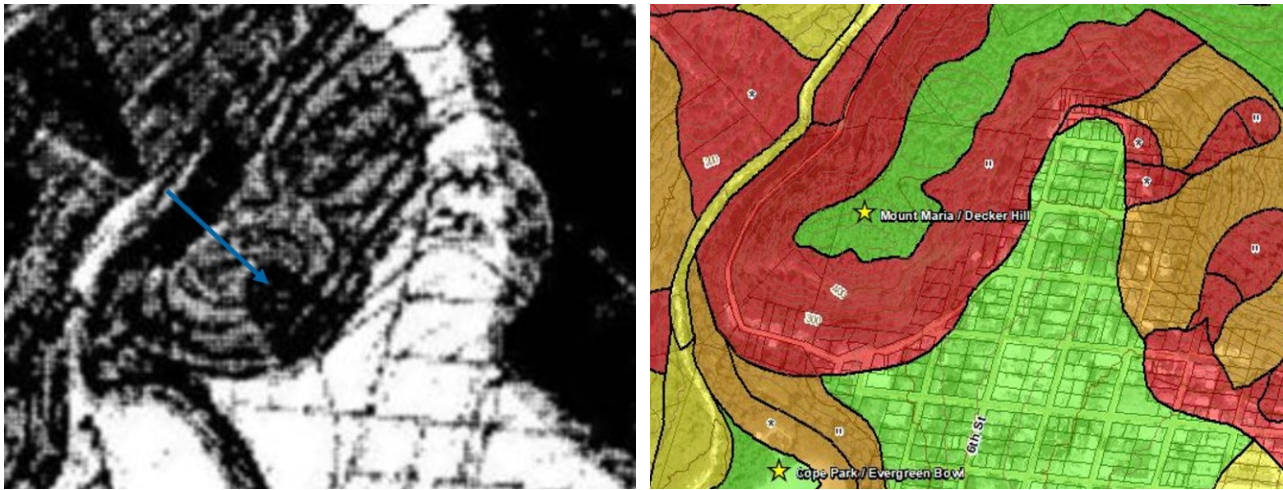
Some parallels can be seen in the locations of the mapping boundaries of Swanston (1972) and Tetra Tech (2021), in that they appear to follow the terrain (in contrast to the 1987 mapping which defers to nearby property lines). However, there are some significant differences in the details, due to better quality data, i.e., higher resolution imagery and new LiDAR data available to Tetra Tech, and more advanced mapping techniques used in the current study (Figure 4).

**Figure 4:** Comparison of Swanston's Figure 6 (left) and Tetra Tech's Figures 1.6c and 1.6h Landslide Hazard Designation Mapping (right). Swanston (1972) uses Potential Hazard (gray) and High Hazard (black), designated in the 1987 adopted mapping as Moderate and Severe hazards. Tetra Tech uses Low (green), Moderate (yellow), High (orange) and Severe (red) hazard designations.

As shown in Figure 4 (left), Swanston mapped most of Mt. Maria on the Starr Hill side as having a Potential Hazard (gray area), except at the prehistoric slide area and a small cliff above the corner of 6<sup>th</sup> and Nelson Streets, which were designated as being in High Hazard areas (blue arrows). These two areas are also shown with blue arrows in Figure 5. Heading northeast along 6<sup>th</sup> Street from Basin Road towards Nelson Street, the lower boundary of Swanston's Potential Hazard area was mapped progressively closer to 6<sup>th</sup> Street.

Along the entire southeast edge of Starr Hill, including a portion of the mapped lots, Swanston (1972) marked an area of Potential Hazard, with High Hazard marked further upslope on Mt. Roberts. The lower boundary of Swanston's Potential Hazard area begins at about Harris and 4<sup>th</sup> Streets, becoming progressively closer to 5<sup>th</sup> Street heading northeast. The northeast corner of Swanston's mapped landslide hazard area curves to the north to encompass the terrain southeast and northeast, upslope of the corner of Nelson and 5<sup>th</sup> Streets. Swanston did not designate hazards along or above the northwest part of Nelson Street. CBJ's 1987 adopted map called that area Moderate (Figure 1, left).

Swanston's mapped rockslide hazard appears to continue around the corner to Nelson Street (more red arrows in Figure 5), although that is less clear due to the poor scan quality of Swanston's mapping. The presence of rockfall / rockslide hazard areas along Nelson Street did not appear to be reflected in Swanston's hazard mapping (Figure 4).

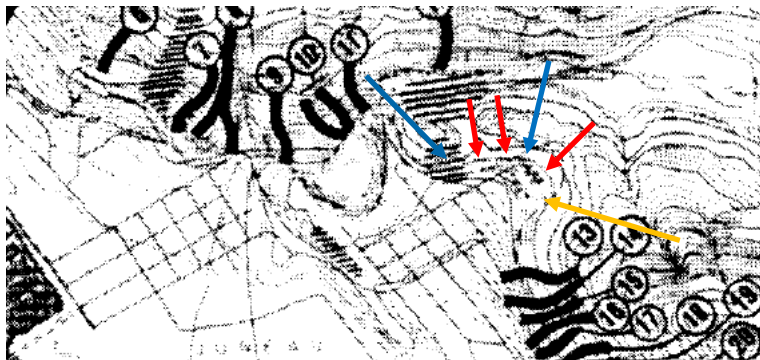
**Figure 5:** Excerpt from Swanston (1972) Figure 7 - Mass Wasting Channels and Rock Slide Hazard Areas. Striped map areas are rockslide hazard areas; heavy numbered lines are mass wasting channels.

The prehistoric slide area (Figure 5, blue arrow on left side) appears to be in the same place where a rockfall / rockslide was reported on October 18, 1913 (Swanston 1972, Figure 6), and where a distinct landslide scar is still present despite reforestation of the slope (Figure 13). Swanston reported that several houses had been destroyed, and that a deposit of angular rock fragments had been created above Basin Road between 6<sup>th</sup> and 7<sup>th</sup> Streets.

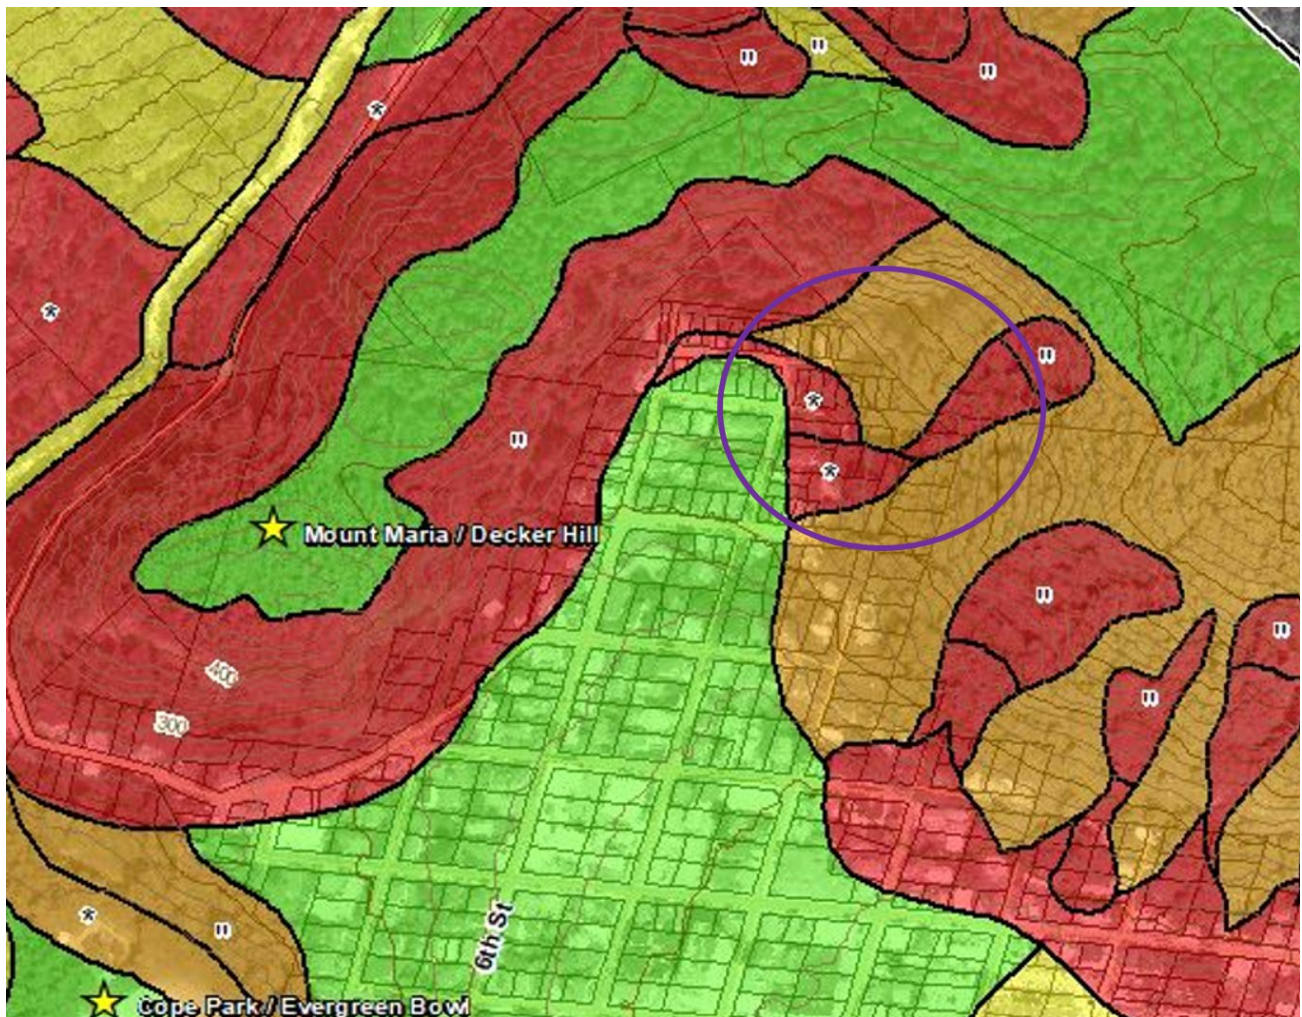
**Figure 17:** Excerpt from the landslide hazard designation mapping. The purple outline shows an area where residents wanted more information to understand the shapes of the mapping units and the reasons supporting the hazard designations.

Specific to this area of Starr Hill, it is now known that a resident has identified a recent landslide event in a High hazard zone (see Question #6 above), which also happens to be within one of the apparently odd-shaped hazard units (Figure 17, purple outline). This area will be reviewed to see if a shifting of the hazard boundary is warranted above Nelson Street. Note that the Severe hazard zone mapped at the toe of slope is due to this area being a deposition zone for slide debris.
