GEOPHYSICAL HAZARDS INVESTIGATION FOR THE
CITY AND BOROUGH OF JUNEAU, ALASKA

TECHNICAL SUPPLEMENT

APPENDIX I

**SEISMIC HAZARD INVENTORY
AND LAND USE CONTROL
FOR THE CITY AND BOROUGH OF JUNEAU**

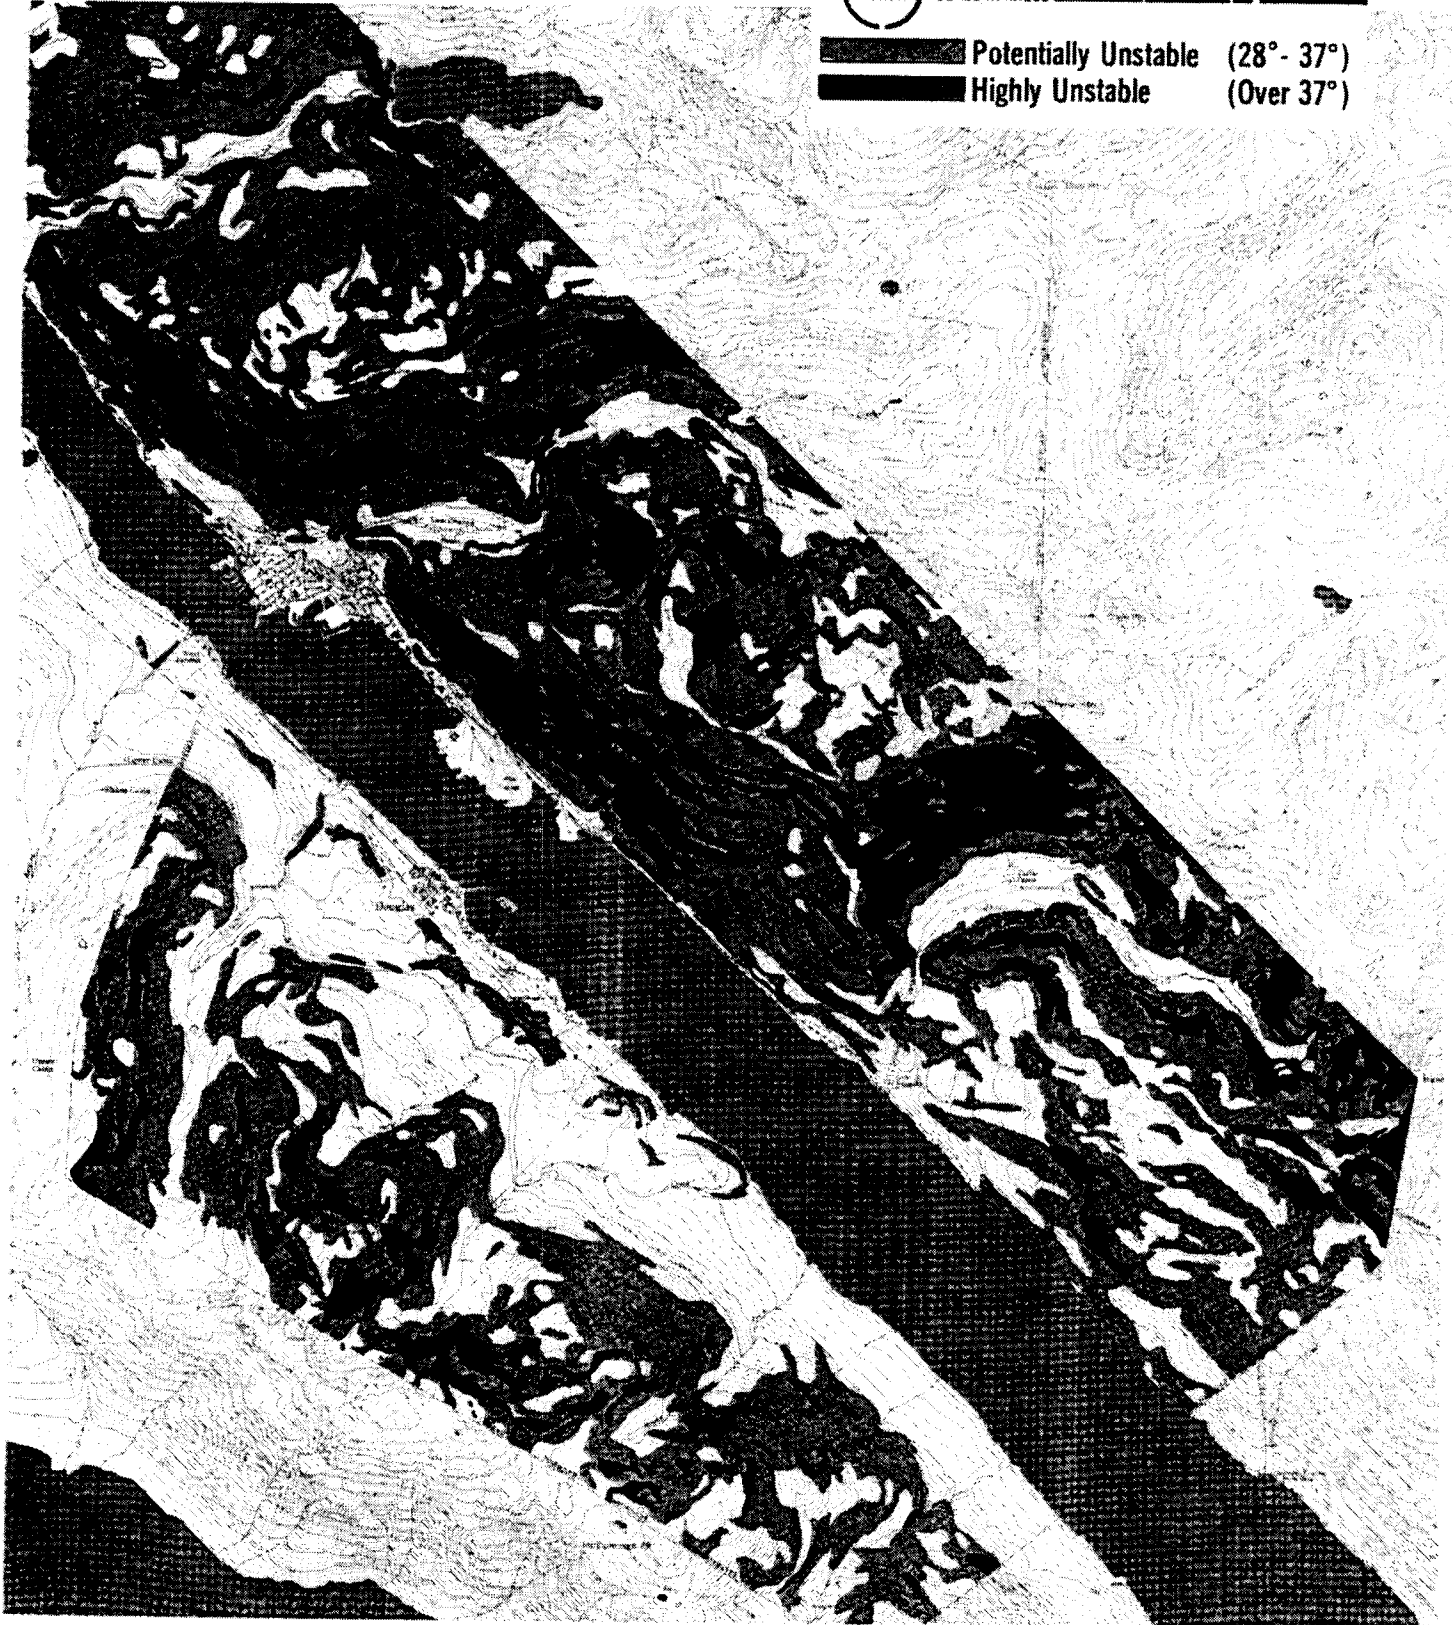
FIGURE 4

GENERALIZED SLOPE INVESTIGATION-JUNEAU DOUGLAS AREA

Highly Unstable (Over 37°)

Figs. 3 and 4 show the stratification of most of the slopes in the Juneau Borough into zones of highly unstable and potentially unstable ground on the basis of slope gradient.

The last major landslide occurred on the Mt. Roberts slope on October 1, 1952 but small debris avalanches and debris flows have continued to occur up to the present. For the most part these are small, flow only a short distance and have not reached into the urban zone. These are currently building up behind rocks, logs and other jammed debris in the gullies and constitute a continuing debris avalanche hazard to the area (Figure 4).

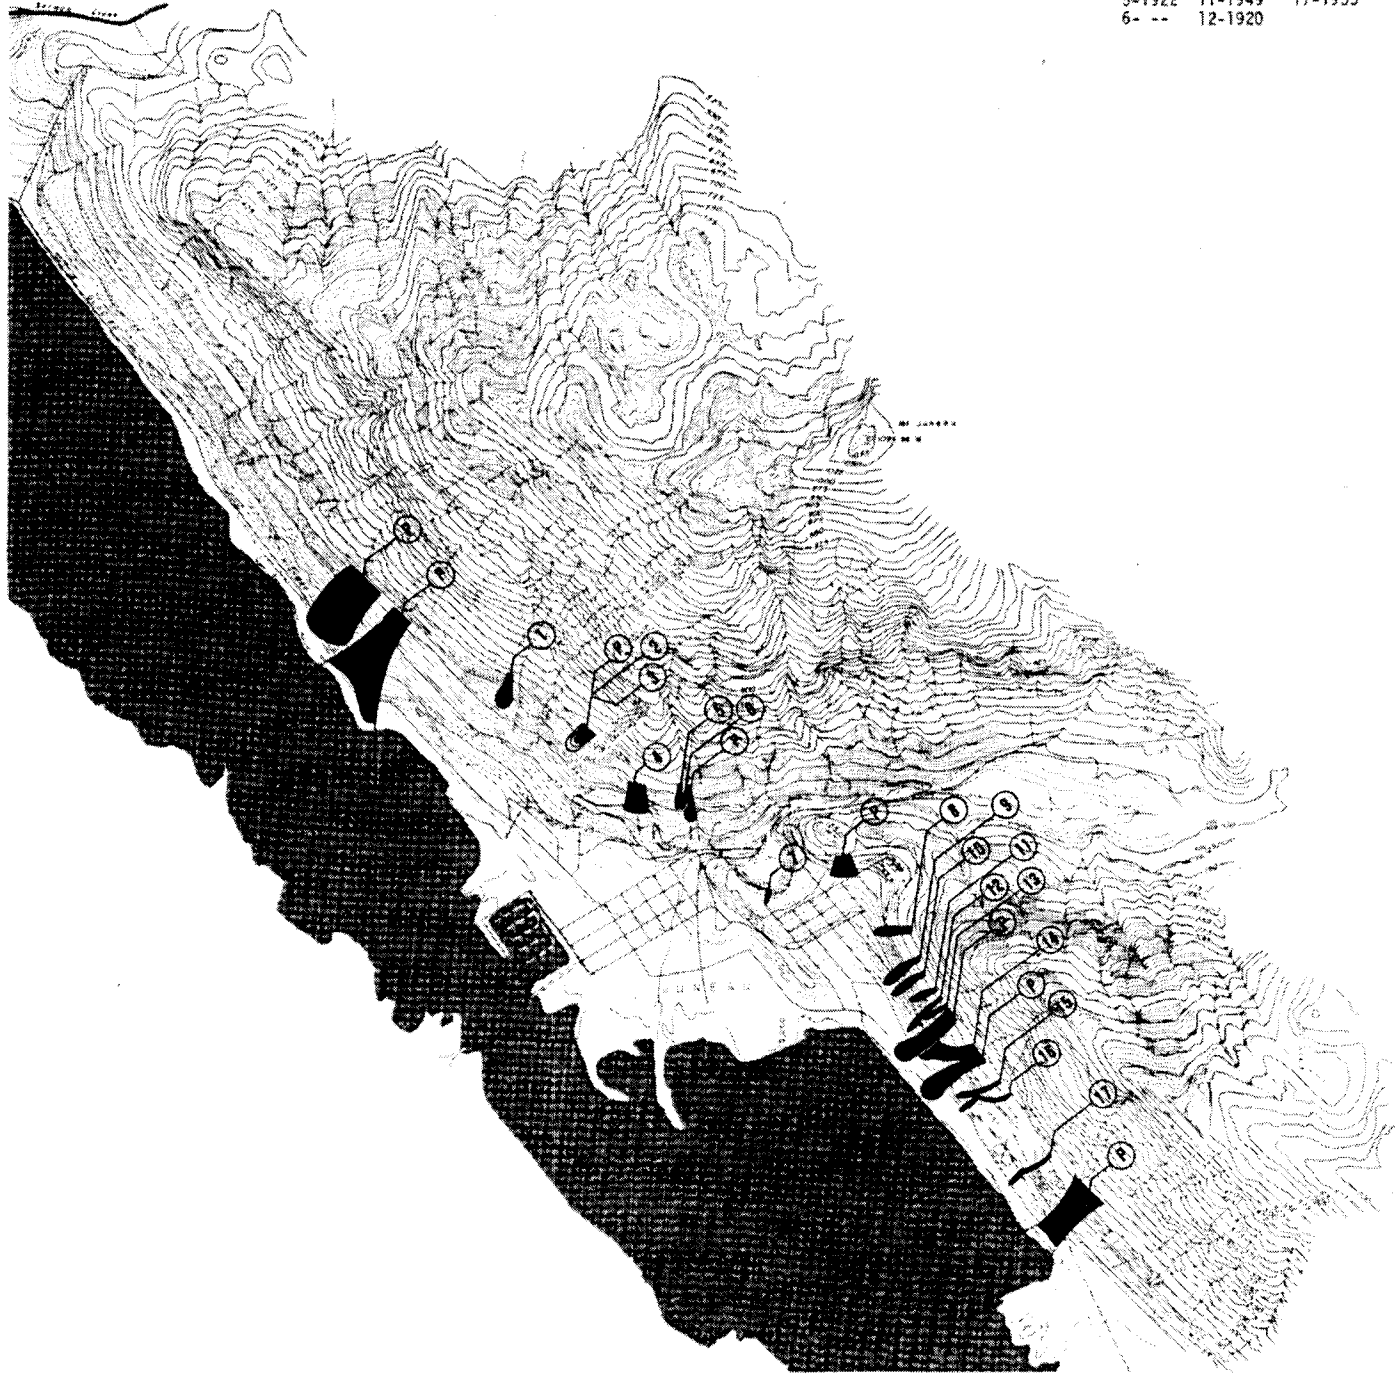
HISTORIC LANDSLIDE DEPOSITS

ESTIMATED AGE OF DEPOSIT

1-1912	7-1918	13-1932
2-1932	8-1935	14-1936
3-1892	9-1918	15-1952
4- --	10-1936	16-1952
5-1922	11-1949	17-1935
6- --	12-1920

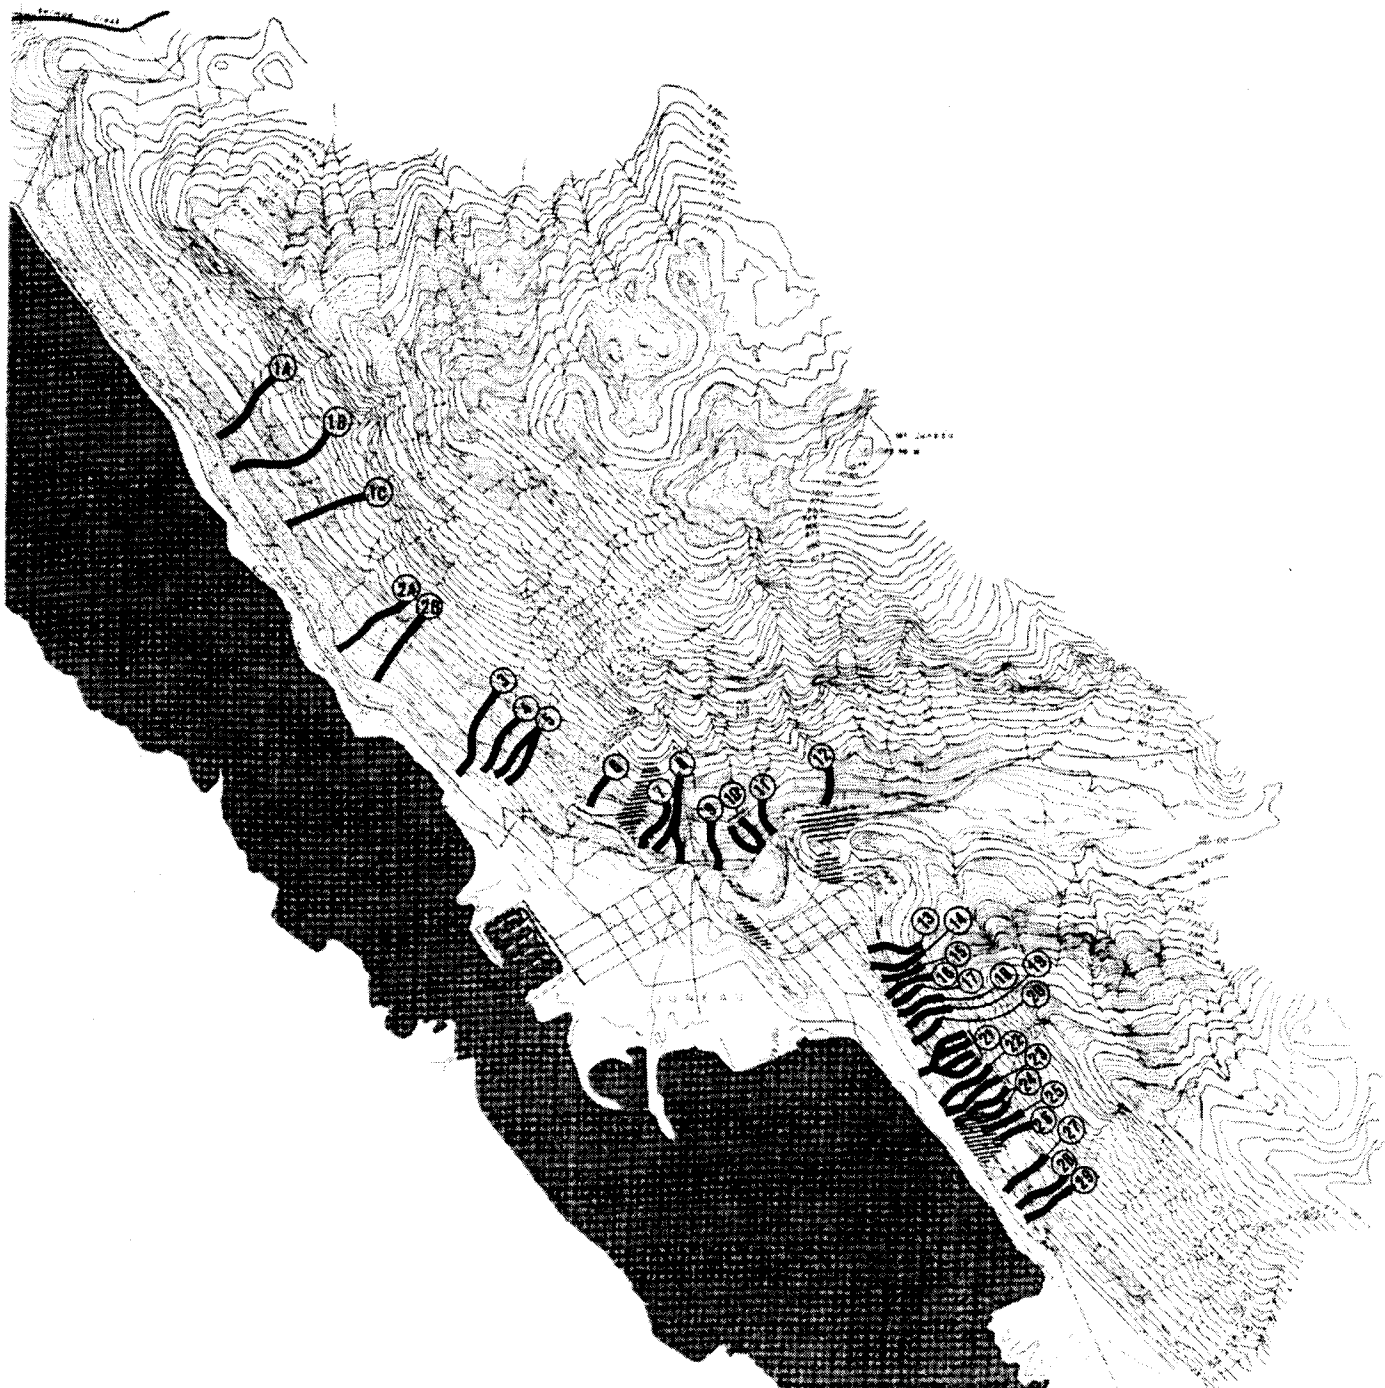
FIGURE 7

MASS WASTING CHANNELS AND ROCK SLIDE AREAS

Rock Slide Hazard Areas

Broad areas of high and potential hazard from landslide damage are shown in Figure 6. Specific gullies and channels with a known or indicated history of past debris avalanche and debris flow activity are mapped in Figure 7.

Gullies with a high hazard rating exhibit substantial accumulations of organic debris, rocks and soil in their channels and have had a past history of debris avalanche-debris flow activity. These are mapped in Figure 7. Those with a potential rating do not exhibit substantial accumulations of debris, but extend to the upper slope and exhibit some evidence of past debris avalanche-debris flow activity. Table 1 summarizes the major historical landslides in the Juneau area with dates of occurrence, approximate location, associated 24-hour rainfall and damage.

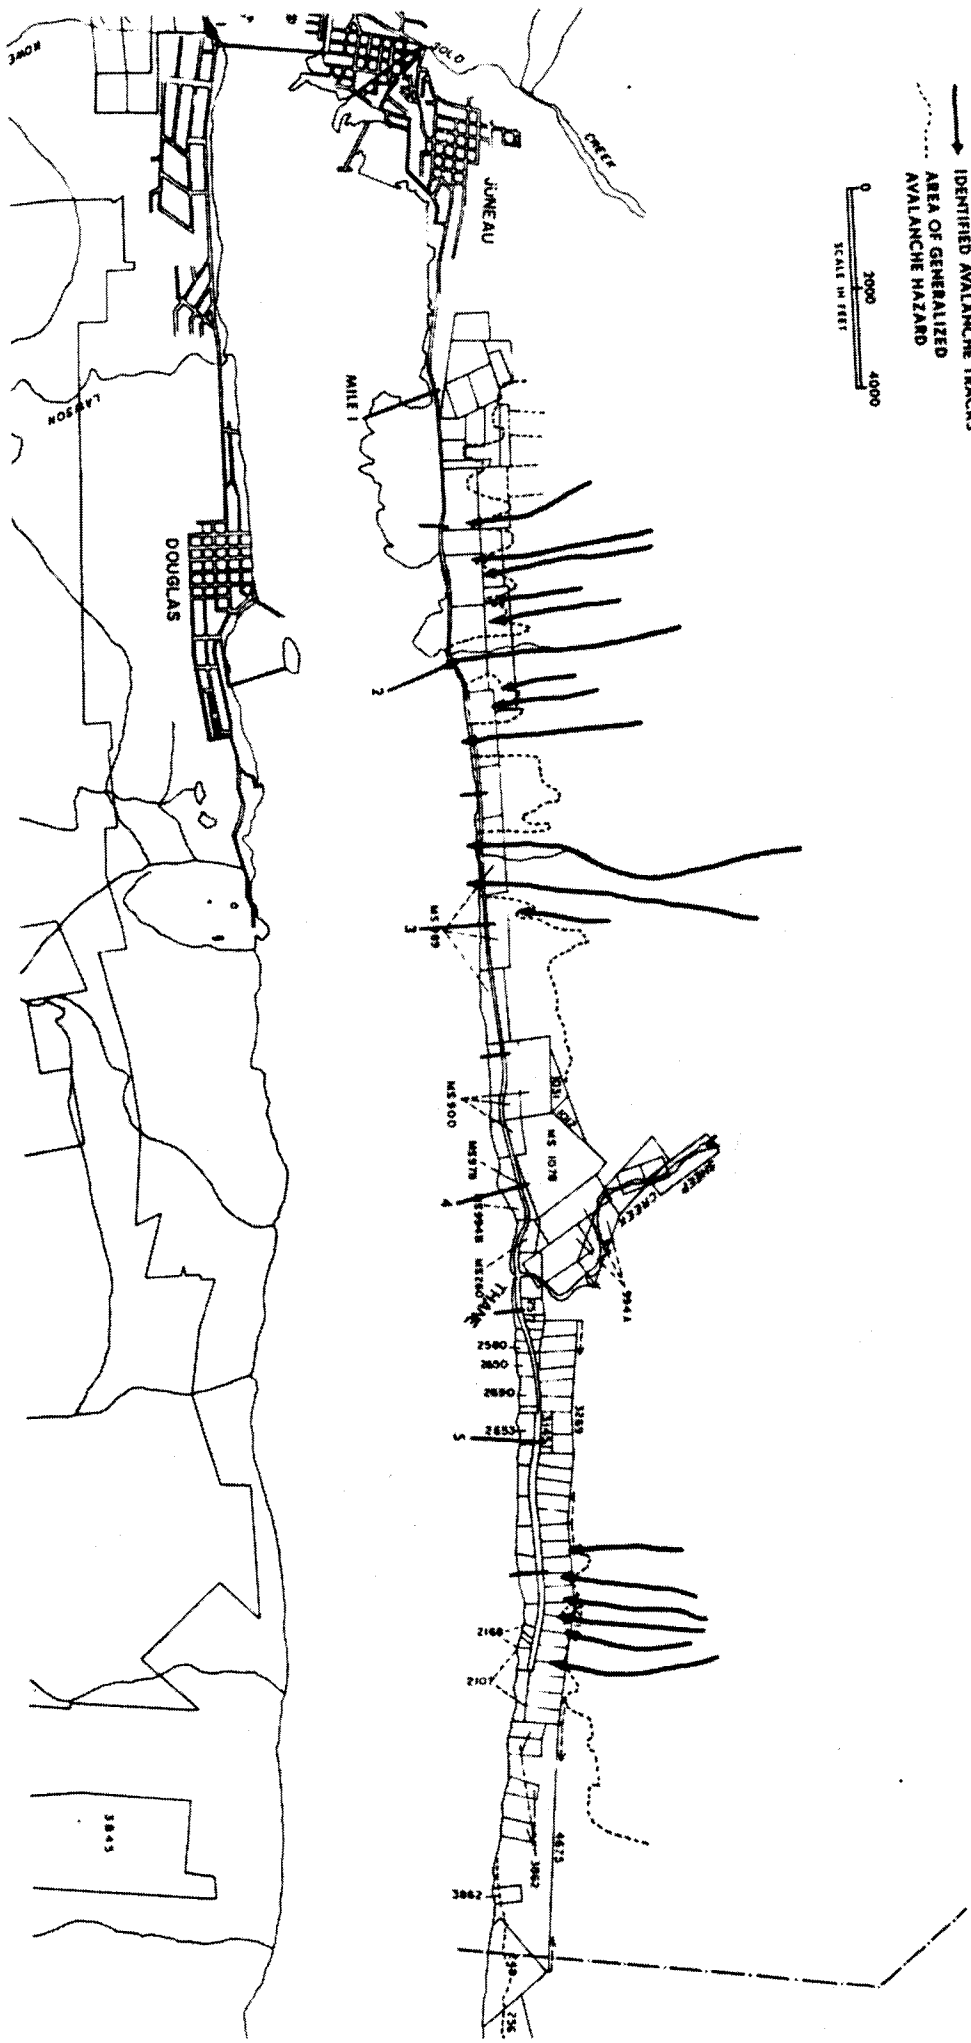
FIGURE 4

**AVALANCHE HAZARD INVESTIGATION
GENERALIZED HAZARD AREAS**

- IDENTIFIED AVALANCHE TRACKS
- AREA OF GENERALIZED AVALANCHE HAZARD

might affect urban development" has to be considered. Urban development, i.e., especially housing, is expected along the four major arterial roads, namely Glacier Highway (41 miles), Thane Road (5.6 miles), Douglas Road North (9 miles) and Douglas Road South (3.7)miles). A superficial survey indicated that there exists avalanche hazard only on the Thane Road. This is the only road affected directly by avalanches and where housing development would create essential hazard (see Figures 3 and 4). The hazard affects both housing and traffic.
