Proposed Work: Construct a metal structure on the existing slab where the gym was previously located.

Project Information Submitted by Ryan Regier via Civic Access

Description: *We are wanting to rebuild our gymnasium at Echo Ranch that collapsed this winter. The new building will go directly back on the slab of the old gym. The structure will be 60x120 and is partially in an AE zone and a V zone. This new building will be a multi-purpose building, for 5 months of the year it will be used for recreational purposes, the other 7 months it will be used as a storage building and for agricultural purposes as well.*

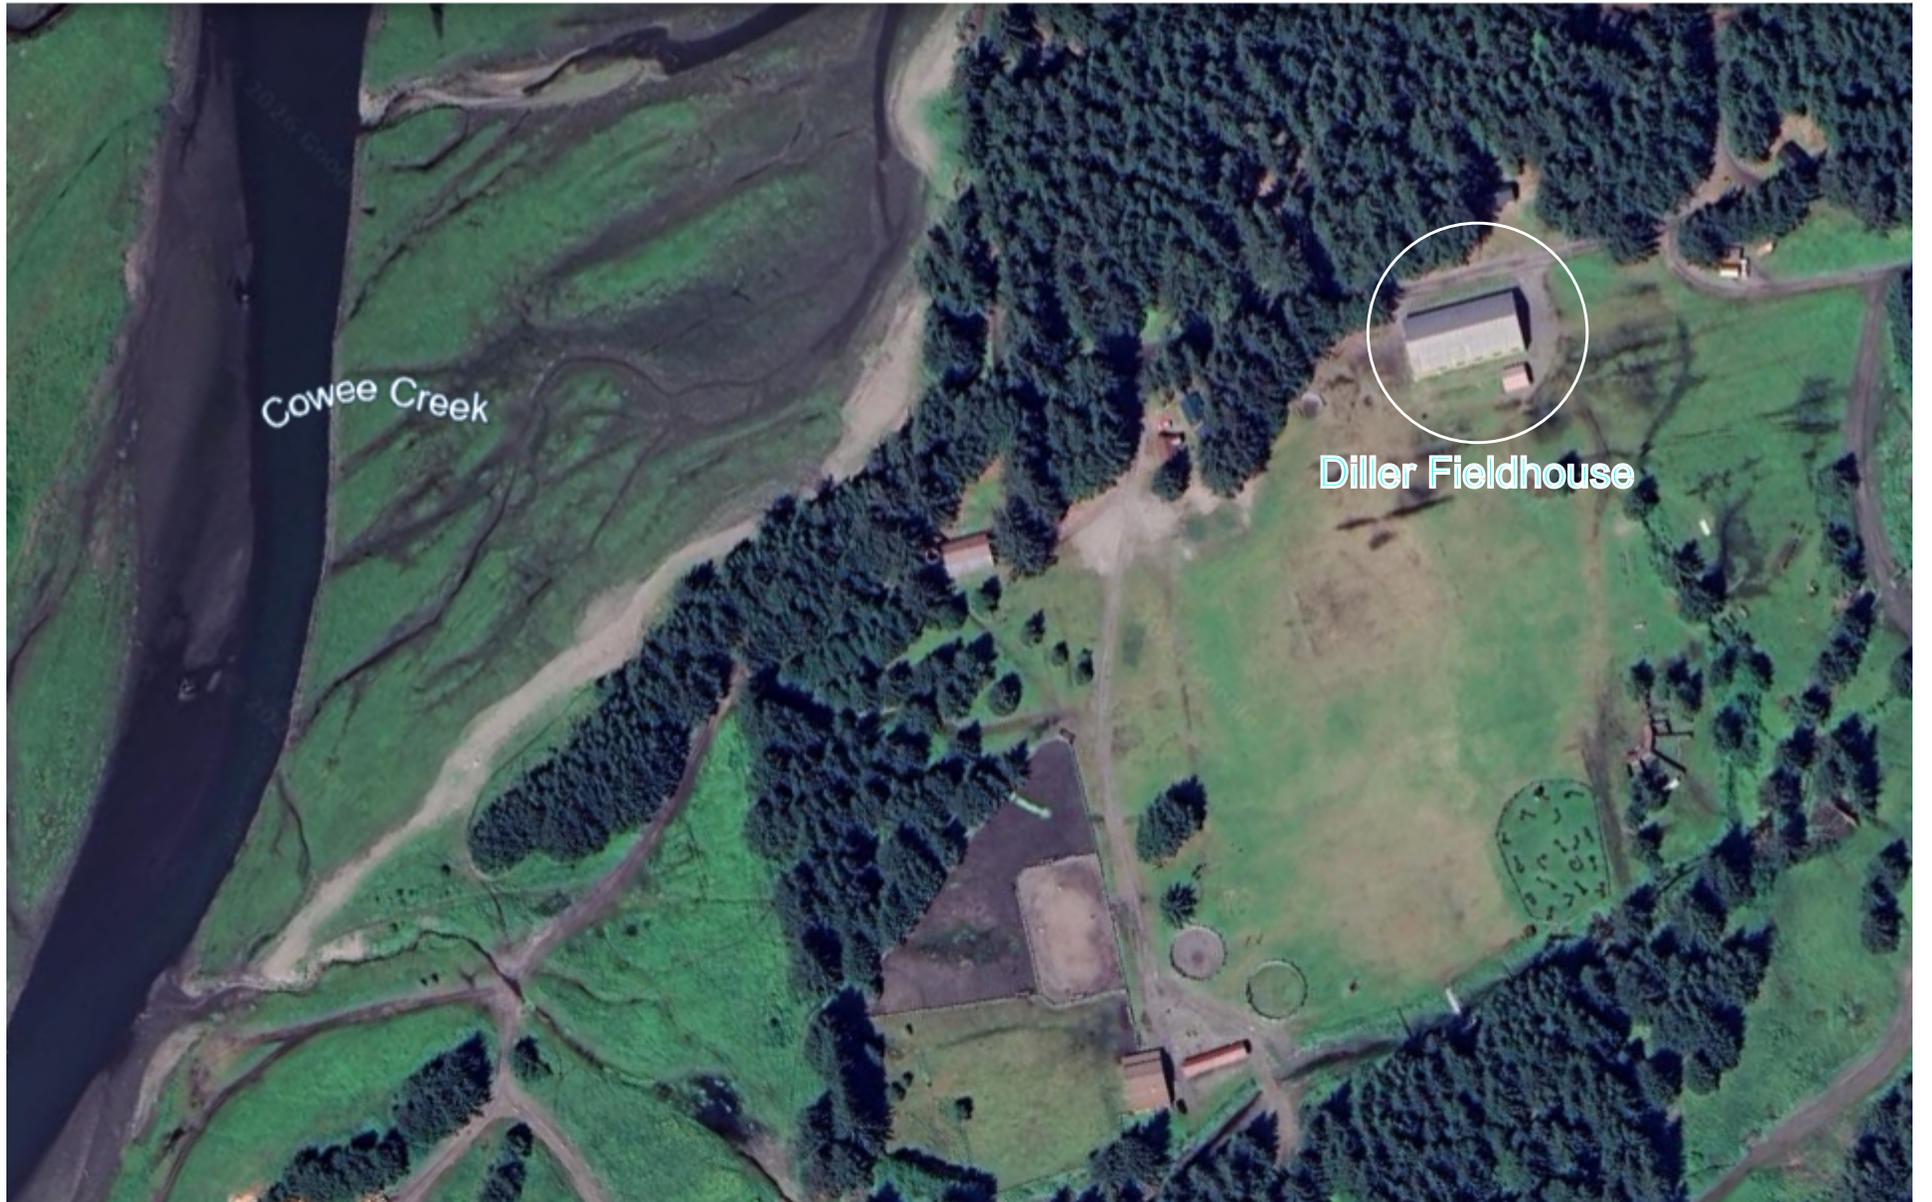
Cowee Creek

Diller Fieldhouse

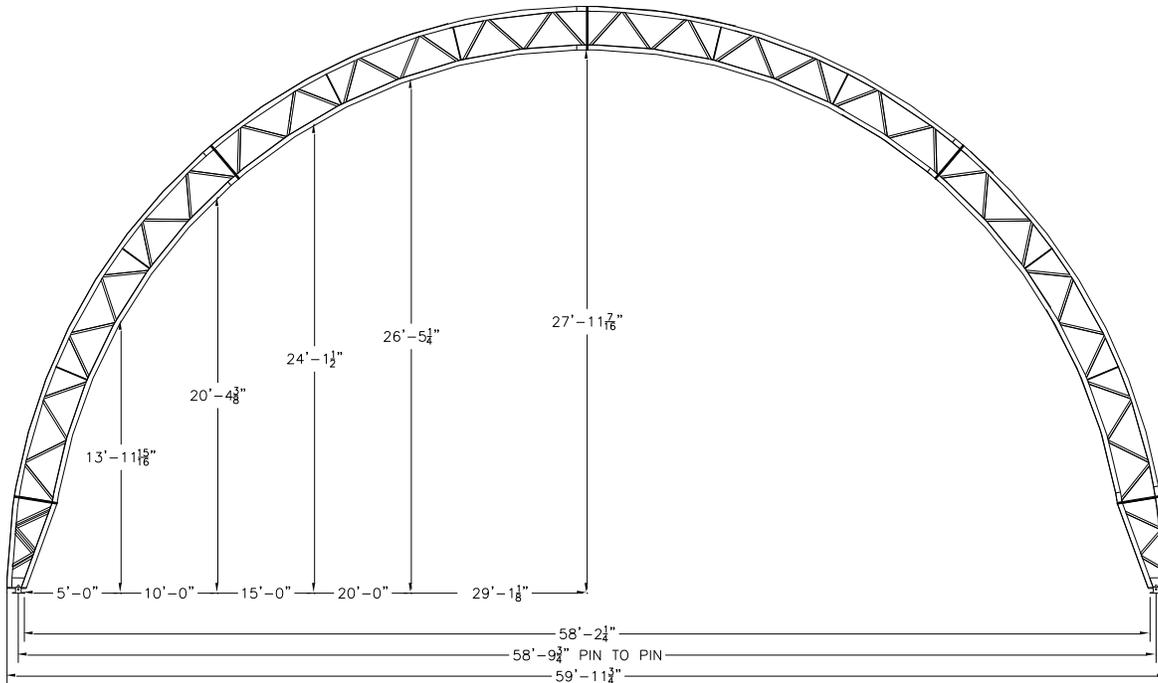
INTERIOR CLEARANCE

FRAME COMPONENTS

- RAFTERS:** Welded truss construction with 3-inch **12 gauge** top and bottom chords.
- RAFTERS AND PURLINS:** Straight and/or "X" bracing configured to application.
- RAFTER SPACING:** Offered in 8-foot, 10-foot, and 14-foot truss spacing depending on local codes..
- PONY WALL MODELS:** Designed to be set on wood, concrete, or steel.
Walls must be at least 24-inches high to allow for tensioning.
- Included:** assembly bolts, lashing winches with mounting brackets.
- Not included:** posts, rub rail, or concrete anchors.

FABRIC COVER

- FABRIC:** 12.5 oz tear resistant high density polyethylene with reinforced corners and pockets.
- COLORS:** White, Blue, Green, Red, Tan, Silver, Frost/translucent.
Available as solid colors (some colors may be up charged), with colored canastoga ends, or stripes.
- TENSIONING:** Pipe and 2" lashing winch at each truss.
Standard end tension kit with ratchets spaced at 36"; high tension kit available.

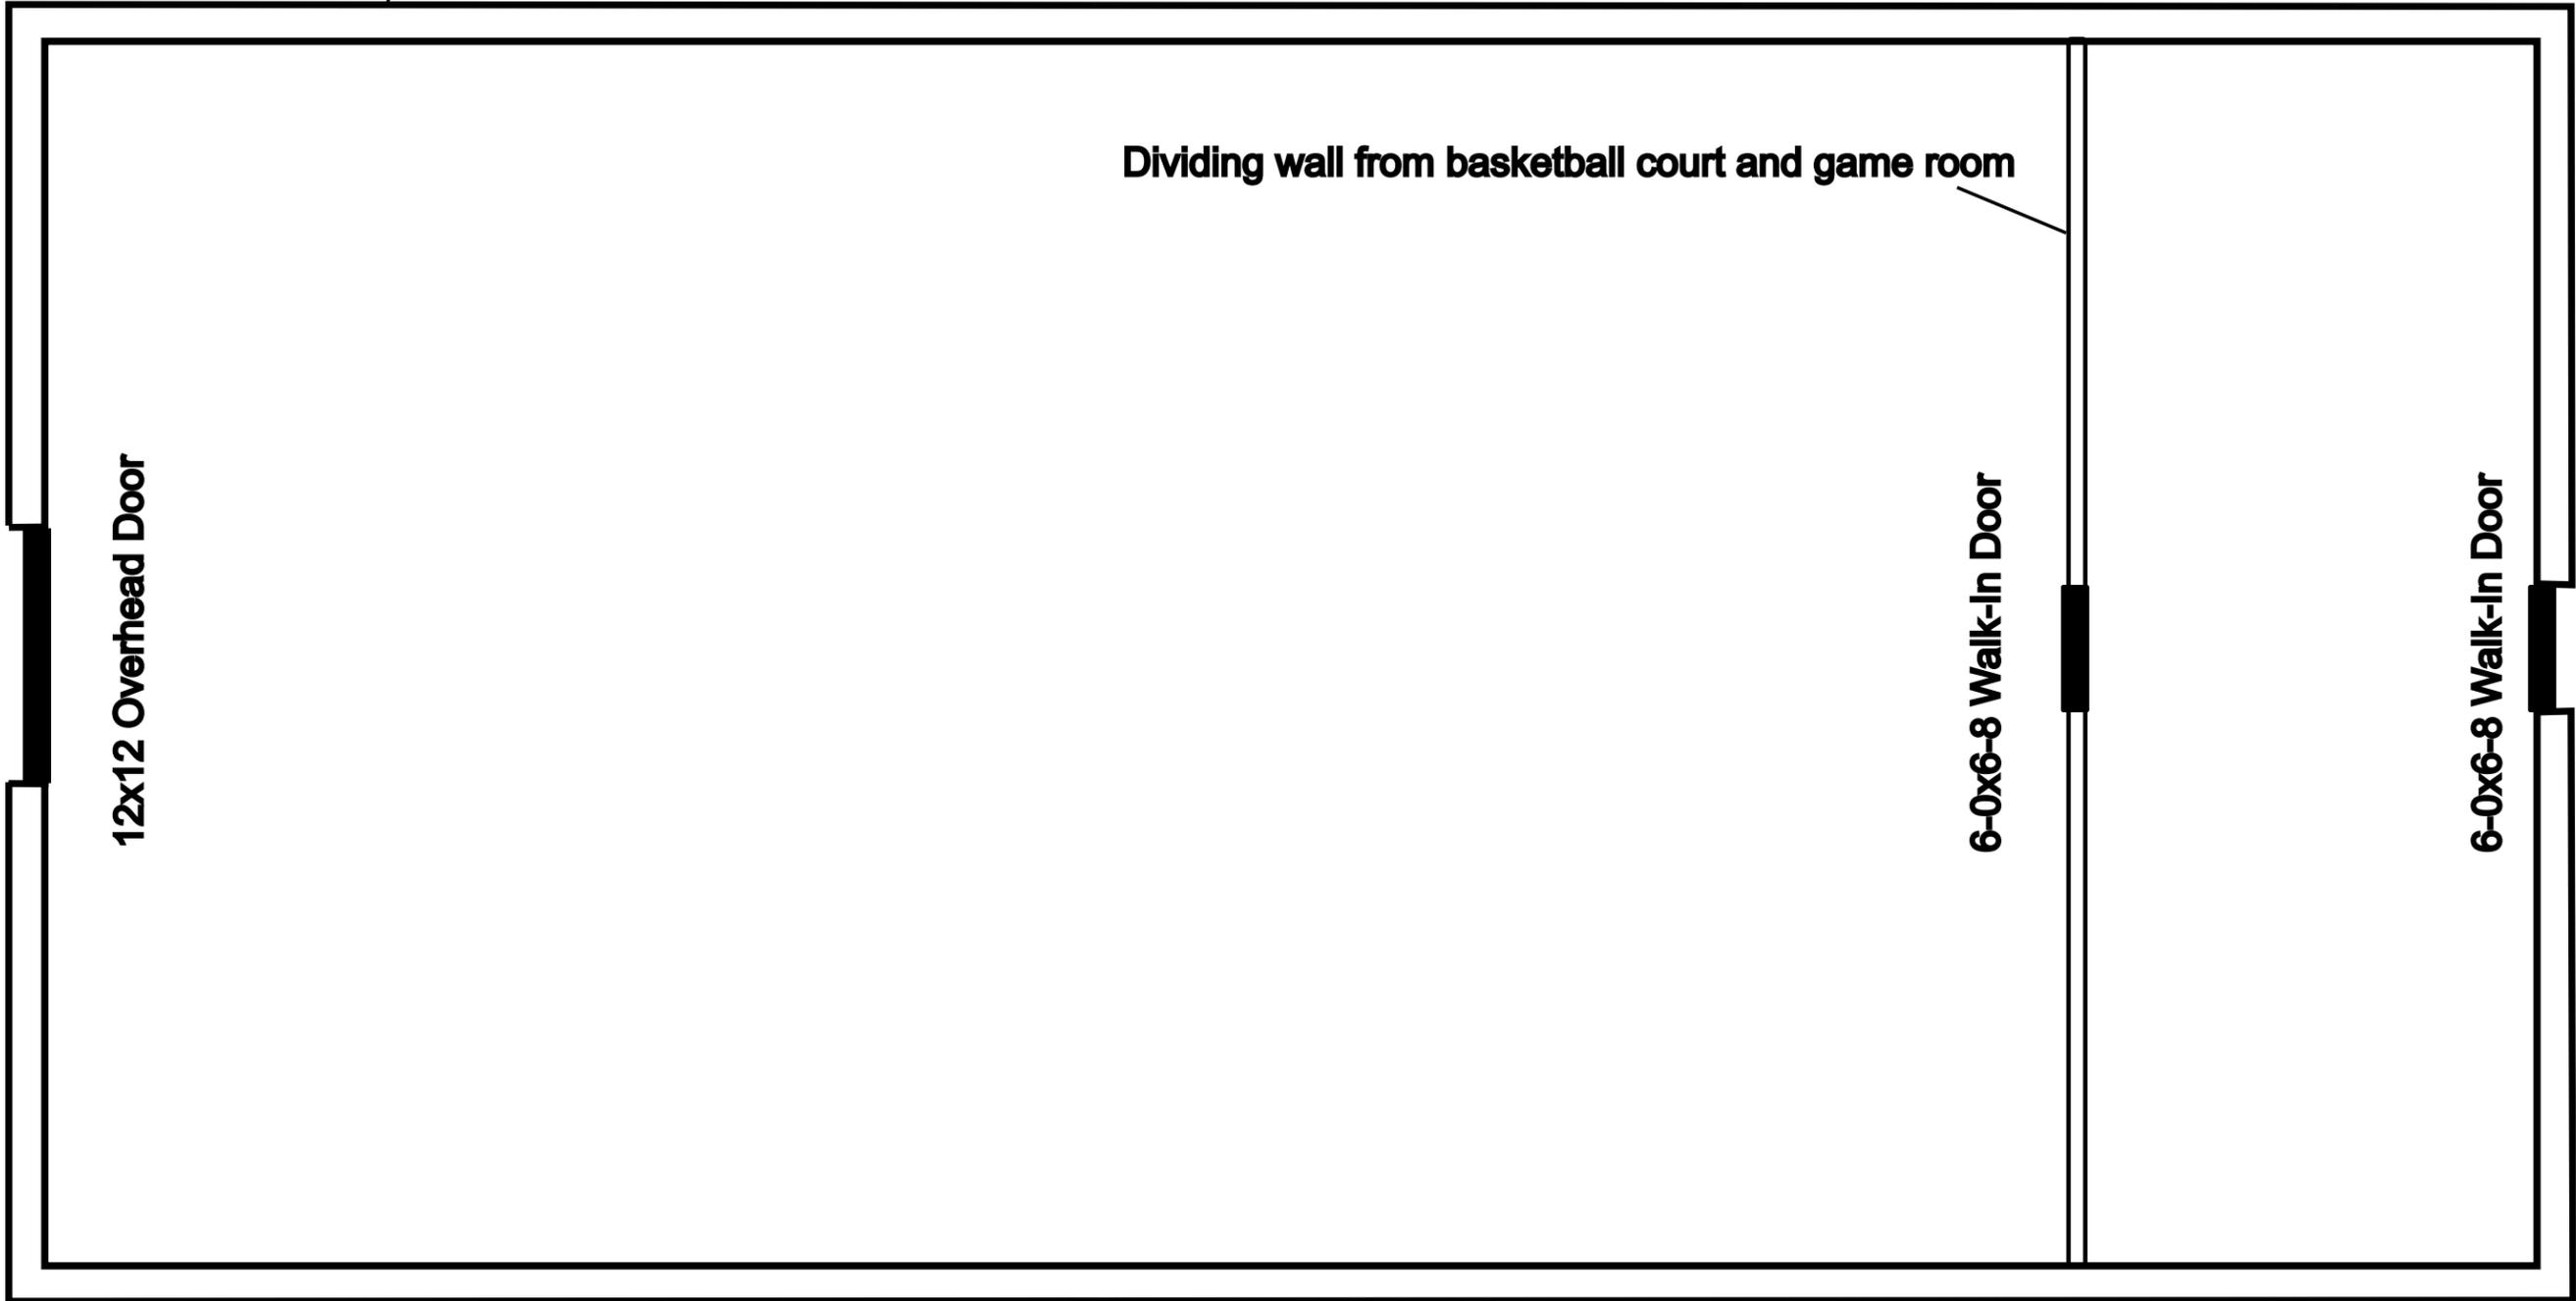
2'x2'x6' Concrete Bin Blocks along perimeter

120'

60'

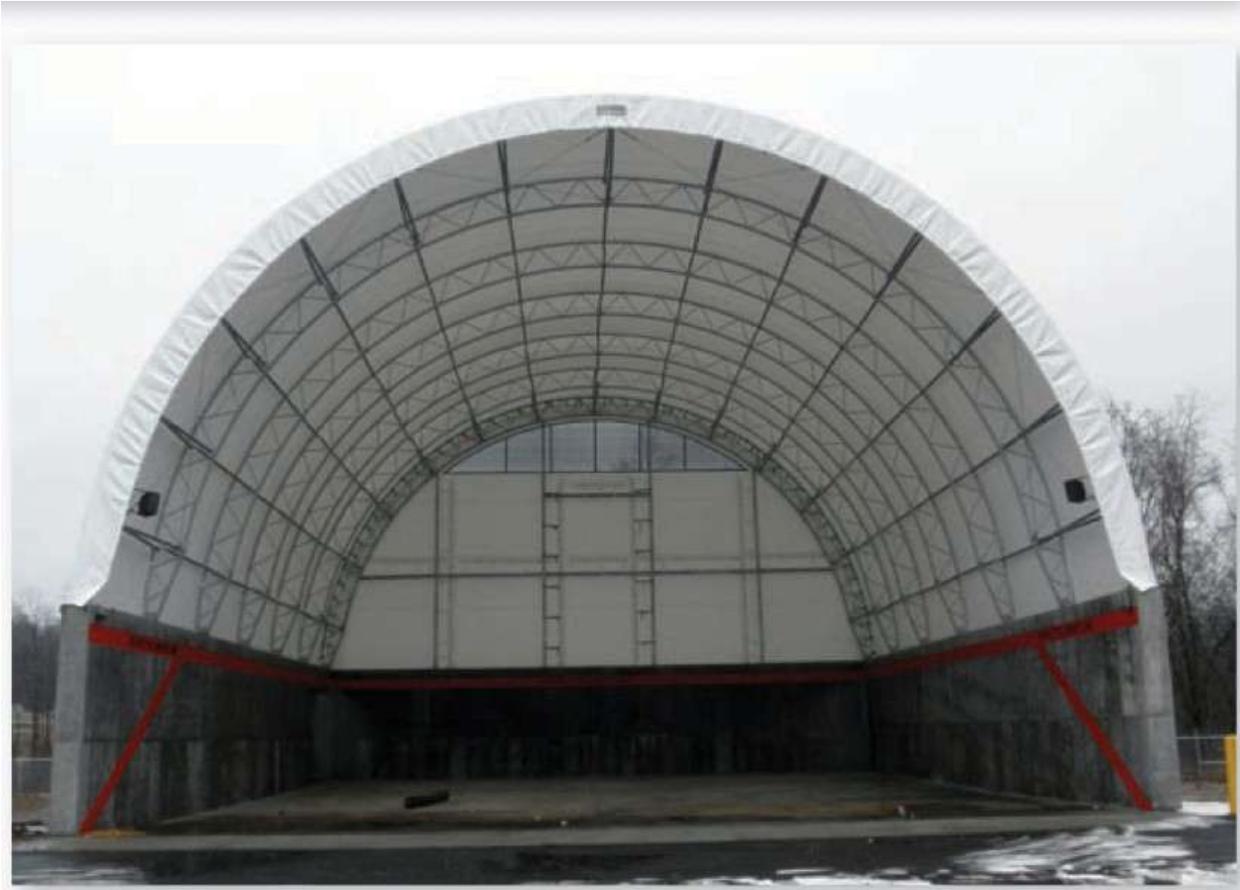
This is a picture of the hoop style structure we are wanting to build. This one is on a poured concrete wall. The Manufacturer recommends the 2x2x6 concrete bin blocks for construction when pouring is not practical. Ours will have two endwalls with an overhead door on one side and a double walk-in door on the other, totally enclosing it for weather purposes.

The endwalls and rafters are engineered to IBC for what Juneau requires. Engineering documents are available if the exception is granted.

The type of building we would like to erect is a metal hoop structure covered in a waterproof canvas. There will be a 12' overhead door on one side, a 6' double walk in door on the opposite end to allow any water that would rise high enough to come in and go right on through. The likelihood of any sort of flood waters reaching the foundation of the old fieldhouse is extremely low. There has never been any recorded level of water near that structure. There is a slough that runs from the Cowee Creek and will occasionally rise with rain water and tidal influence. This slough is over 620 feet away and there is no evidence of past flooding that the slough has ever overflowed its banks onto the sports field.

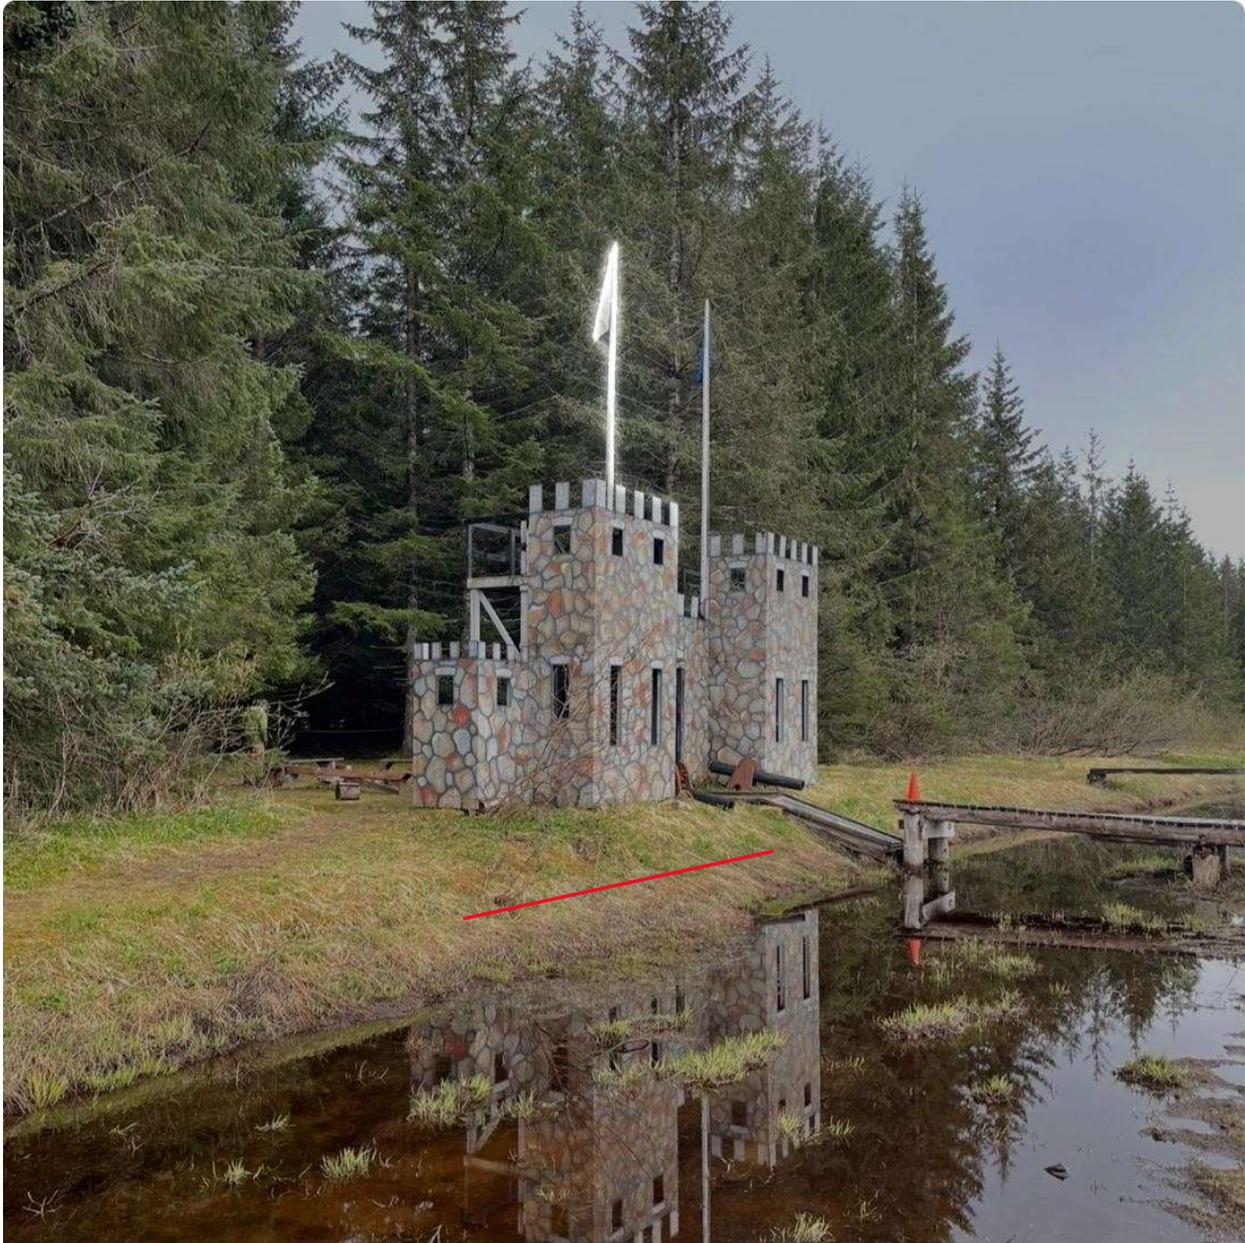
Slough Picture #1

This is a picture of the slough mentioned in the narrative. This is over 620 feet from the fieldhouse. You can tell in picture that there isn't any high water marks above the bank of the slough from marks on the beams of the bridge. We have rot on the bridge from not treating the lumber, but no evidence of high water above the bank. Average water line marked in red. This line is approximately 4-5 lower than the elevation of the floor of the fieldhouse. Water hasn't gotten above the red line in the last 8 years due to fixing culverts and other watercourse corrections done in 2017.

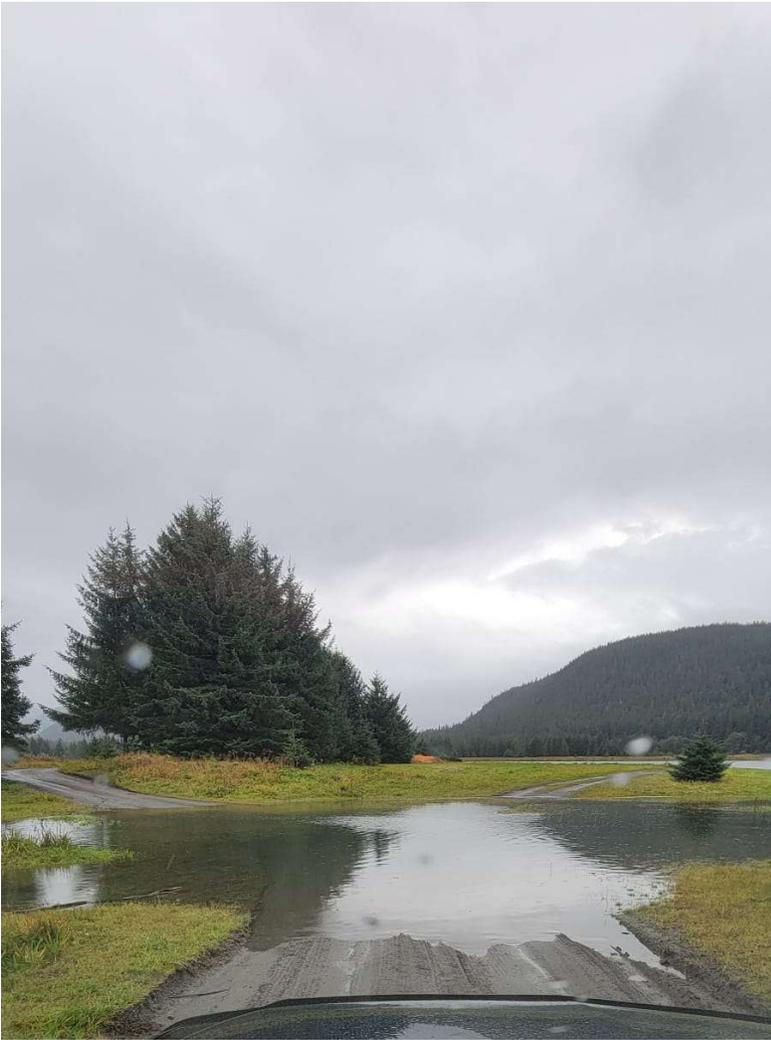
Slough Picture #2

This is a picture of our slough within 250 feet of the banks of the Cowee Creek. This is a high tide and is as high as we have seen this slough at this location. When it has been this high here, it still is not above the red mark on the picture of the slough by the castle. This picture was taken when river was full of runoff couple with a high tide.

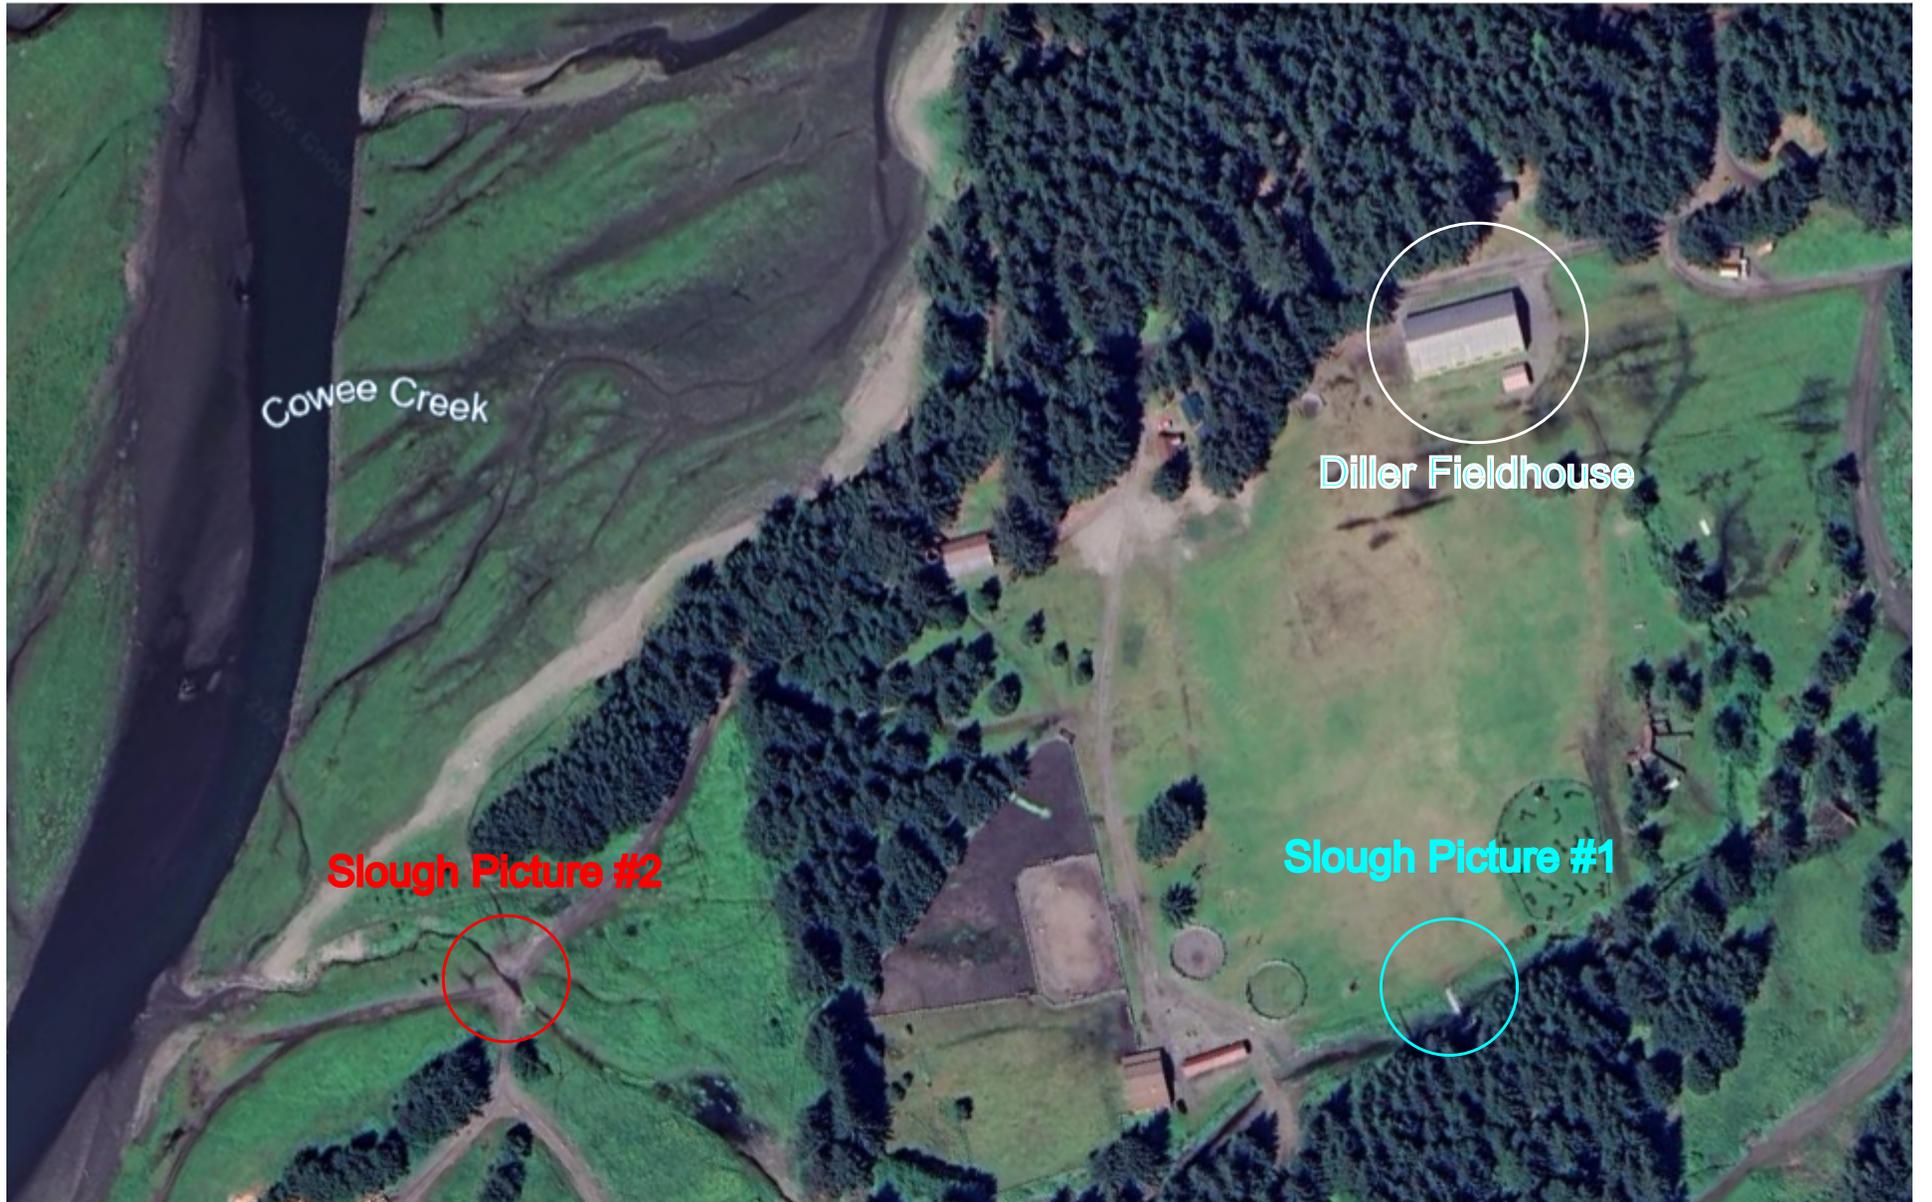
Cowee Creek

Diller Fieldhouse

Slough Picture #2

Slough Picture #1
