## MEMORANDUM

RE: Project Office Monthly Report

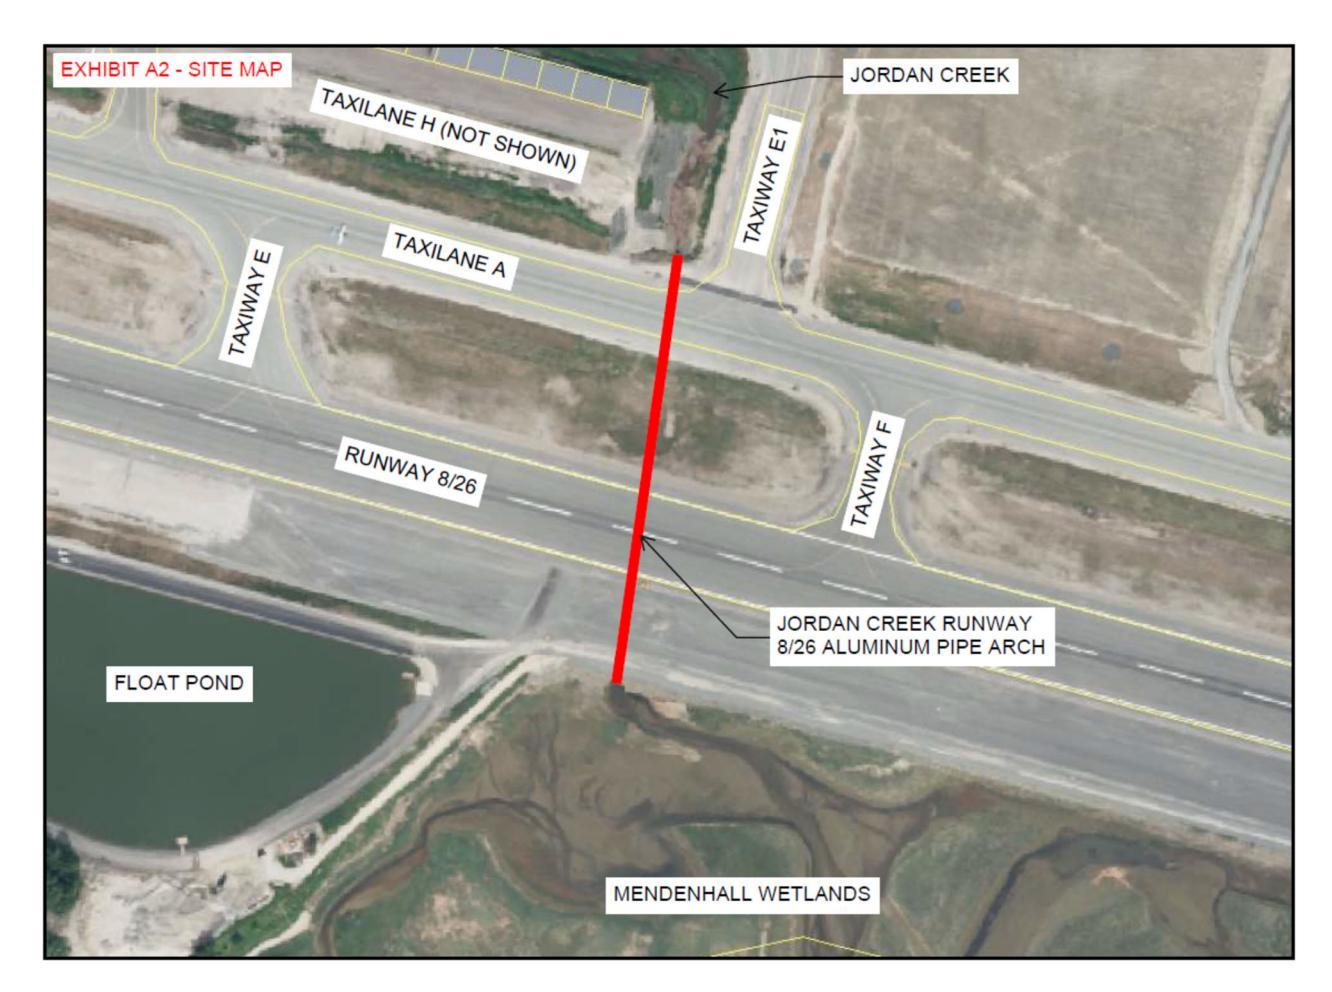
<u>Culvert Condition Survey – Jordan Creek @ Runway 8-26</u>: No change since last report. As previously reported, JNU has received the condition survey as prepared by proHNS engineering for the large half-arch aluminum culvert assembly which allows Jordan Creek to pass beneath Taxiway A and Runway 8-26. In their report, proHNS stated the opinion that an immediate catastrophic failure of the culvert is unlikely. The report goes on to state that continued deterioration is likely, and that repair work is recommended, even if the source of deterioration is determined and eliminated. proHNS has identified three (3) repair-in-place options, recommending them for further study. They would not require open trenching, would not require a closure of Runway 8-26 and would not require extensive permitting.

The three recommended repair-in-place options are: 1. HDPE (High Density Polyethylene) Slip Lining

- Pros: a. Corrosion resistant structure.
  - b. Local contractors are familiar with construction installation methods.
  - c. Cost effective due to shipping and construction costs.
  - d. Would not require runway closure for construction.
- Cons: a. Grouting annular space where lengths are over 100' can be challenging.
  - b. 800' length push and pull resistance on pipe will be significant.
    - c. Requires large area for insertion/jacking/welding pit.
    - d. Potential to reduce flow capacity.

## 2. Carbon Fiber Lining

- Pros: a. Corrosion resistant structure.
  - b. Could be done while maintaining streamflow in existing pipe.
  - c. Wouldn't impact existing stream bed material, which should make for easier permitting process.
  - d. Can be designed to be structurally independent and fully withstand runway loading.
- Cons: Specialized equipment and trained personnel required, known installer (National Plant Services, Michels Trenchless), known Manufacturer (Structural Technologies).

## 3. GeoPolymer Lining

- Pros: a. Corrosion resistant structure.
  - b. Could be done while maintaining streamflow in existing pipe.
  - c. Wouldn't impact existing stream bed material, which should make for easier permitting process. Product has extensive research on chemical properties not affecting fish.
- Cons: Specialized equipment and trained personnel required, known installer (National Plant Services, Michels Trenchless), known Manufacturer (Structural Technologies, GeoTree)
  - b. Questions on whether this product would be strong enough to fully withstand runway loading.
