TO: Patricia deLaBruere, DATE: April 3, 2014

FROM: Catherine Fritz, AIA

RE: Gate 5 Jet Bridge.

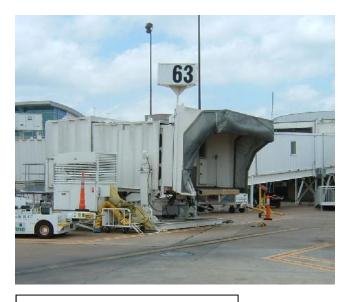
Existing stairway is too short for 757 jet bridge settings.

The more unpredictable components are those related to the moving jet bridge parts. Given the age and condition of the existing jet bridge, we are pursuing replacement. Ken and I have been working with consultant Roland Hill from JetBridge America (Fort Worth, TX http://jetbridgeamerica.com) on possible replacement of a portion of Gate 5 JetBridge. Roland sells and installs both used (refurbished) and new jet bridges across the US. His company also does maintenance, repair, and relocation of jet bridges.

Roland agrees that we should keep section 1 (walkway) for now, due to complications associated with replacing the component that extends into the building. This section could be replaced in the future, especially if associated with an expansion of the Hold Room and Gates. There are at least two options for replacing section 2 (moveable sections) with used equipment. Used equipment is easy for the Airport to procure, and is significantly less costly than new. The used equipment we would be interested in is typically about 10 years old and very basic in design. The first replacement option is to remove the rotating end piece and add a new nose loader that will adjust as needed to connect to both a 757 and a 737. A second option is to purchase a used ramp bridge that would extend from the existing support column and telescope out to meet the jet.
