MEMORANDUM

DATE: March 5, 2021

RE: Projects Office Monthly Report

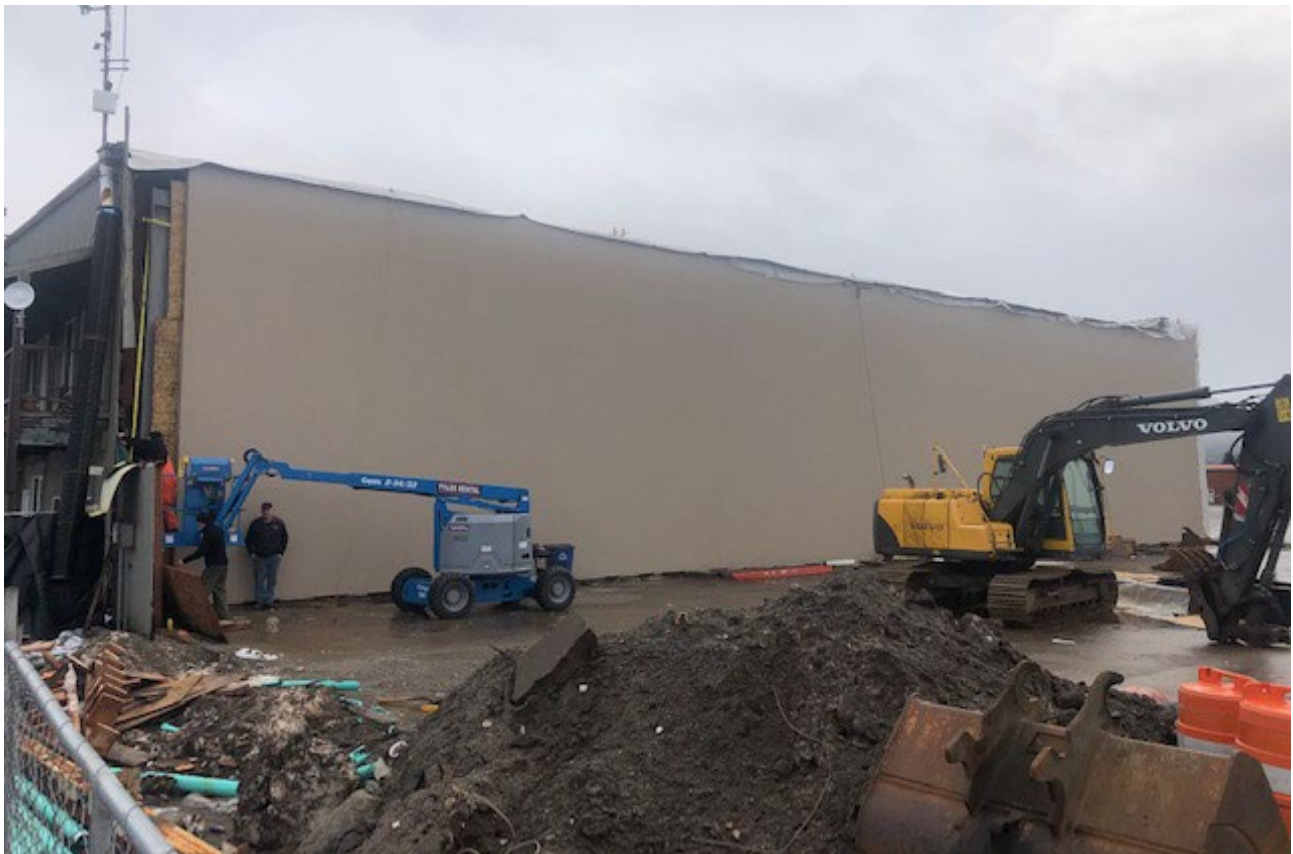
**Photo 01:** Southeast Earthmovers installing the last of the insulated metal panel siding over the new columns, beams and horizontal girts at the northwest corner of the Loken Hangar.

**Sand Shed Demolition:** Southeast Earthmovers (SEEMs) has completed work on the installation of the large exterior insulated wall panels over the new structural steel frame and girts. Crew is now working on the installation of the new corner flashings on the north and south ends of this new wall. Crew is also working on the installation of the new wall base flashings. Crew is also working on the installation of the new security fencing and on the installation of the new enclosure for the trash compactor controls.
