City and Borough of Juneau Aurora Harbor

PHASE III - FLOATS H & J MUNICIPAL HARBOR FACILITY GRANT APPLICATION

August 1, 2018

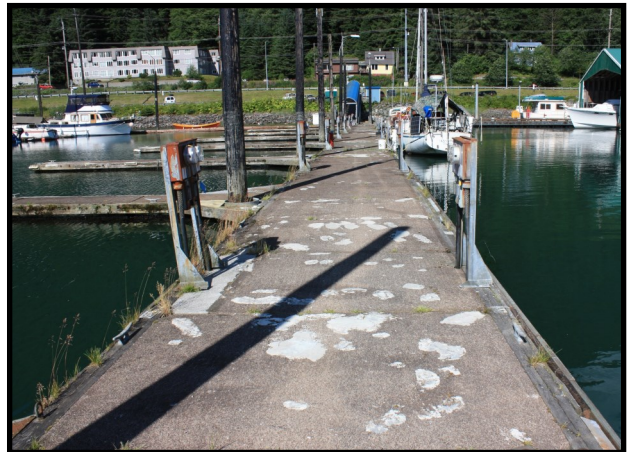
Mainwalk Float H

- Main float freeboard = 10" throughout with no listing. End of mainwalk float is sagging with freeboard = 8".
- Little organic growth on timbers.
- Approximately 25% of floats show concrete cracking throughout mainwalk and fingers.
- Piles are in good condition with no mechanical damage.
- Approximately 50% of finger walers are twisted, however none severely.

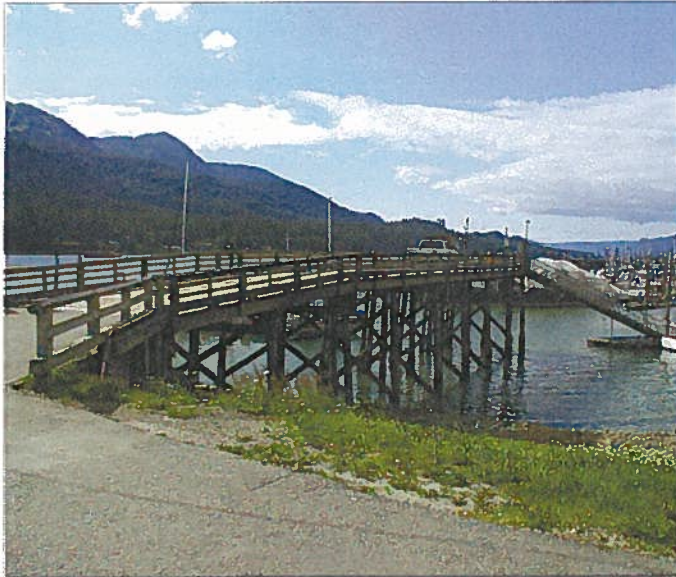
AURORA 001.jpg
EAST SIDE OF "A" GANGWAY APPROACH DOCK

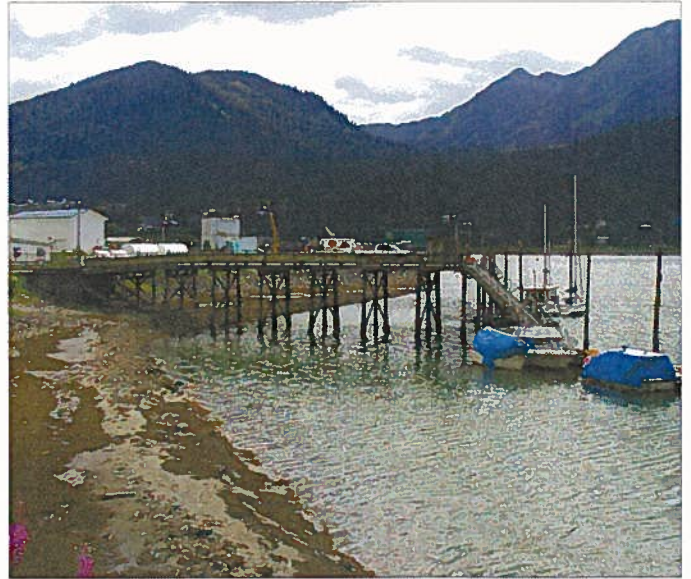
AURORA 004.jpg
"A" GANGWAY AND APPROACH DOCK FROM UPLANDS VIEWING SOUTH

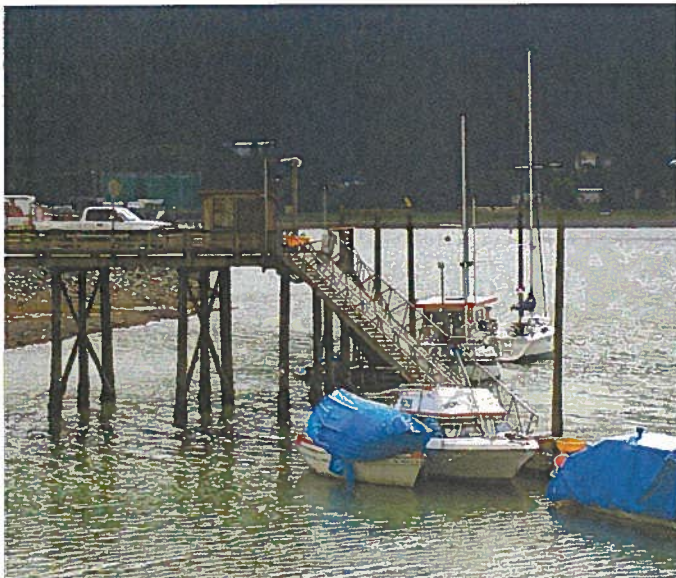
AURORA 005.jpg
"A" GANGWAY APPROACH DOCK

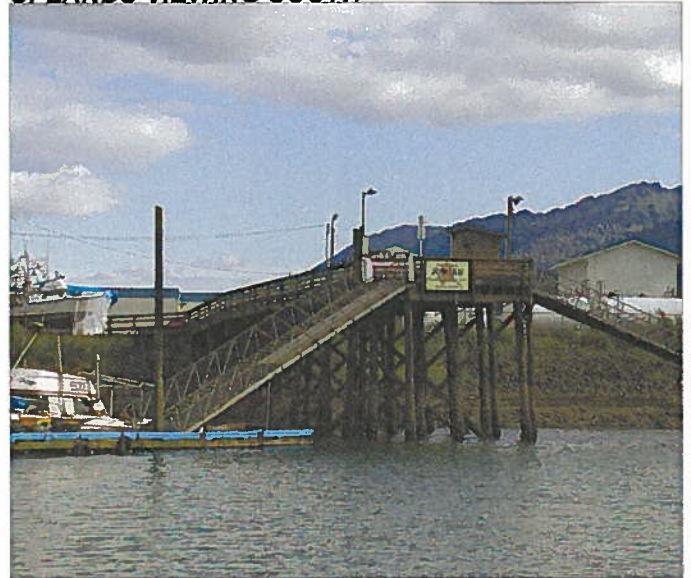
AURORA 006.jpg
"A" GANGWAY

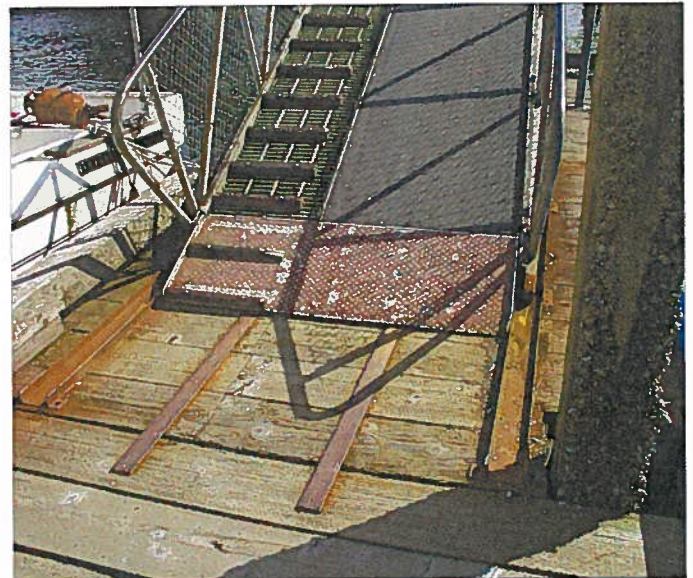
AURORA 008.jpg
"A" GANGWAY SKID AND TRANSITION PLATES

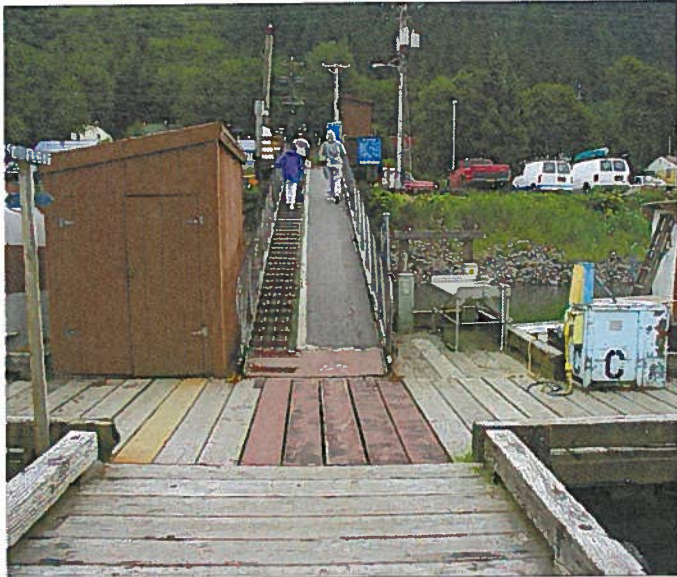
AURORA 013.jpg
VIEW UP "C" GANGWAY

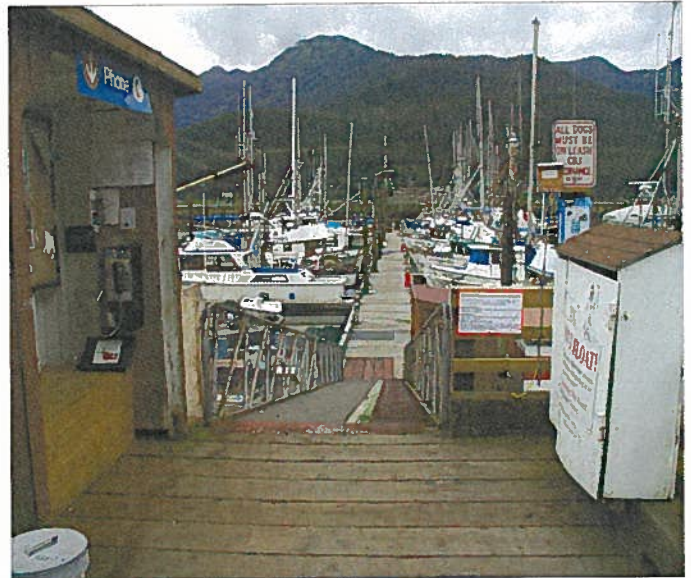
AURORA 014.jpg
VIEW DOWN "C" FLOAT FROM TOP OF "C" GANGWAY

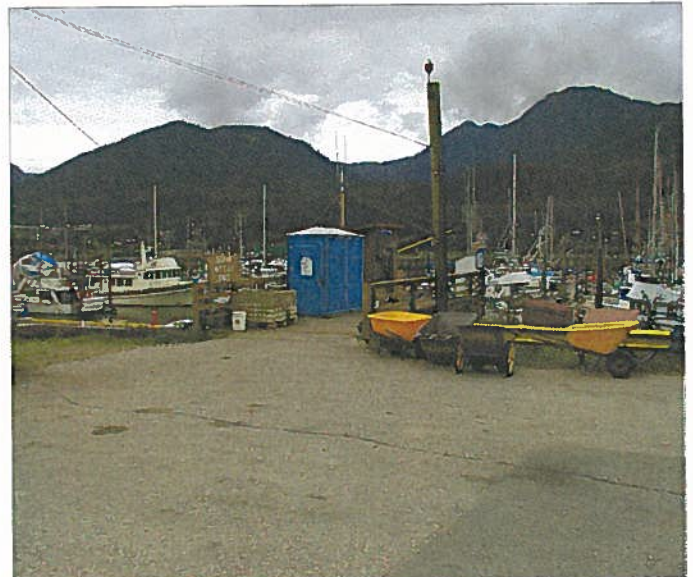
AURORA 018.jpg
UPLANDS AT "C" GANGWAY

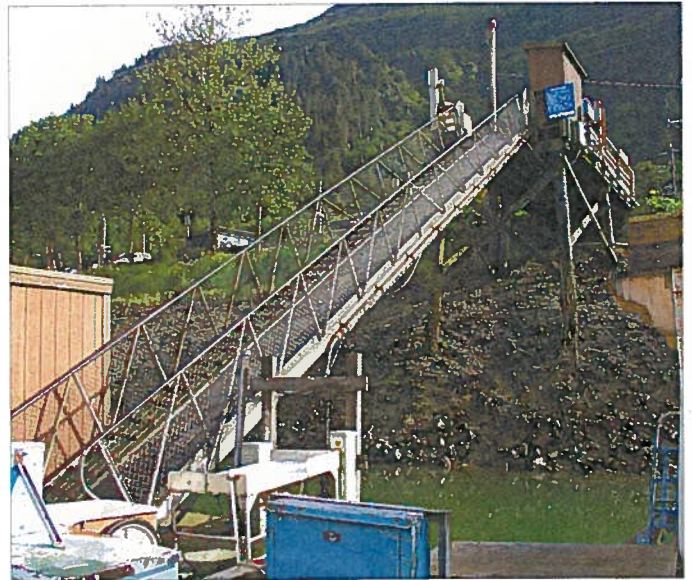
AURORA 020.jpg
"C" GANGWAY AT LOW TIDE

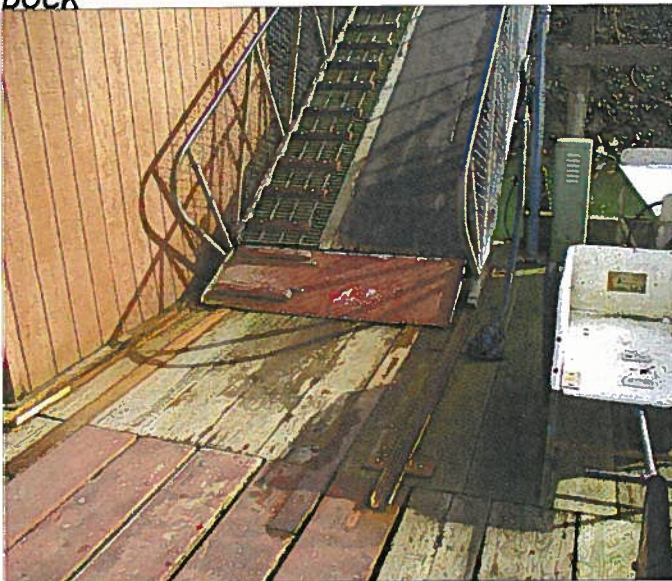
AURORA 021.jpg
TRANSITION AND SKID PLATES AT "C" GANGWAY

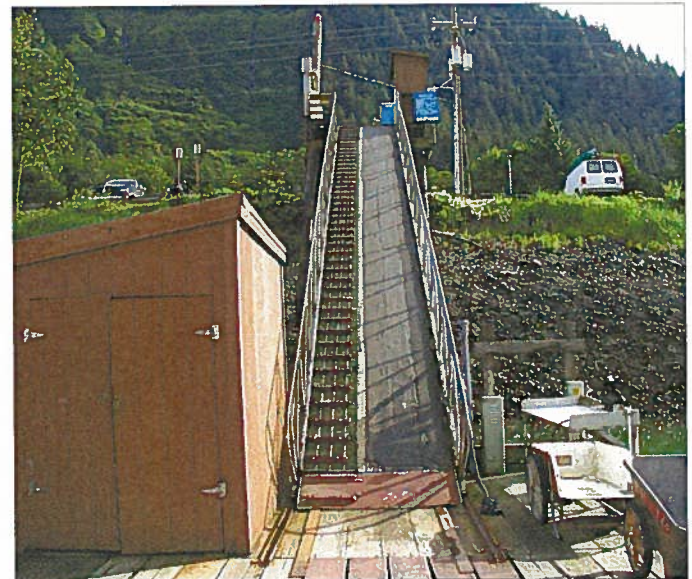
AURORA 022.jpg
VIEW UP "C" GANGWAY AT LOW TIDE

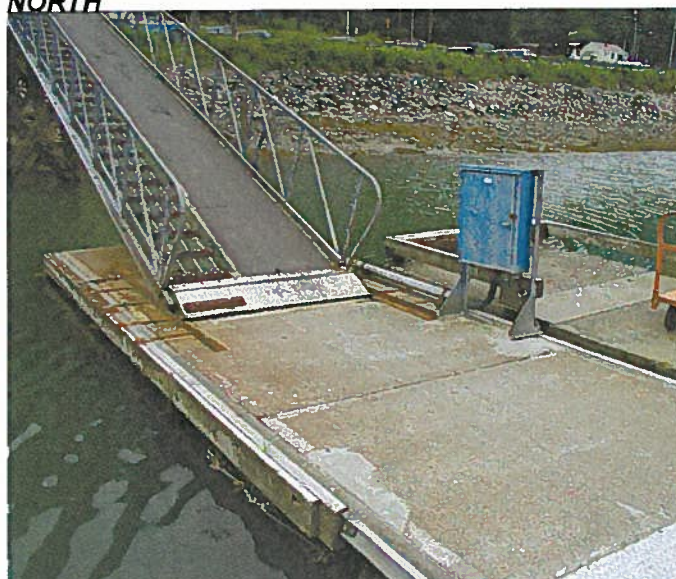
AURORA 029.jpg
"H" GANGWAY LANDING

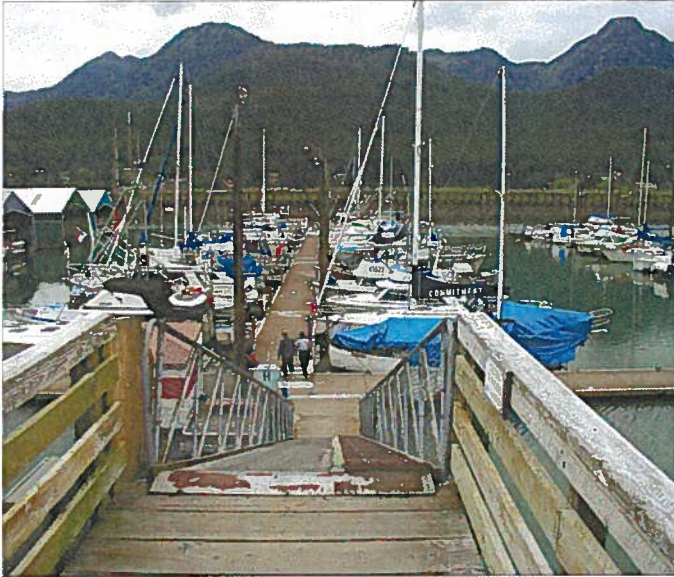
AURORA 031.jpg
"H" GANGWAY TRANSITION PLATE

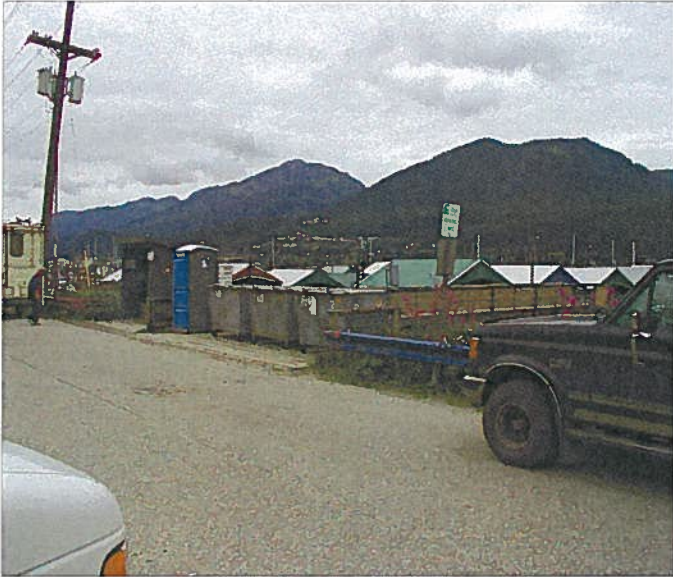
AURORA 037.jpg
UPLANDS AT "H" APPROACH DOCK

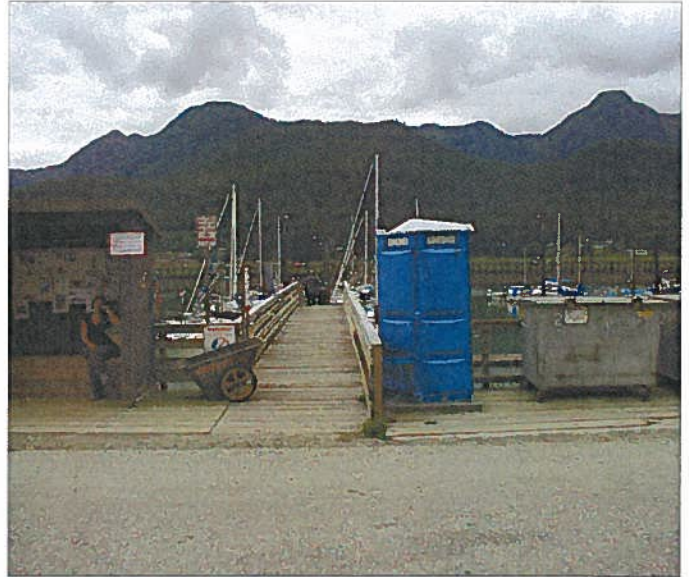
AURORA 038.jpg
UPLANDS AT "H" APPROACH DOCK

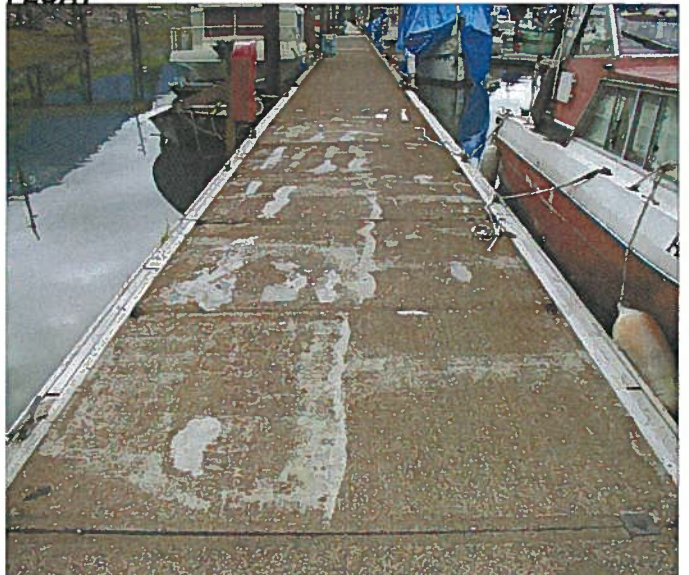
AURORA 042.jpg
VIEW SOUTH DOWN HEADWALK FLOAT FROM "K" FLOAT

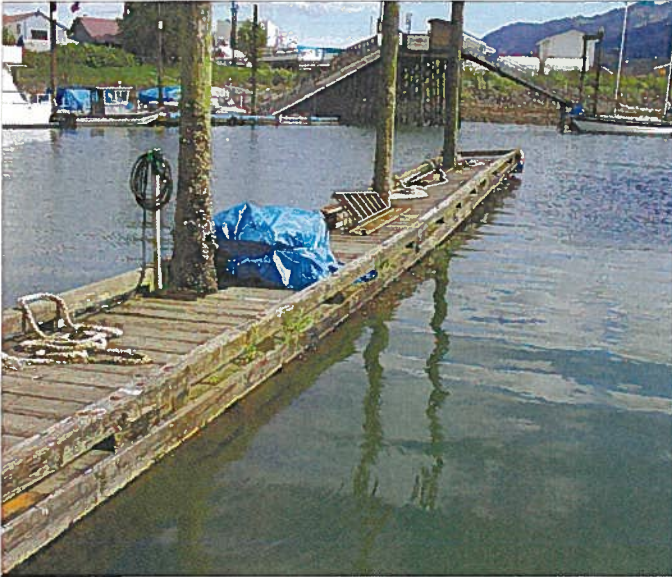
AURORA 067.jpg
SAGGING/TWISTED FINGER FLOAT WITH
SUBMERGED STRINGERS ON "A" FLOAT

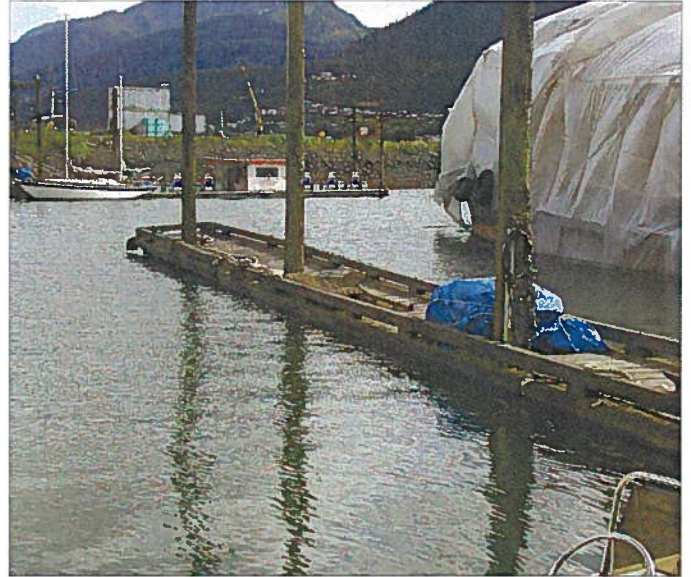
AURORA 068.jpg
SAGGING/TWISTED FINGER FLOAT WITH
SUBMERGED STRINGERS ON "A" FLOAT

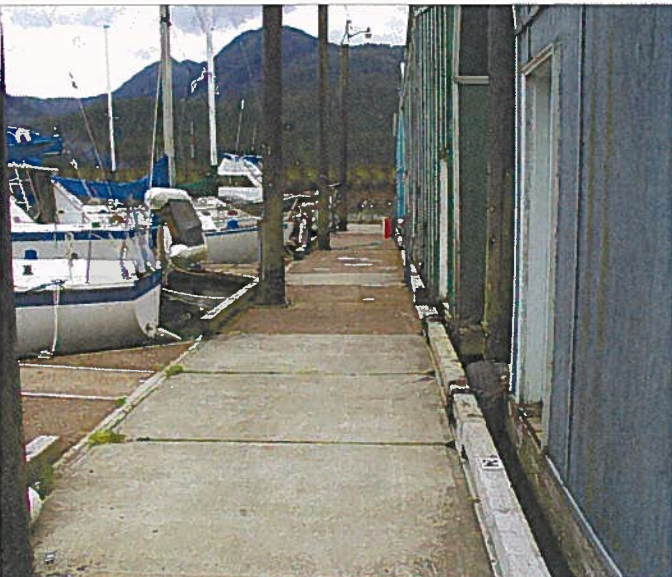
AURORA 089.jpg
VIEW WEST DOWN "G" FLOAT

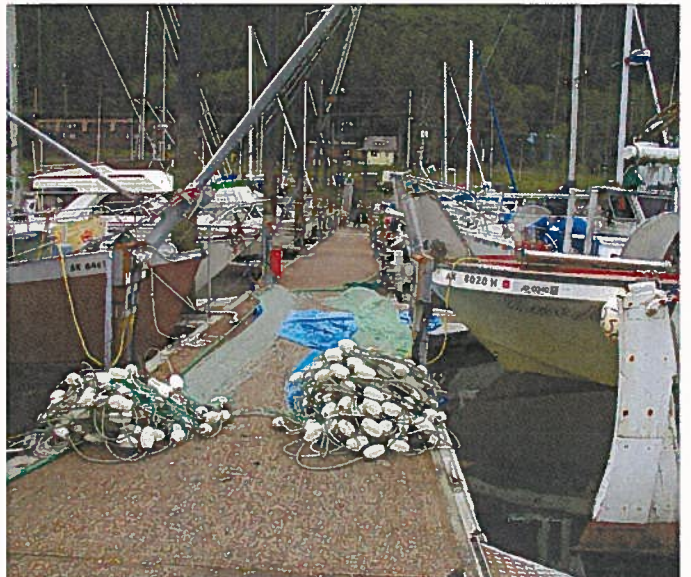
AURORA 090.jpg
VIEW EAST DOWN "H" FLOAT

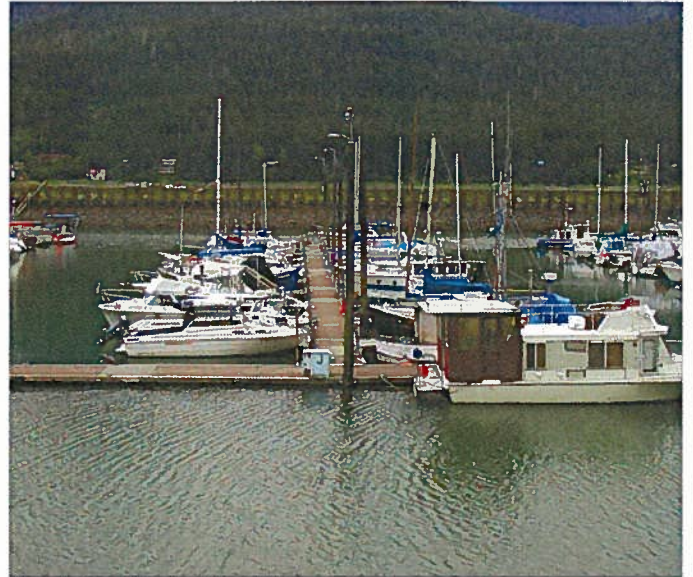
AURORA 094.jpg
VIEW WEST DOWN "J" FLOAT

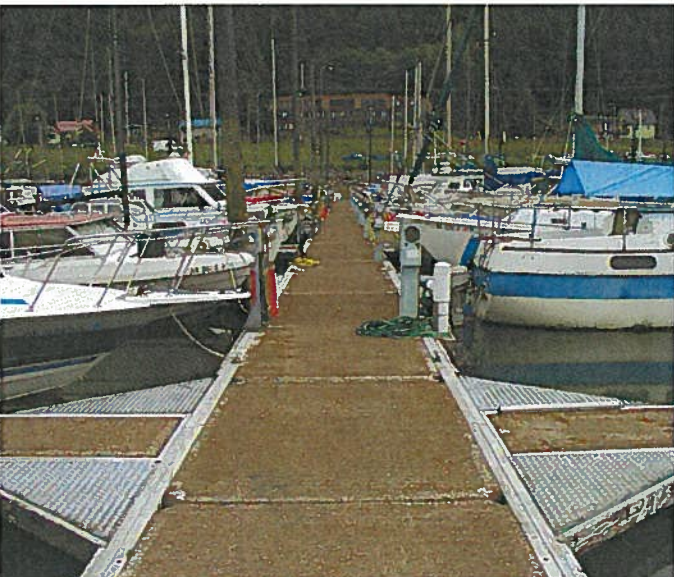
AURORA 095.jpg
VIEW EAST DOWN "K" FLOAT

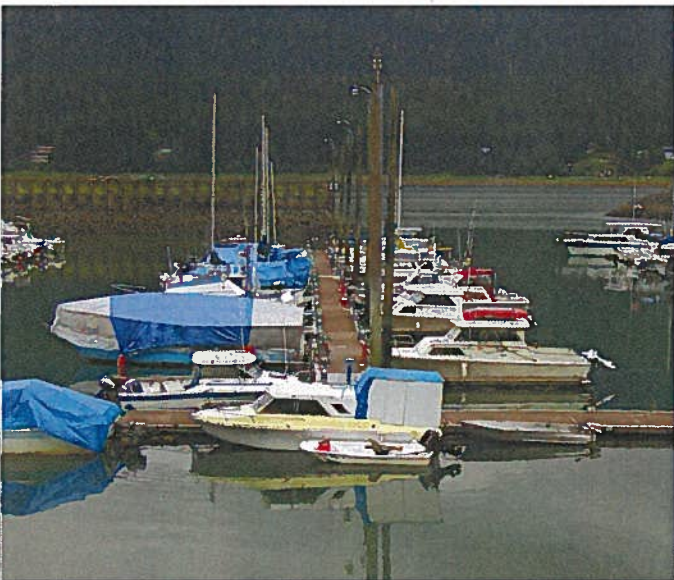
AURORA 099.jpg
VIEW WEST DOWN "L" FLOAT

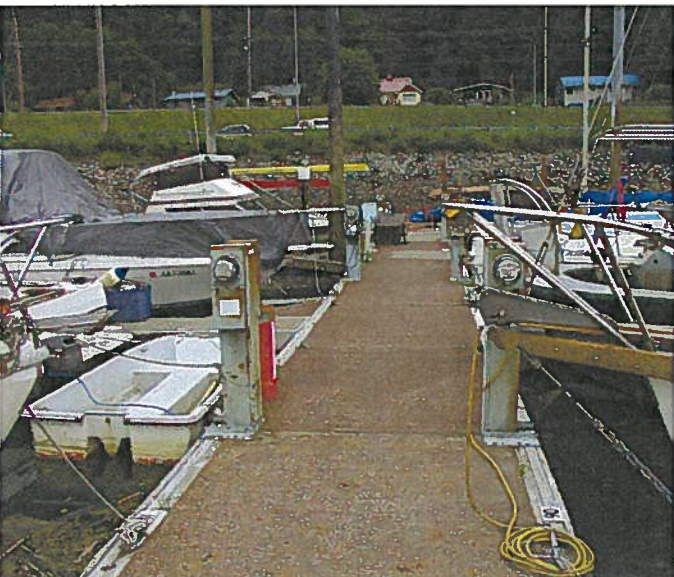
AURORA 101.jpg
VIEW EAST DOWN "N" FLOAT

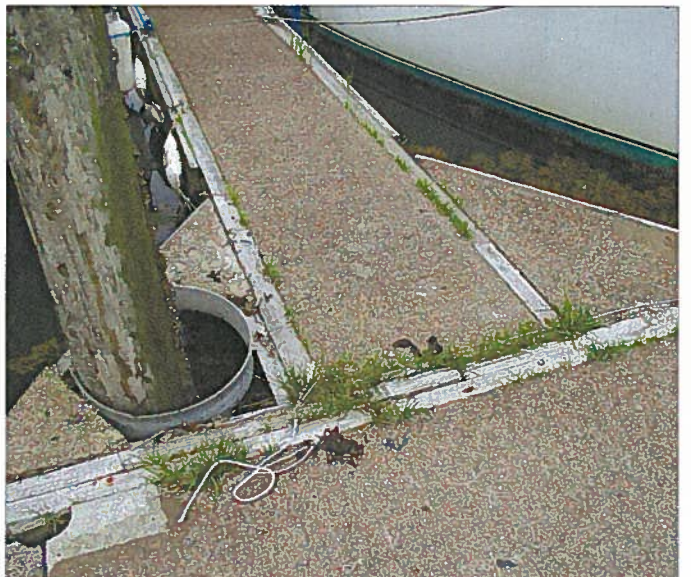
AURORA 102.jpg
FINGER ON "N" FLOAT SHOWING VEGETATION

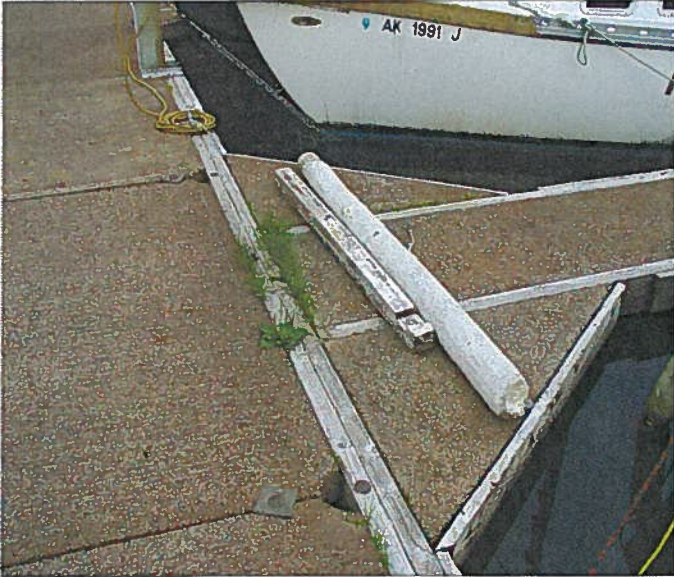
AURORA 103.jpg
FINGER ON "N" FLOAT SHOWING VEGETATION

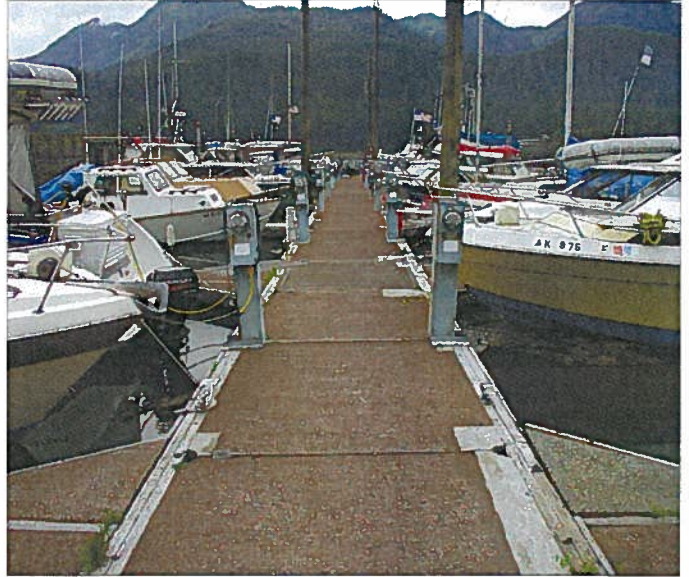
AURORA 104.jpg
VIEW WEST DOWN "N" FLOAT

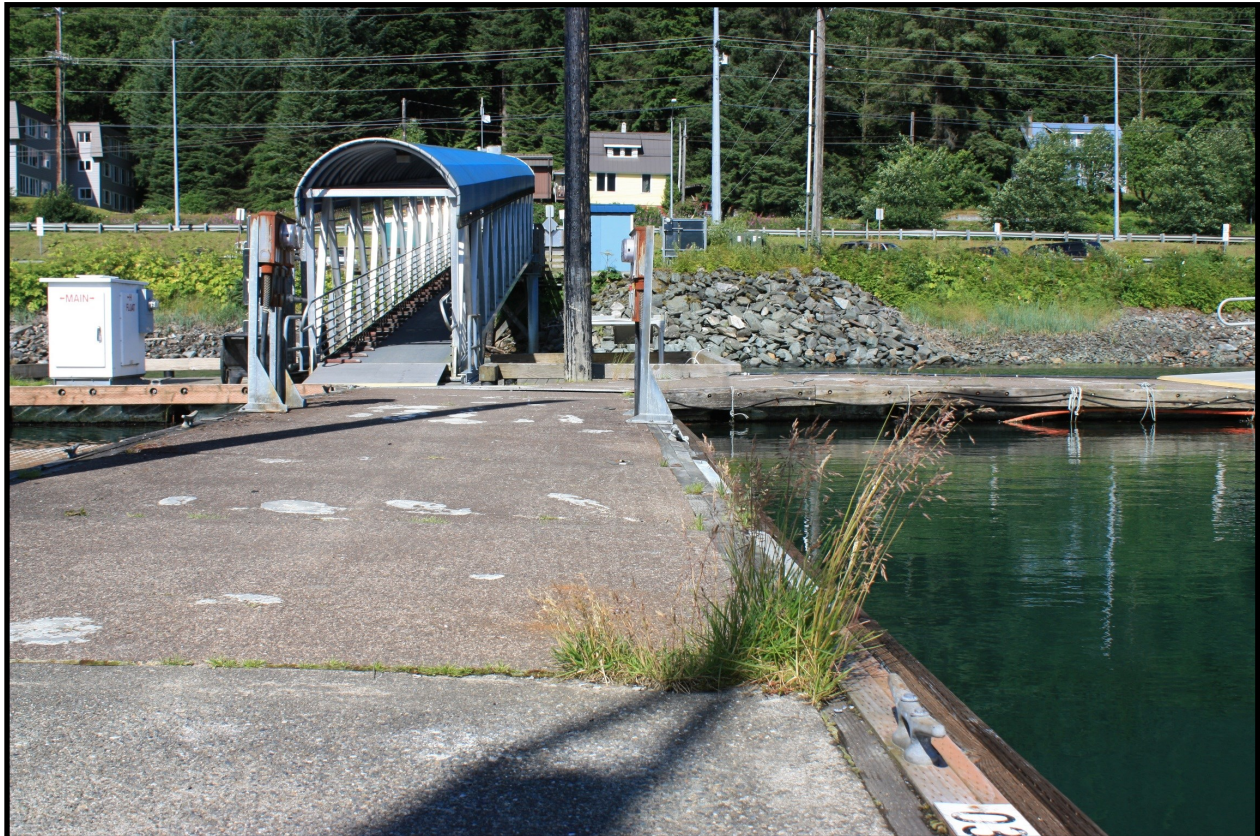
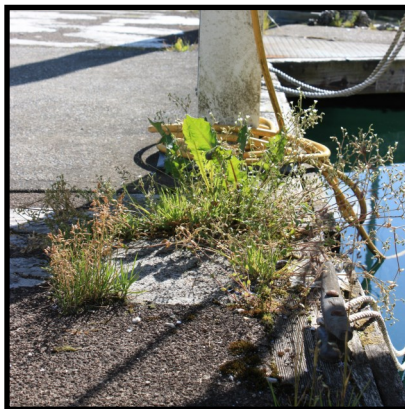
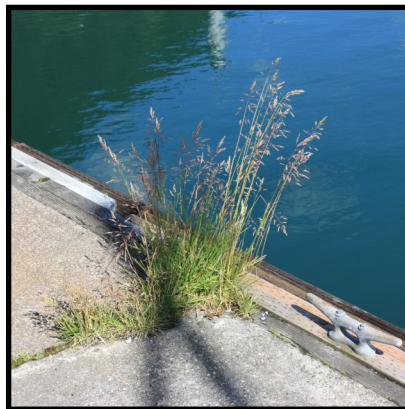
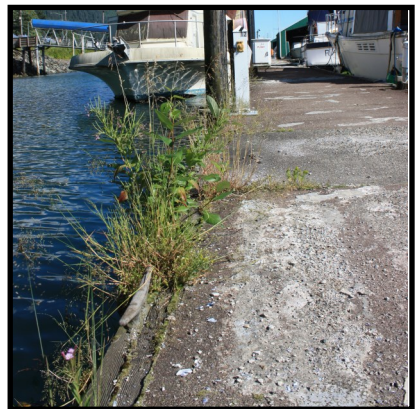
Significant vegetation growth on floats

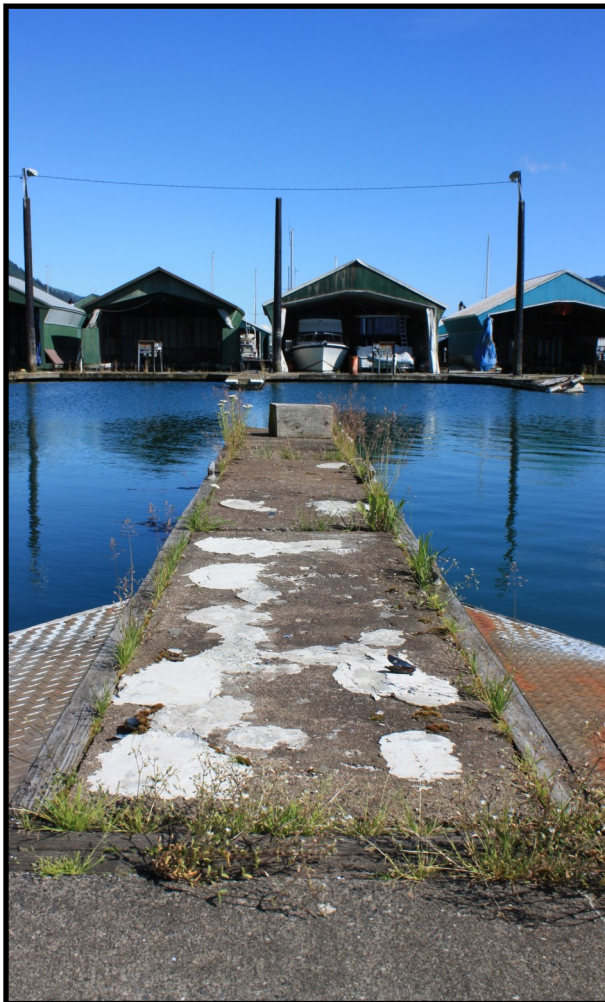
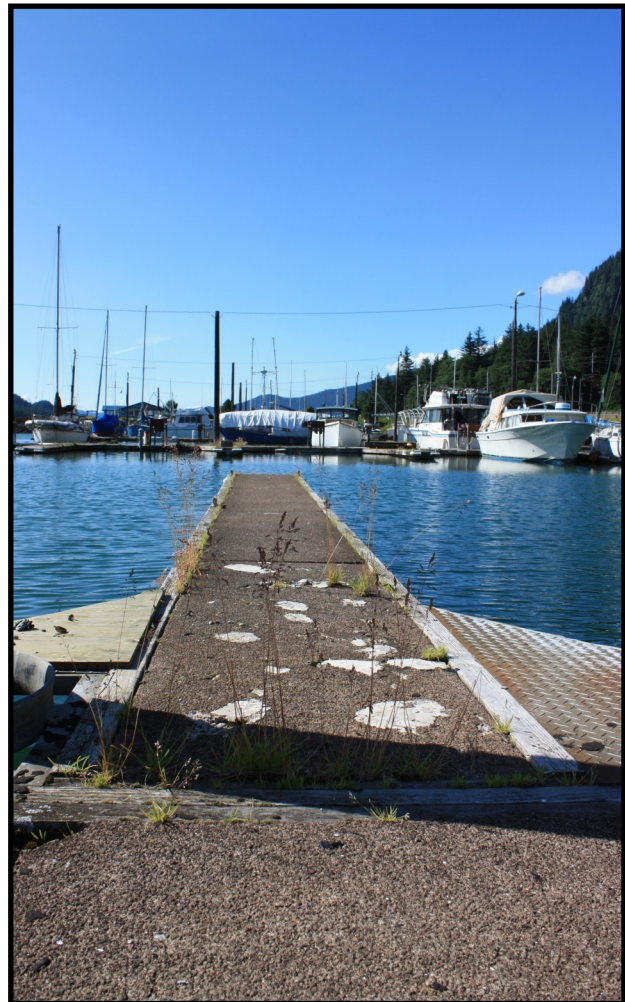
Concrete wear and vegetation growth on floats

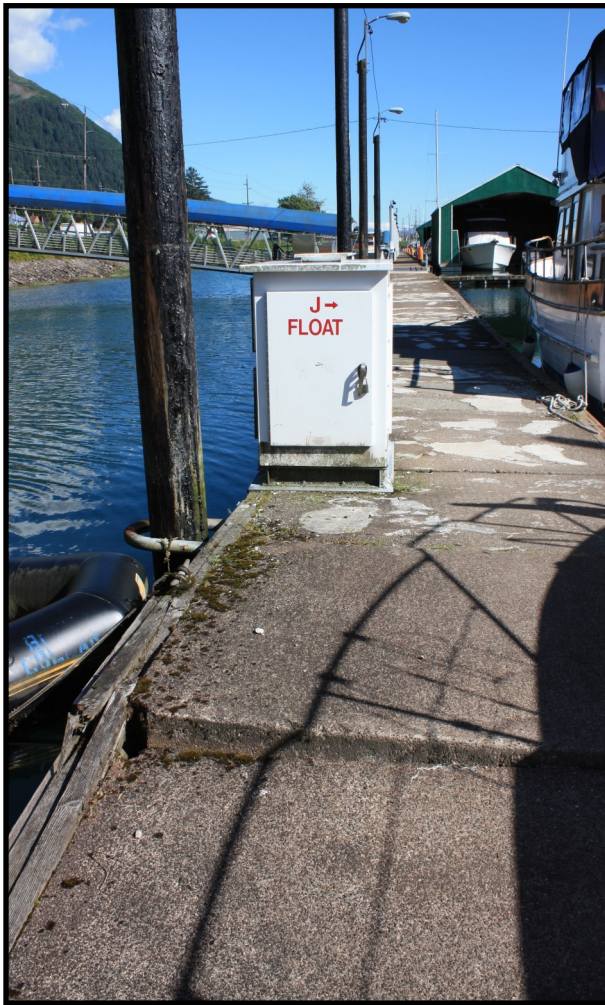
Damaged headwalk float
